**SAFETY
RECALL**

SR15-04A

DATE :	MARCH 2015	SECTION :	01 - Engine
SUBJECT:	AFTERTREATMENT HYDROCARBON INJECTOR (AHI) - HARD FUEL LINE INSPECTION

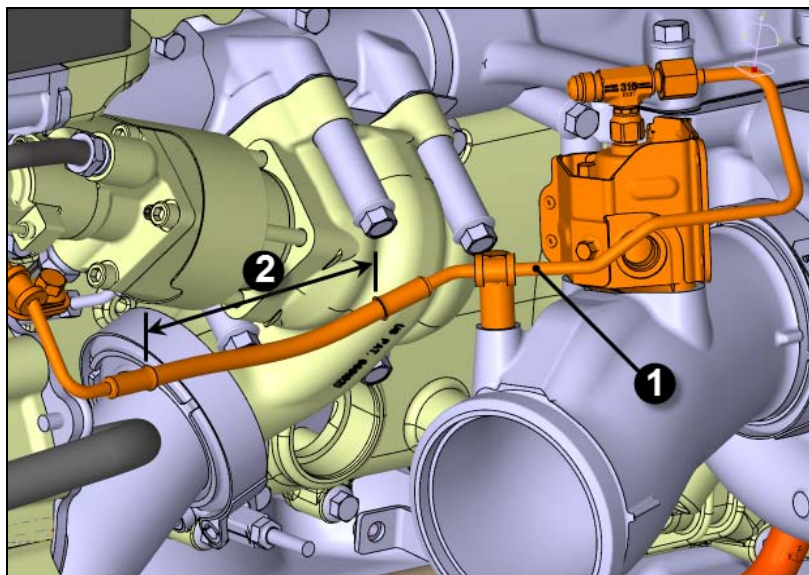
FIGURE 1 : INVOLVED GENERATION OF AHI

It was determined that there is a risk that rubbing between the hard fuel line and the coolant line may seriously damage the hard fuel line. Perforation of the hard fuel line could result in spraying fuel onto hot exhaust components potentially resulting in an engine fire. This bulletin is applicable to the AHI of first generation only (see FIGURE 1 to identify involved AHI generation).

- 1- Aftertreatment hydrocarbon injector (AHI) hard fuel line
- 2- Braided section of the hard fuel line

1. Open the engine compartment rear door.
2. Locate the aftertreatment hydrocarbon injector (AHI) (FIGURE 1). It is mounted on top of the turbocharger outlet pipe.
3. Locate the AHI hard fuel line (item 1, FIGURE 1).

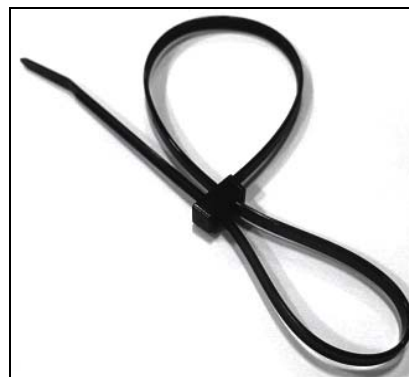
FIGURE 2 : APPROPRIATE DOUBLE LOOP NYLON TIE

4. Locate the braided section of the AHI hard fuel line (item 2, FIGURE 1).
5. Confirm that a double loop nylon tie is installed on the braided section of the injector's hard fuel line (see FIGURE 2 to identify the appropriate type of nylon tie). This can easily be done from behind the coach by visual inspection with a flashlight. This double loop nylon tie should be installed there to

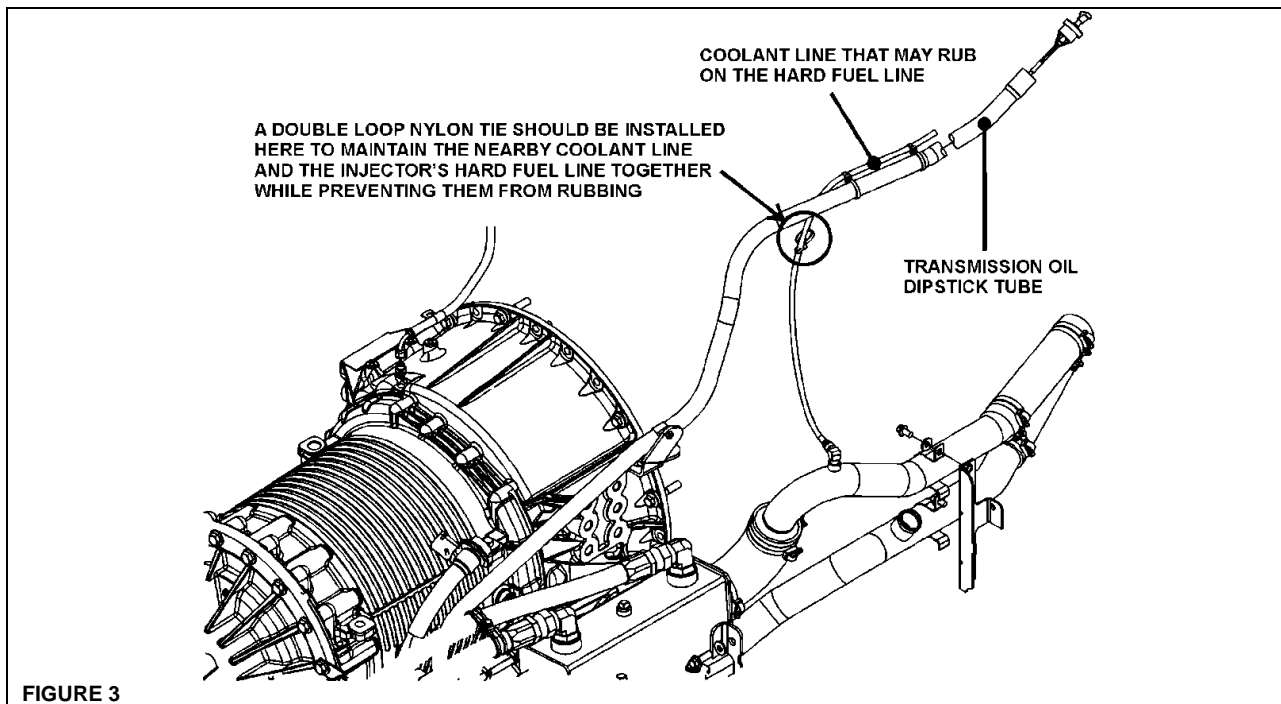
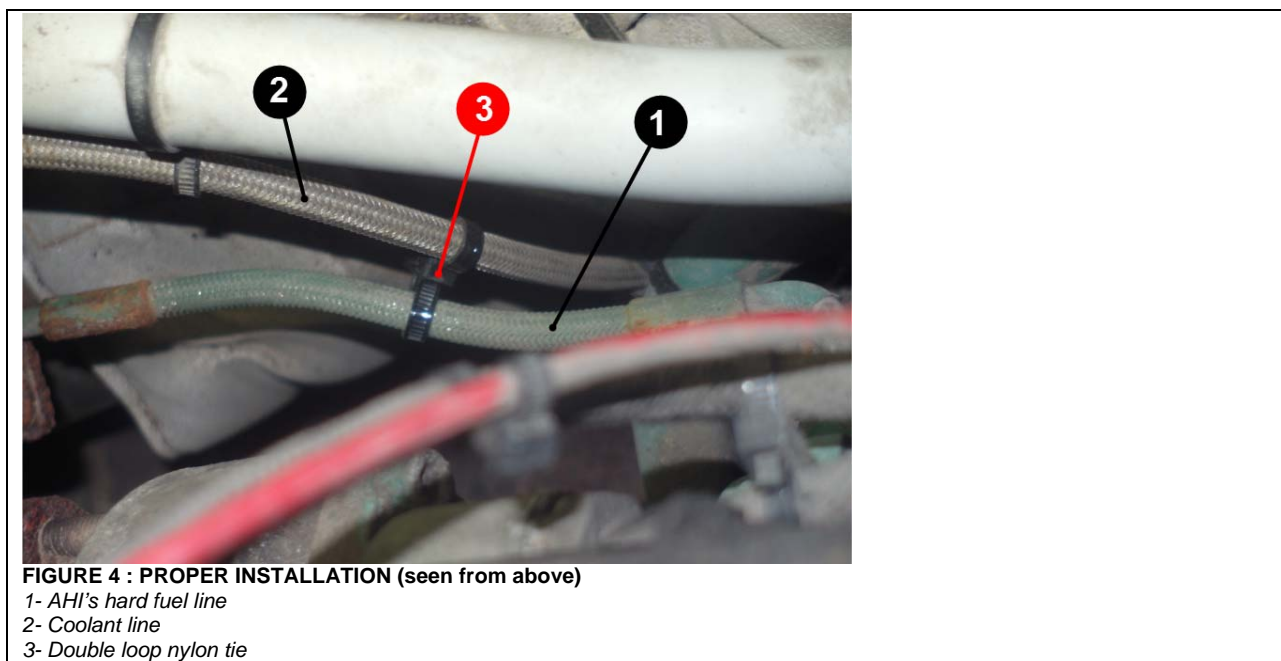
maintain the nearby coolant line and the injector's hard fuel line (AHI) together while preventing them from rubbing against each other (see FIGURE 3).

6. If the double loop nylon tie is present as shown in FIGURE 4, then the installation is correct. This completes this bulletin, no further verification is required.

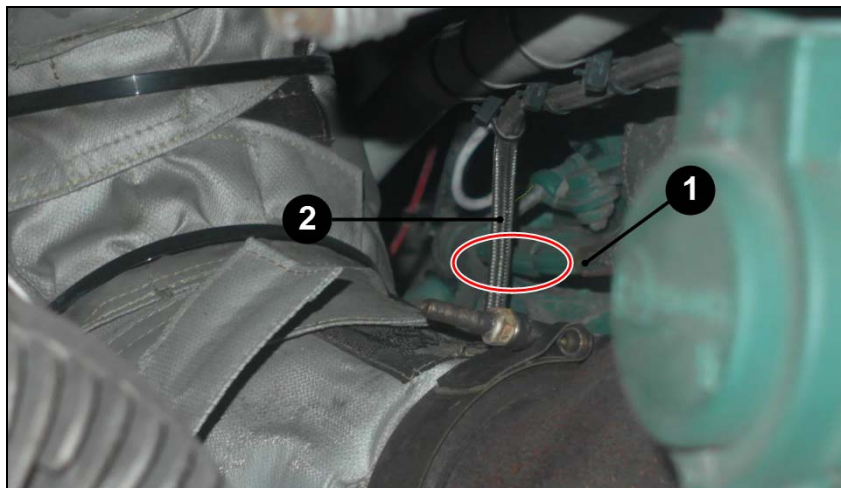
FIGURE 5: MISSING DOUBLE LOOP NYLON TIE

1- AHJ's hard fuel line
2- Coolant line

7. If, as in FIGURE 5, the nylon tie is missing or an inappropriate nylon tie is installed (as shown on FIGURE 6), there is a risk that the injector's hard fuel line be damaged by rubbing against the coolant line. **The AHJ's hard fuel line must be checked and if damaged, it must be replaced.**

Given the risks associated with the replacement and installation of fuel line located close to hot components such as turbocharger, **you must make an appointment** in a Prevest Service Center or Prevest Certified Service Provider to have the hard fuel line checked and replaced if necessary, free of charge.
