PREVOST

SAFETY RECALL

Sr98-32A

DATE : September 1998	SECTION : 06
SUBJECT : INSPECTION OF STARTER AND BATTERY CABLES

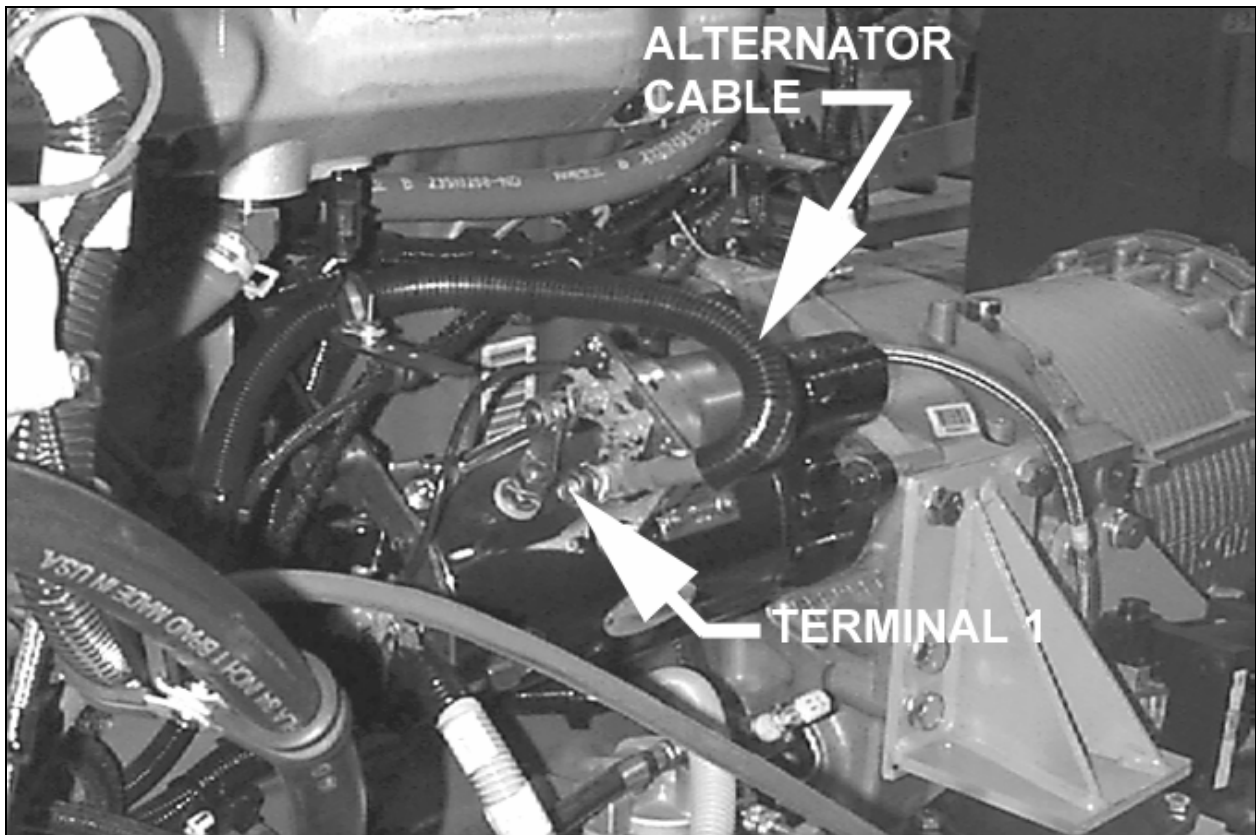
FIGURE 1 : STARTER CABLES

On the above-mentioned vehicles, wrong installation or incorrect torquing of starter cable fixing nuts may have occurred. Nuts may become loose after a period of time which could cause a short circuit or possibly a fire hazard.

1. Inspect alternator and battery cables connected to starter terminal # 1 (refer to figure 1).
2. Remove protective coating, loosen cable fixing nuts. Thoroughly clean cables and starter terminals.

3. Tighten first nut to 20 lbf?ft (27 N?m) torque.
4. Install alternator cable. Ensure alternator cable is positioned horizontally (3 o'clock). Refer to fig. 1.
5. Add two copper washers or one lock-washer.
6. Install battery cable to a 5 o'clock position, add one lock-washer and tighten to 27 lbf?ft (37 N?m) torque.

7. Install plastic protector cap.

Note : Ensure nothing was installed onto battery and alternator cables, also that there is a loop in order to absorb vibrations. From engine compartment, pull on battery cable to increase length if needed.
