**WARRANTY  
BULLETIN**

Wb00-06

<b>DATE :</b> FEBRUARY 2000	<b>SECTION :</b> 07 - Transmission
<b>EXPIRATION:</b> FEBRUARY 2001	
<b>SUBJECT :</b> TRANSMISSION OIL COOLER SUPPORT BRACKET MODIFICATION

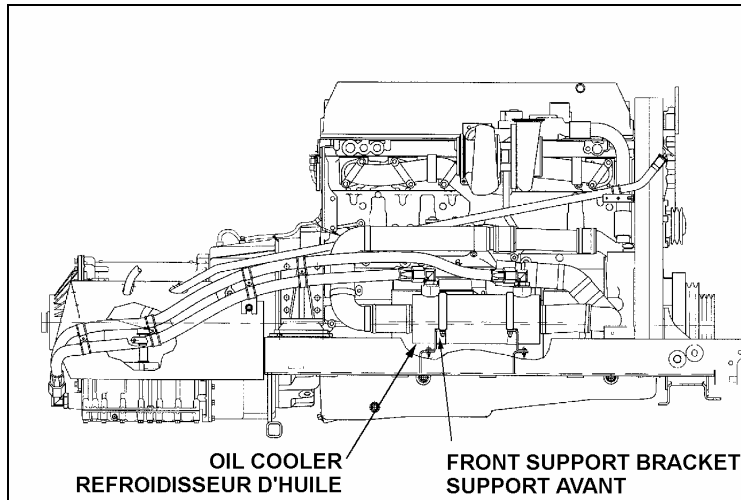
**FIGURE 1 : LEFT HAND SIDE OF ENGINE**

On the above mentioned vehicles, the transmission oil cooler front support bracket is too close to the engine oil filter and there is a risk of perforation due to the rotating movement of the engine. A modification is necessary in order to keep a minimal clearance between the support bracket and the filter.

1. Underneath the vehicle, on the left side of the motor, unscrew the front U-shaped clamp (figure 1).
2. Adequately support the oil cooler.
3. Unscrew and remove the front support bracket (figure 2).
4. Cut the corner of the support bracket to an angle of 45° as per figure 2.
5. Drill two 15/32" (12mm) diameter holes as per figure 2.
6. Using the new holes, reinstall the support bracket.
7. Reinstall the U-shaped clamp. Tighten the bolts properly.
8. The modification is now completed.
