PREVOST

**WARRANTY
 BULLETIN**

Wb03-19

DATE : SEPTEMBER 2003 SECTION : 16 - Suspension
EXPIRATION: SEPTEMBER 2005
SUBJECT VERIFICATION OF TIGHTENING TORQUE ON : 18000LBS INDEPENDENT SUSPENSION LOWER A-ARM

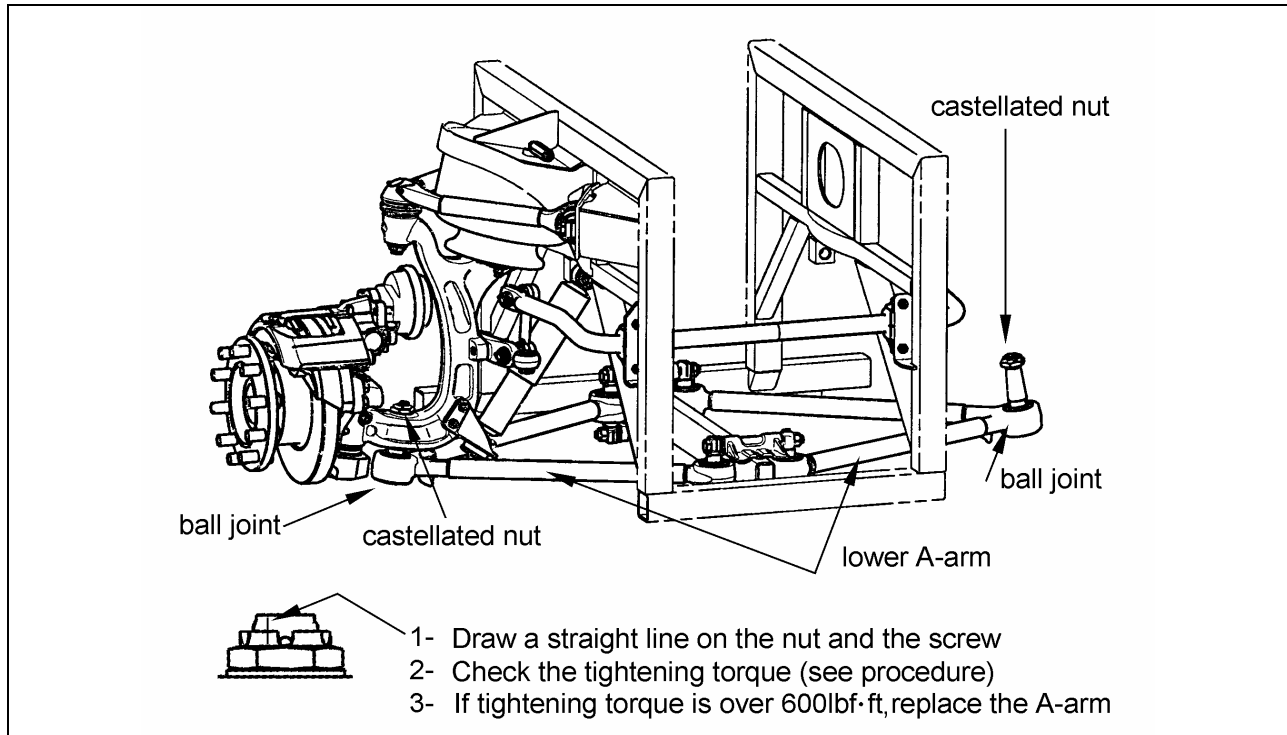
FIGURE 1

On the above mentioned vehicles, the castellated nut on R.H. and L.H. side lower A-arm ball joint may have been tightened to high. It is necessary to check the tightening torque. **Part A** of this bulletin describes how to check the tightening torque of the nut. If the castellated nut is tightened to high, the A-arm has to be replaced as described in **part B**.

1. Raise the vehicle. Remove the front wheels.
2. Locate the castellated nut (see figure 1). Remove the cotter pin.
3. As a reference mark, draw a straight line on the nut and the screw (figure 1). This mark will indicate if the nut has turned during the test.

Note: The maximum admitted tightening torque is 600lb·ft. It is necessary to check if the present tightening torque is under 600lb·ft. To do so, use a torque setting type torque wrench (automatic cut-out) adjusted to 600lb·ft. The goal is to check if the castellated nut turns during application of a torque, while avoiding triggering off of the torque wrench. The reference line on the nut and screw will help to detect a small rotation. Apply a torque clockwise, which is the normal direction to tighten the nut. **While tightening, do not pass the cotter pin insertion hole in order to avoid increasing the torque higher than 600lb·ft.**

If the nut rotates and there is no triggering off of the torque wrench, then the castellated nut is not tighten to high, the A-arm doesn't have to be replaced. If there is triggering off of the torque wrench with no rotation of the castellated nut, then the nut is tighten to high.

4. Check the tightening torque.
5. If the tightening torque is less than 600lb·ft, no replacement is required and part B of this bulletin doesn't have to be performed. Just place a new cotter pin #502106. If the castellated nut has been tightened to high, the lower A-arm has to be replaced as described in **part B**.
