**PREVOST**

**WARRANTY  
BULLETIN**

Wb06-05A

<b>DATE : JUNE 2006</b>	<b>SECTION : 23 - Accessories</b>
<b>EXPIRATION: JUNE 2008</b>	
<b>SUBJECT : INSPECTION OF A PIVOT ON THE WINDSHIELD WIPERS MECHANISM</b>

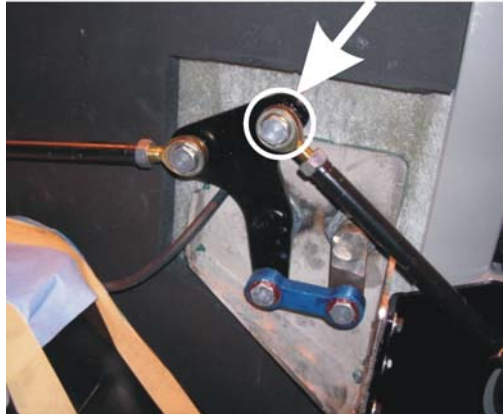
<p>3. The pivot which has to be inspected is indicated on the picture at right.</p>

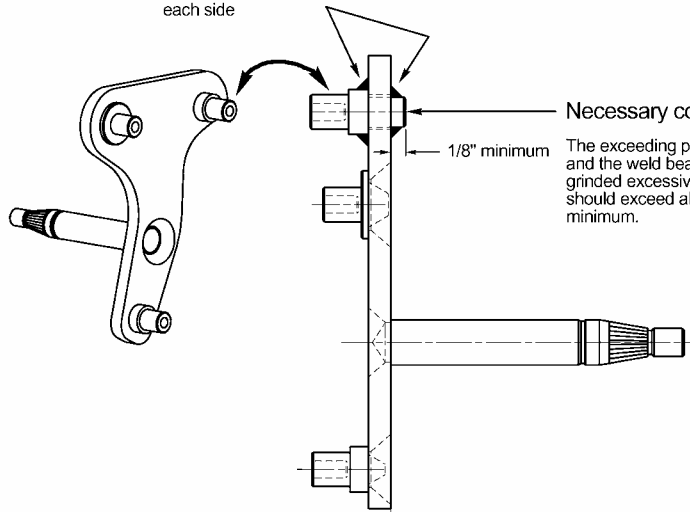
Necessary condition #1

There must be a weld bead of at least 1/8" each side

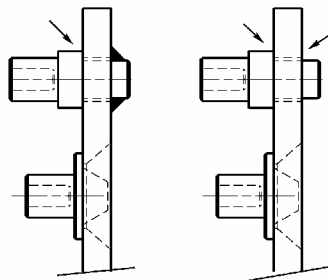
Part is not up to the standards of quality and must be replaced in the following cases (see figure at right).

One or both weld beads are missing

The exceeding part of the pivot and the weld bead are grinded too much

Replace part if:
