**WARRANTY
BULLETIN**

Wb07-02

DATE : AUGUST 2007	SECTION : 04 - Exhaust
EXPIRATION: AUGUST 2009	
SUBJECT: INSTALLATION OF AN EXHAUST PIPE REINFORCEMENT BRACKET AT TURBO OUTLET

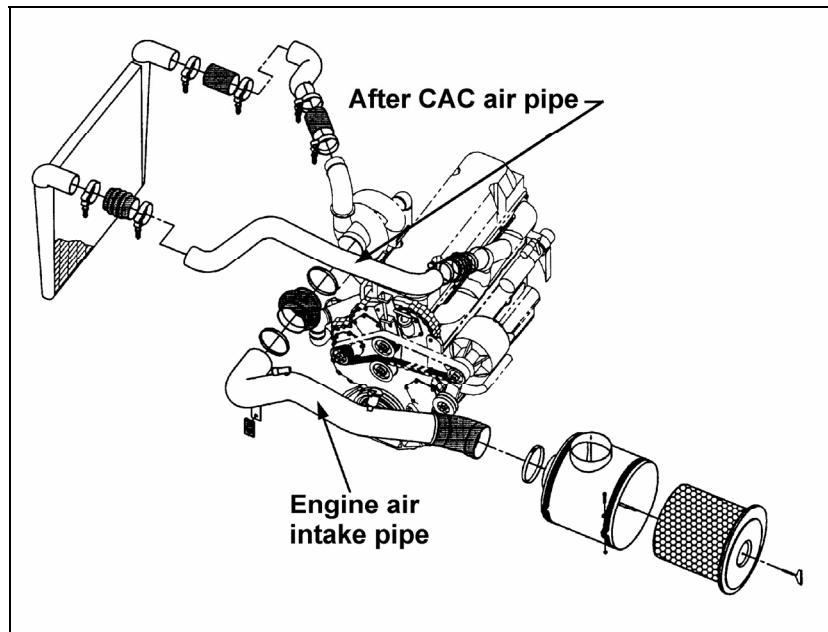
FIGURE 1: ENGINE COMPARTMENT

On the above-mentioned vehicles, there is a possibility that the exhaust pipe at turbocompressor outlet breaks due to lack of support or engine vibrations.

3. Remove engine air intake pipe (refer to fig. 1).
4. Remove after CAC air pipe (refer to fig. 1).
5. Remove the two bolts which secure the exhaust pipe.
6. Torque both engine stud bolts (Prévost #510626) to 43 - 54 lbf·ft (58 - 73 Nm). Install new reinforcement bracket (Prévost #040561) and tighten Stover nuts (Prévost #500680) as shown in figure 2.
7. Install U bolt assembly (Prévost #540018) and tighten U bolt nuts.
8. Reinstall after CAC air pipe and engine air intake pipe.
