**WARRANTY  
BULLETIN**

Wb07-12

<b>DATE : DECEMBER 2007</b>	<b>SECTION : 05 - Cooling</b>
<b>EXPIRATION: DECEMBER 2009</b>	
<b>SUBJECT : REPLACING THE PIPE CONNECTING THE TURBOCOMPRESSOR TO THE CHARGE AIR COOLER (CAC)</b>

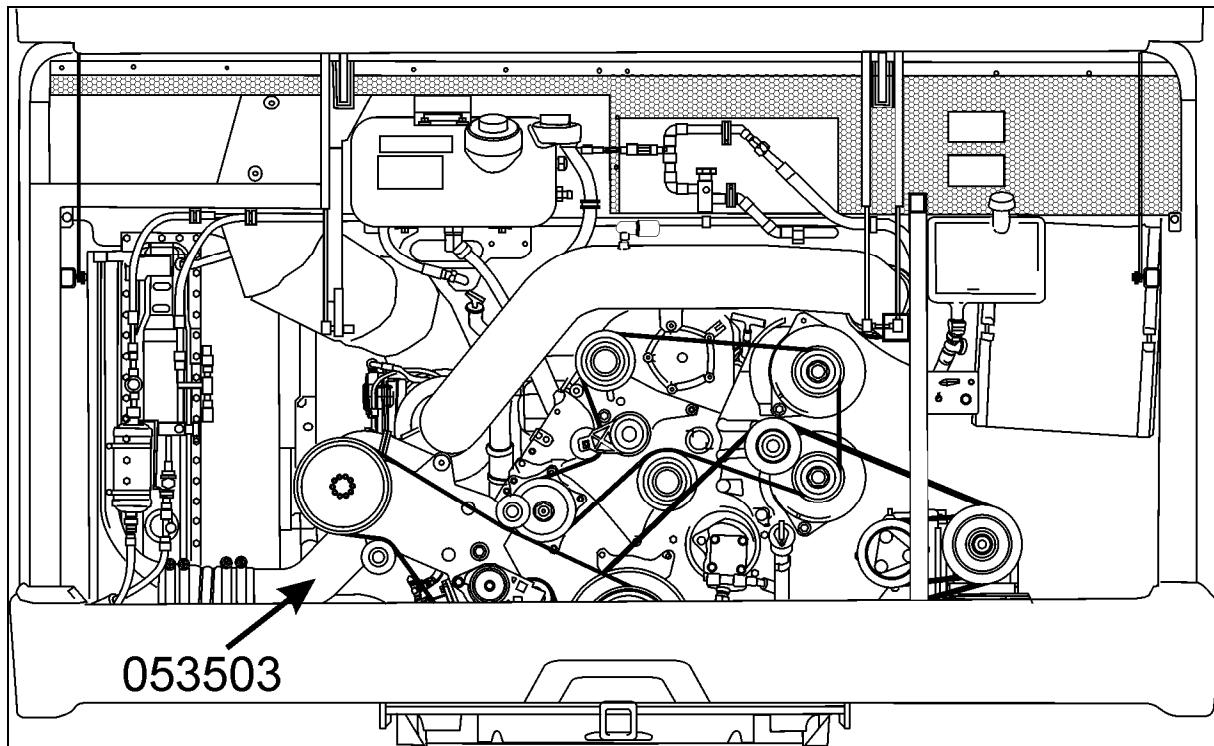
FIGURE 1: ENGINE COMPARTMENT

On the above-mentioned vehicle, there is a possibility that the connecting pipe located at the turbocompressor outlet strikes against the radiator fan drive mechanism support. Abrasion or perforation could result and thus result over the long run in damage to the Diesel Particulate Filter (DPF) or loss of engine performance.

1. Open engine compartment door.
2. Set rear start switch to the OFF position.
3. Locate connecting pipe then untighten the constant-torque hose clamps fixing the connecting pipe (Refer to figures 1 and 2).
4. Remove the connecting pipe and install the new one (053503).
5. Torque hose clamps to 9-11 lbf·ft (Refer to figure 2).
6. Position the CAC pipe, coolant line and cooling fan drive mechanism universal shaft so that the various gaps are respected and that no rubbing occurs between the various parts.
