**PREVOST**ENREGISTRÉ - REGISTERED  
**ISO 9001 & ISO 14001**

## WARRANTY BULLETIN

Wb10-13

| SUBJECT : OVERHEATING OF HALOGEN LOW BEAM HEADLIGHT CABLE CONNECTOR | |

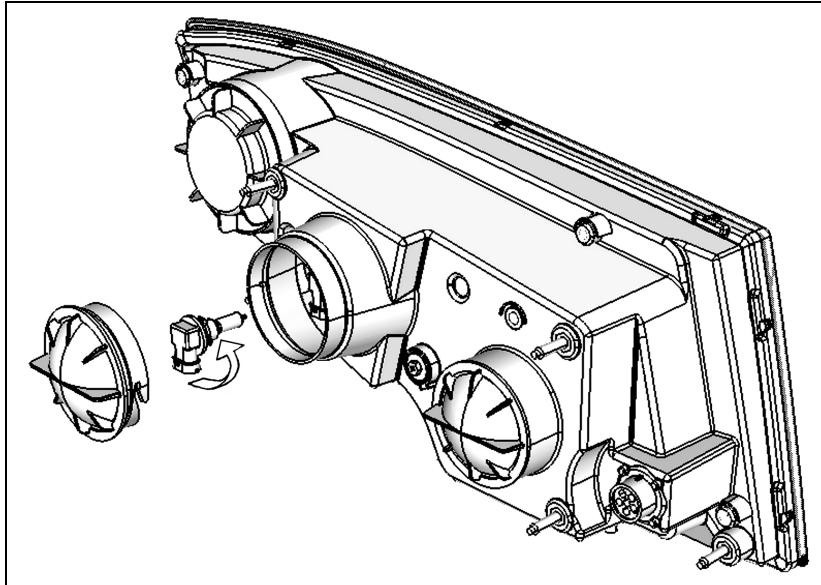
FIGURE 3: LOW BEAM AND CONNECTOR

On the vehicles affected by this bulletin, there is a risk that the low beam electrical connector overheats; which may prevent the low beam headlights from being used.

4. Unscrew the low beam access cap to gain access to the bulb connector.

5. Turn the bulb base counterclockwise (figure 3).

6. Separate connector from bulb base.
