PREVOST

WARRANTY BULLETIN

Wb11-05

DATE : JUNE 2011	SECTION :	04 - Exhaust
EXPIRATION: JUNE 2013		
SUBJECT : EXHAUST PIPE ANGLE BRACKET INSPECTION

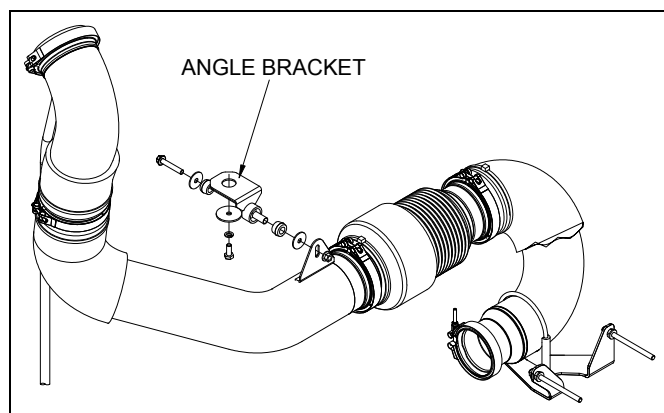
FIGURE 2: INSTALLATION WITH DDEC SERIES 60

On the vehicles affected by this bulletin, the bolt holding the exhaust pipe angle bracket to the ceiling of the engine compartment may come loose. The exhaust pipe could then start to move and vibrate causing the exhaust pipe to break. Adding a jam nut or replacing the angle bracket if damaged will eliminate the problem and increase the reliability of the installation.

4. Inspect the angle bracket to see if the fixing bolt is missing.
5. If the bolt is present, tighten the bolt and secure the assembly by adding a jam nut

(500847) on top of the nut.

6. If the bolt is missing, install a new bolt

(502804) and secure the assembly by adding a jam nut

7. If the angle bracket is damaged, it can be replaced with the new bracket

(040892).
