# PREVOST

## WARRANTY BULLETIN

### WB13-32A

DATE :	JUNE 2013	SECTION :	04 - Exhaust
EXPIRATION:	JUNE 2015		
SUBJECT :	NOX SENSOR REPLACEMENT & SOFTWARE UPDATE

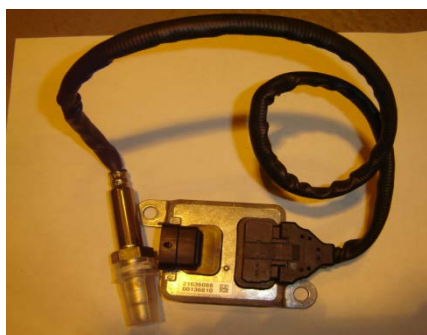
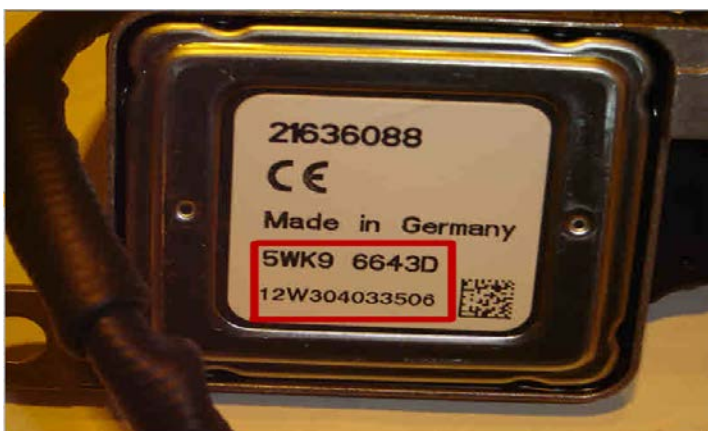
1. Open the SCR access door.
2. Write down new electronic module serial number before installing.

(Located at the back of the electronic module).
