PREVOST

**WARRANTY
BULLETIN**

WB14-08C

DATE :	MAY 2014	SECTION :	06 - Electrical
EXPIRATION:	MAY 2016		
SUBJECT :	GATEWAY MODULE REPLACEMENT

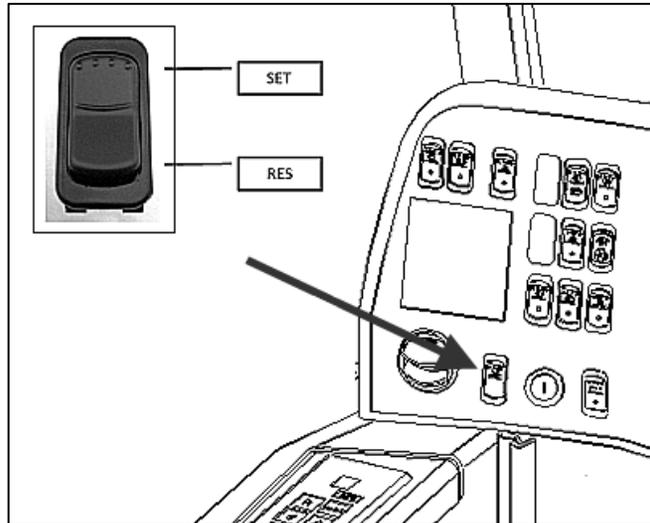
Figure 1

First identify if vehicle has a *temporary cruise set/resume switch* on the left dashboard.

STEP A will detail how to remove the temporary cruise control switch installation.
