## WARRANTY BULLETIN

### WB14-28E

DATE :	OCTOBER 2014	SECTION :	23 - Accessories
EXPIRATION:	OCTOBER 2016		
SUBJECT :	AFSS LINEAR THERMAL DETECTOR (LTD) REPLACEMENT AND RELOCATION OF IR SENSOR

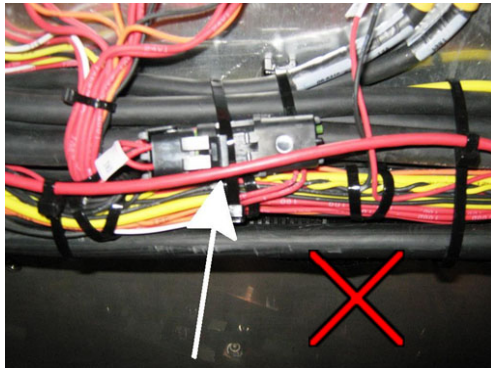
**NOT ALLOWED**

Possible contact or rubbing against screws, edges, etc.

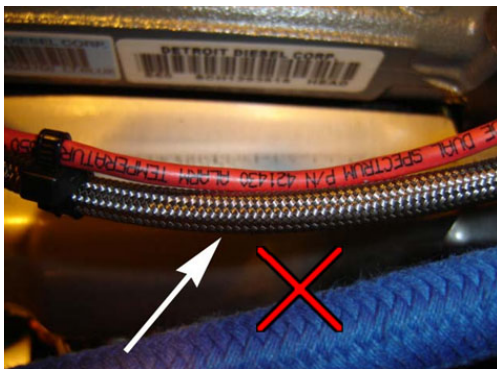
**NOT ALLOWED**

Rubbing or possible rubbing against abrasive surfaces

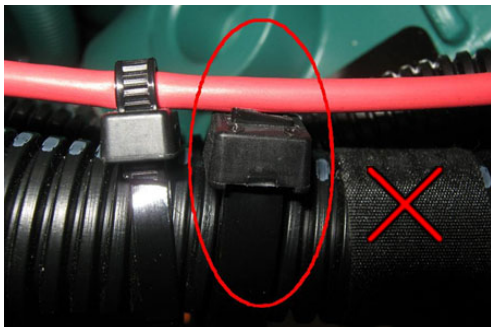
**NOT ALLOWED**

LTD touching cut cable tie

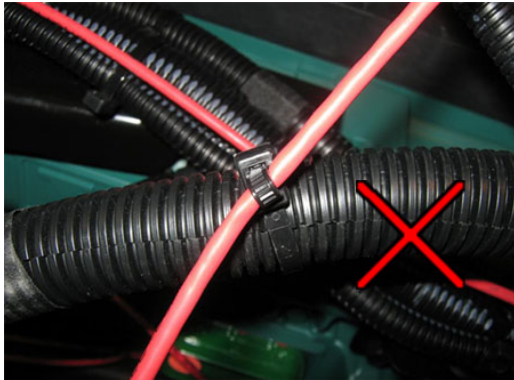
**NOT ALLOWED**

LTD extending slantingly from the cable tie

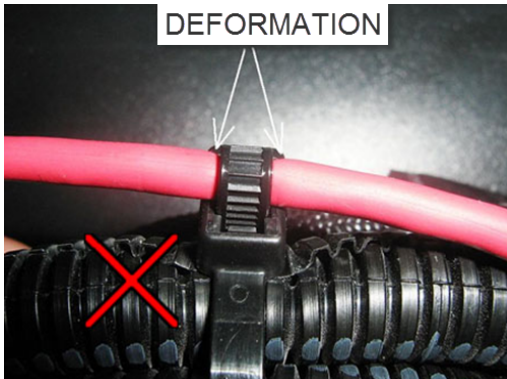
**NOT ALLOWED**

Cable tie tighten in excess on the LTD. Tighten cable tie on LTD by hand only. Tighten just enough to prevent LTD from slipping from once side to the other inside the cable tie loop
