Warranty Bulletin**95-33**Date: **August 1995**Section: **03**Subject: **"U" BRACKET ADDED TO THE RADIATOR SEALING FRAME - H3
VEHICLES WITH PLASTIC FUEL TANK**

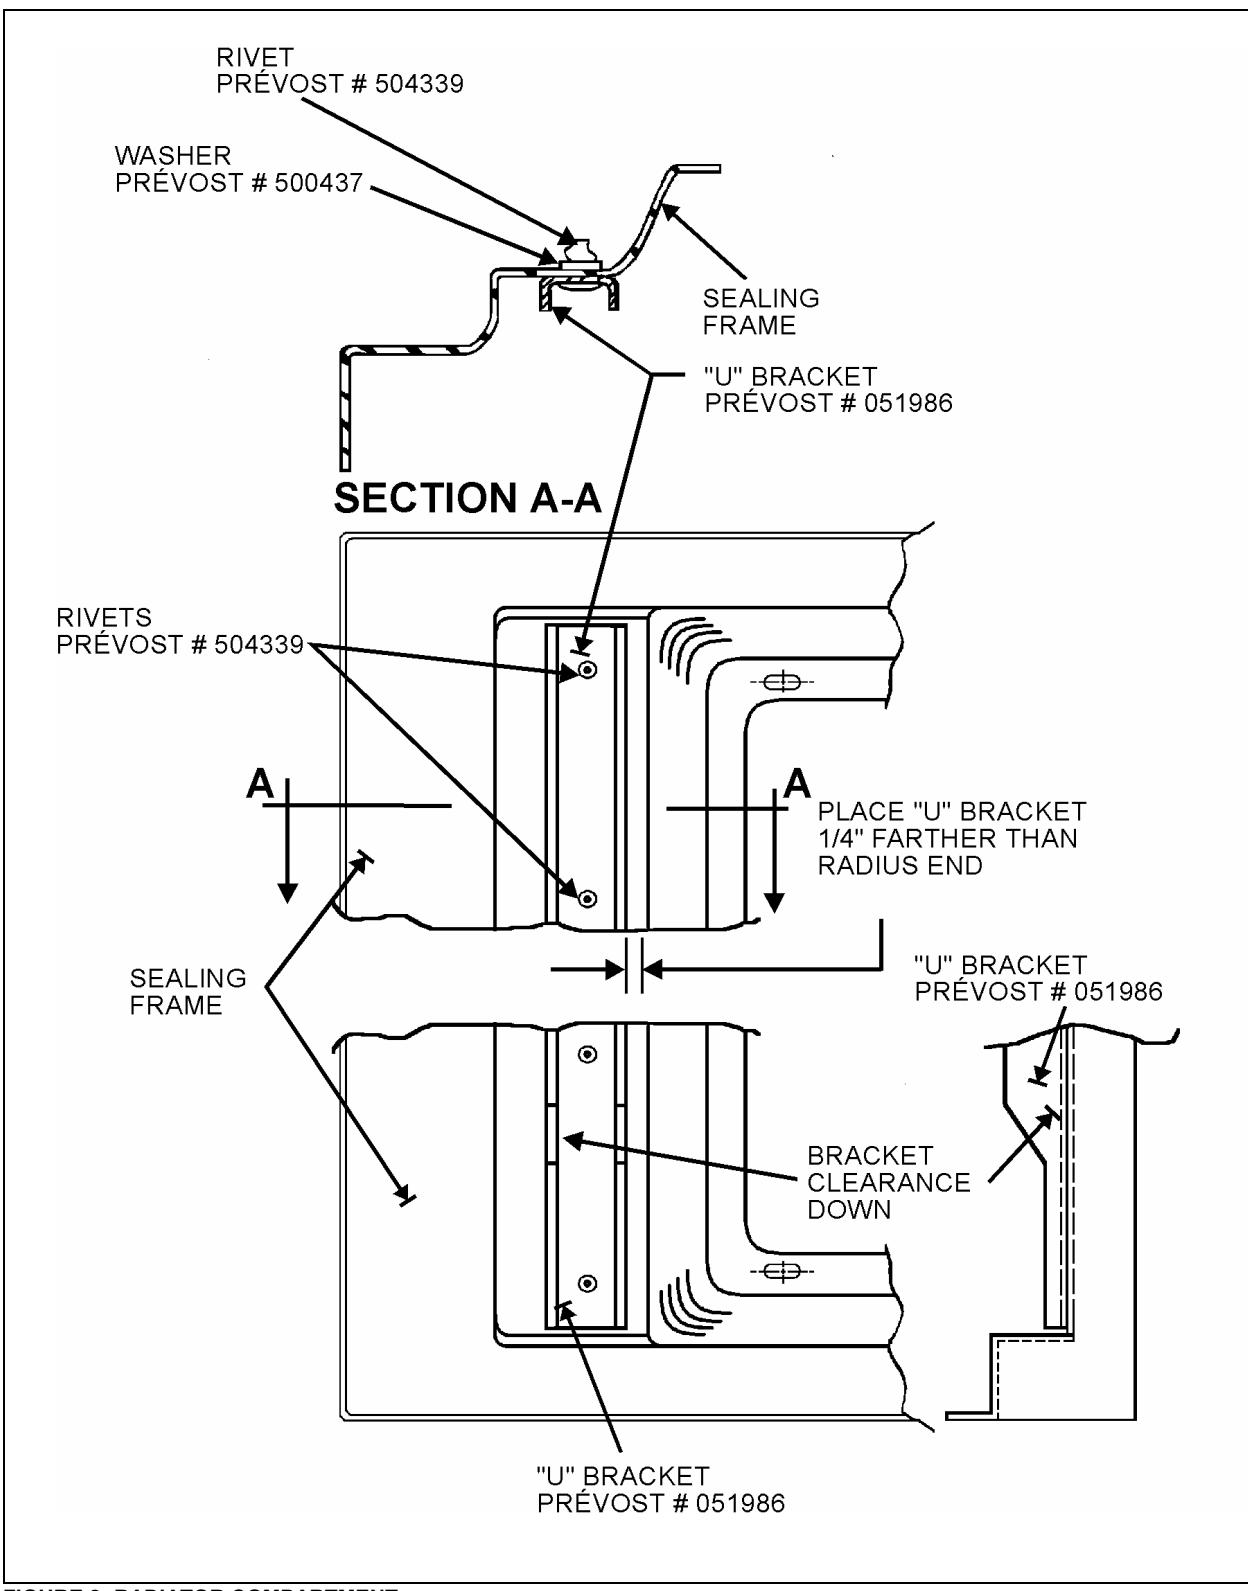
FIGURE 2: RADIATOR COMPARTMENT

On the above mentioned vehicles, a "U" bracket must be installed to increase radiator sealing frame's stiffness. To perform this modification, proceed according to the following procedure.

4. Place "U" bracket on radiator sealing frame. Horizontally, the bracket should be 1/4" farther than the radius end. (see figure 2). Vertically, center "U" bracket on sealing frame.
5. Drill sealing frame with a 1/8" drill in the "U" bracket holes (7).
6. For each hole (7), place pop-up rivet and washer (see figure 2, Section A-A).
7. Reinstall preheating system panel.
8. Close compartment doors.
