# PREVOST

## Warranty Bulletin

96-07

Date: **April 1996**  
Section: **07**  
Subject: **WIRING HARNESS MODIFICATIONS - W/T TRANSMISSION**  
Application:

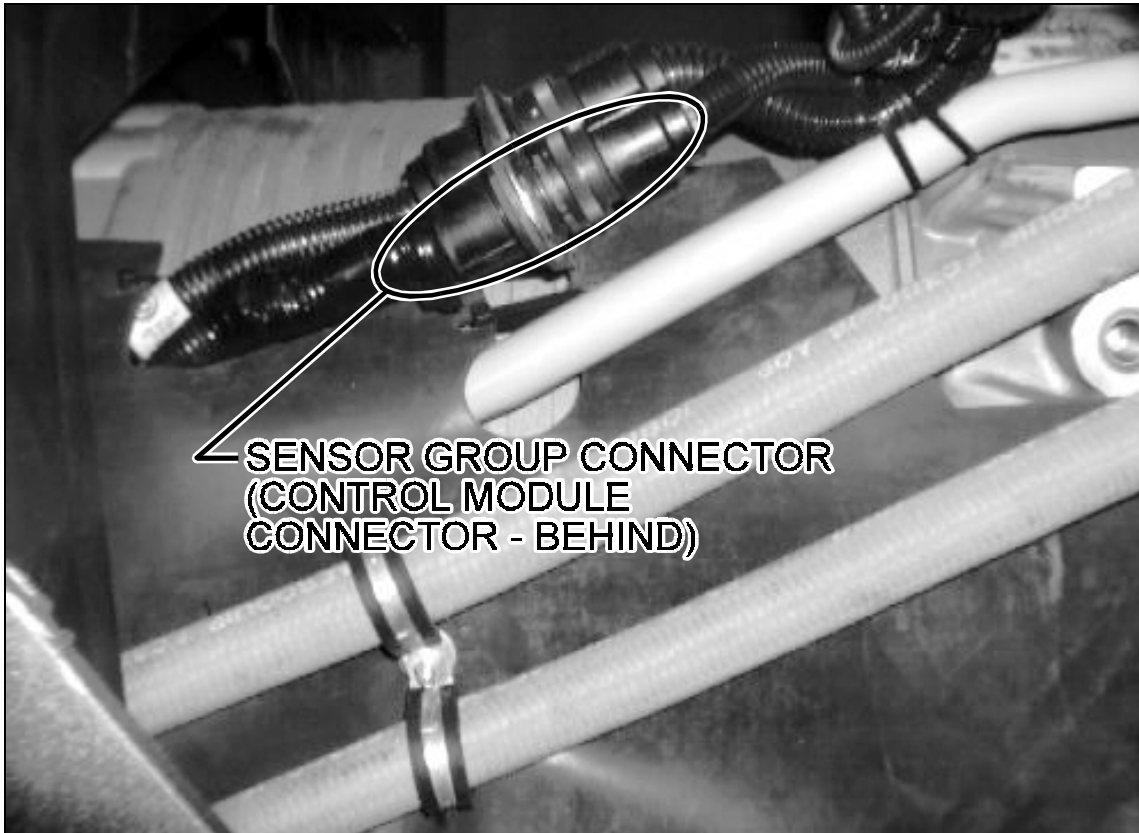
FIGURE 1: VIEWED FROM DRIVER'S SIDE

An error has been found in the manufacturing of two connectors on World transmission wiring harness. Wire 140 on both connectors is installed in position "A" and should be in position "L". This error does not cause any malfunction or problems other than the fact that when harness #064237 is replaced, a code 22-15 gets logged into the queue. To remedy this situation, proceed as follows.

1. Access transmission (driver's side) from behind tag axle and locate wiring harness. (Fig. 1)
2. Disjoin harness connector for sensor group (Fig. 1).
3. Using the proper tool, extract wire 140 from position "A" and reinsert into position "L" for both male and female connectors.
4. Rejoin connector.
