**WARRANTY
BULLETIN**

Wb98-31A

DATE : October 1998	SECTION : 05
EXPIRATION : October 1999	
SUBJECT : AUXILLIARY A/C REFRIGERANT PIPE PROTECTION

Model	VIN
XL M-40, M-45 AND ME-45 Bus shells equipped with auxilliary A/C Model year: 1993-1999

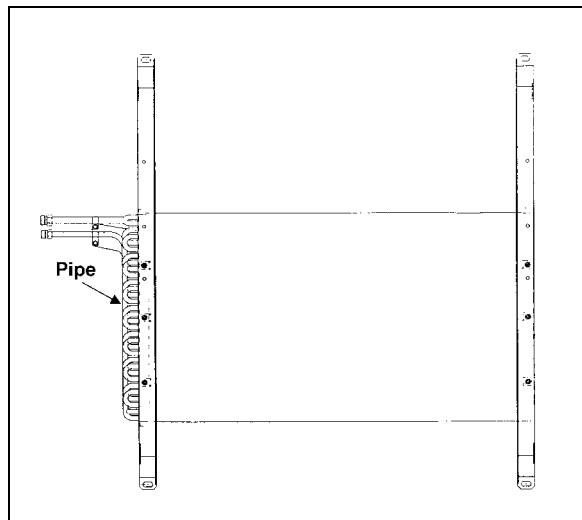
FIGURE 2 : CONDENSER

The refrigerant pipe may wear by rubbing against welds on the condenser. Installing a protective sheath will prevent this situation.

1. Open the radiator door (Fig. 1);
2. Find the refrigerant pipe to the left of the condenser (Fig. 2);
3. Cut about 13-3/4" (350 mm) of sheath;

4. Install the sheath on the length of the pipe at risk of being in contact with the condenser;
5. Close the radiator door.
