MAINTENANCE INFORMATION

MI15-18

SUBJECT: STRUCTURE INSPECTION FOR CORROSION - HOW

TO PREVENT CORROSION

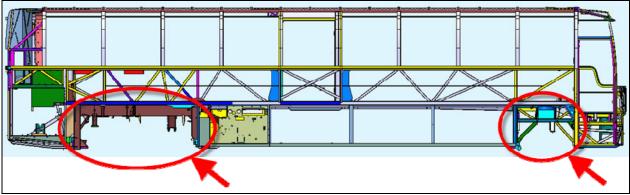
Front & rear sub-frames, drive axle cradle and tag axle (FIGURE 1) on Prevost structures are made of high strength steel. Although the structure on a Prevost vehicle receives a beneficial corrosion preventive compound application at the end of the manufacturing process, after many years of service with exposure to harsh environments (winter, frequent rains, road salt, stone projection, sand accumulation, etc.), the carbon steel can be subject to severe corrosion. The use of high strength steel remains a requirement to withstand peak loads.

FIGURE 1 - CRITICAL AREAS: FRONT SUB-FRAME, REAR SUB-FRAME, DRIVE AXLE CRADLE AND TAG AXLE

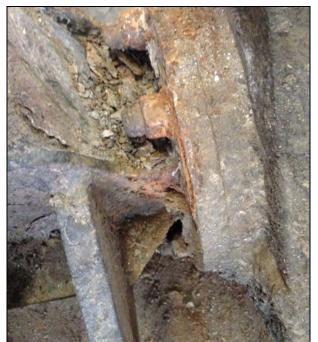
Vehicles operating in harsh environments without an appropriate corrosion protection compound applied to the front and rear sub-frames, drive axle cradle and tag axle could be subject to corrosion. If parts of the tag axle or front and rear sub-frames structures present metal flaking, separation of metal layers, loss of material, perforation, etc. then they should be inspected in order to confirm that the <u>minimum wall thickness remains</u> (FIGURE 2 to FIGURE 5).

FIGURE 3: METAL FLAKING AND ACCUMULATED SAND
