PREVOST

**SAFETY
RECALL**

SR15-27B

DATE :	JULY 2015	SECTION :	06 - Electrical
SUBJECT:	BOOSTER STUD AND CABLE PROTECTION

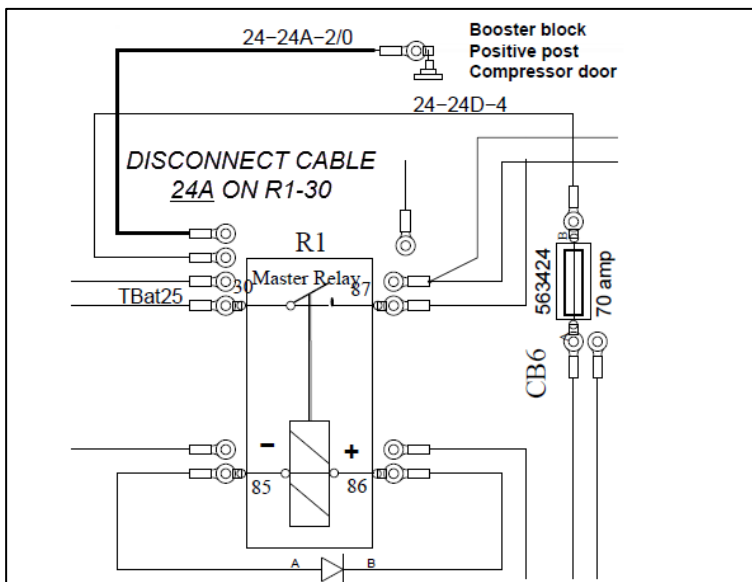
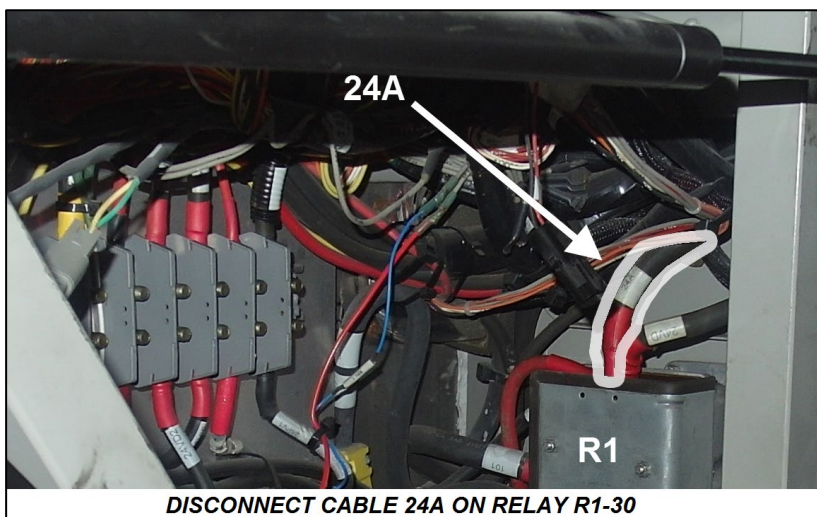
Figure 3 : 24A Cable Disconnection

Cable **24A** to the positive booster block *remains live* after tripping the breakers. In the main power compartment box, disconnect cables on main relay R1 *before* starting Step "A" below. (Fig 3&4)

Disconnect power source to the positive booster block.

Secure cables to avoid accidental contact.

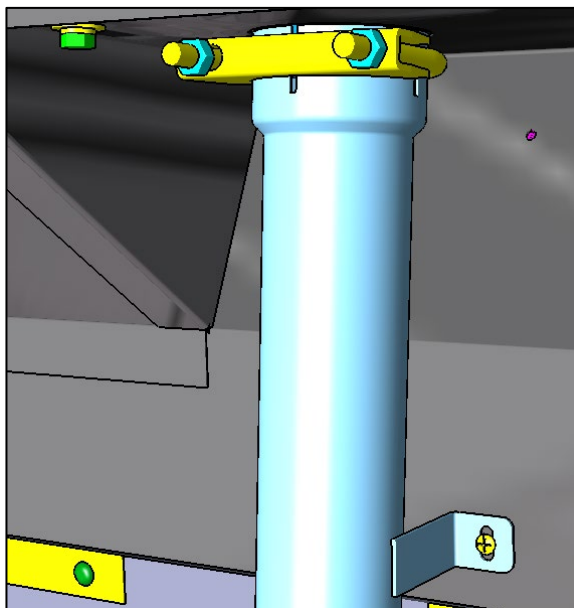
Figure 5

If tube and / or clamps are too corroded;
change parts.

- a. Close the water heating circuit shut-off valves.
- b. Prepare a suitable container and collection gutter or hose to empty coolant at water connections on heating unit. Remove coolant connections and empty cooling system.
- c. Remove heating unit exhaust tube.

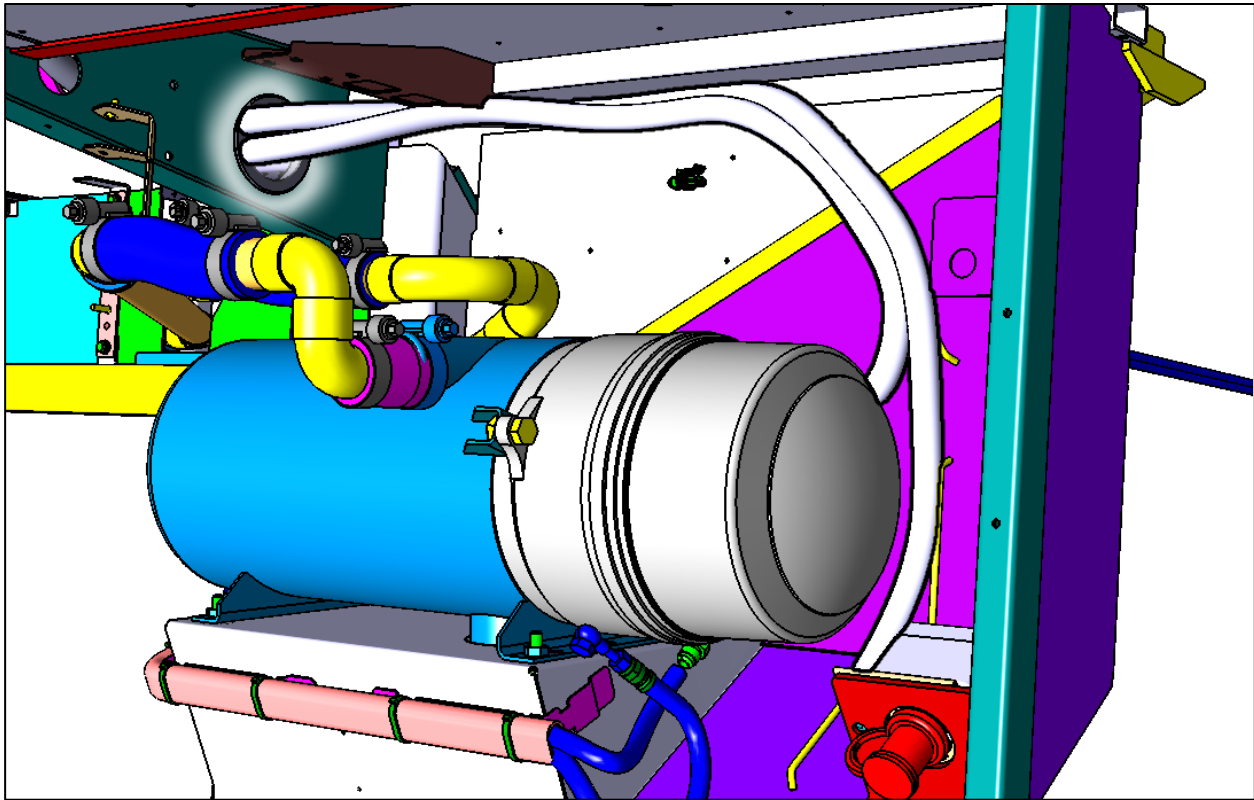
Figure 6 : Typical Volvo D13 cable routing

A2. Vehicles with **Volvo D13 engine** with or without pre-heater: perform a careful visual inspection of cable and grommet condition. (Figure 6)

If cable is significantly damaged, contact a Prevest regional service manager for further instructions.

If grommet appears damaged, replace grommet with a new # 504720.

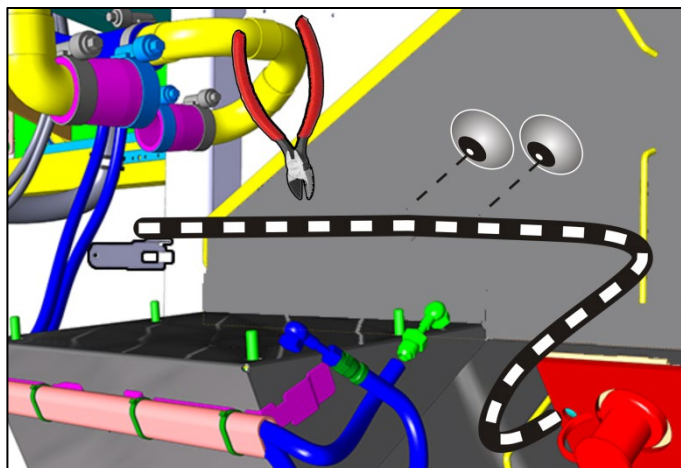
Figure 7

A5. *Perform a careful visual inspection of 24A power cable condition.*

If cable is significantly damaged, contact a Prevest regional service manager for further instructions.

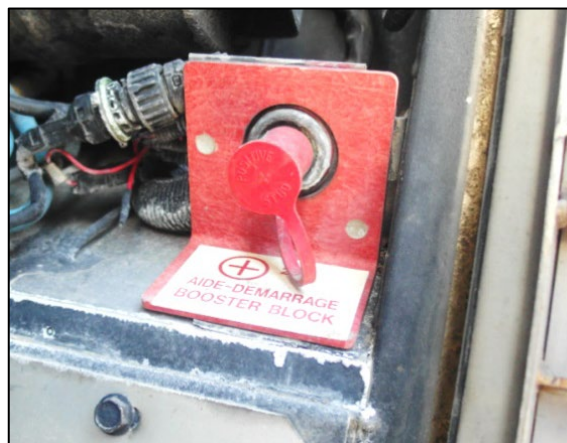
Figure 10

B5. After cutting the cable, look for any trace of corrosion that may have seeped up the cable. If corrosion is found, cut the cable further until good copper is found.

B4. Cut power cable just past the ring terminal where cable isolation begins. We must have clean, un-corroded copper for the new connection.

B7. Slip *black* heat shrink tube #563156 over terminal shank and cable, as close as possible from terminal (fig. 10)

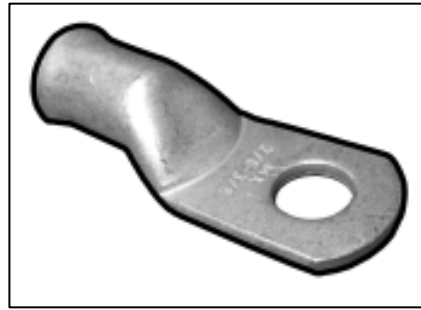
Open barrel terminals that expose the cable strands to corrosion should not be used for this recall.

Use closed barrel terminal 560895 only.
