PREVOST

WARRANTY BULLETIN

WB15-48A

SUBJECT: BITZER – ADDITION OF A REINFORCEMENT

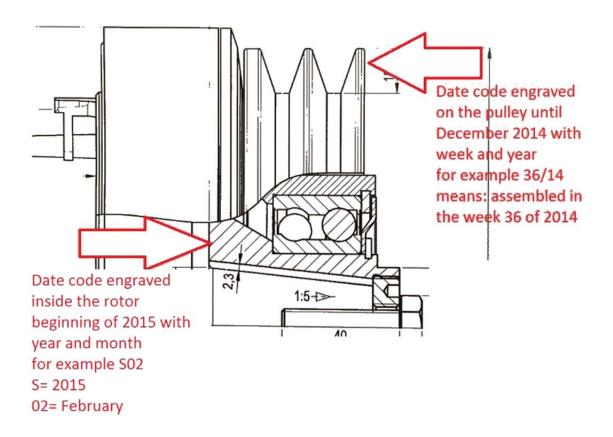
7.6. IF CLUTCH DOES NOT HAVE A DATE CODE, OR CODE FORMAT IS DIFFERENT FROM BELOW, **DO NOT REPLACE THE COIL.**

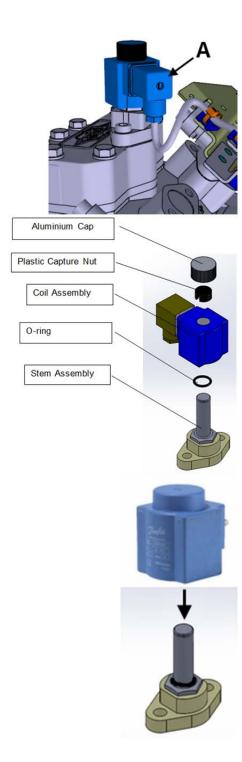
A new "clip-on" type unloader coil must be installed in order to avoid unloader failure.

- Loosen the screw securing the connector to the coil and then unplug the connector (A). Keep the screw and the connector rubber gasket for later use.
- 2. Unscrew the aluminum cap and discard.
- 3. Remove the plastic capture nut and discard.
- 4. Remove the coil and discard
- 5. **Keep** the O-ring on the stem.

- 6. Install the new clip-on coil on the stem.
- 7. Slide the coil over the stem assembly with the O-ring at the base of the stem.
