# PREVOST

## WARRANTY BULLETIN

**WB17-21**

DATE :	July 2017	SECTION :	06 ELECTRICAL
EXPIRATION:	July 2019		
SUBJECT :	<b>AE52-J2 GROUND MODIFICATION</b>

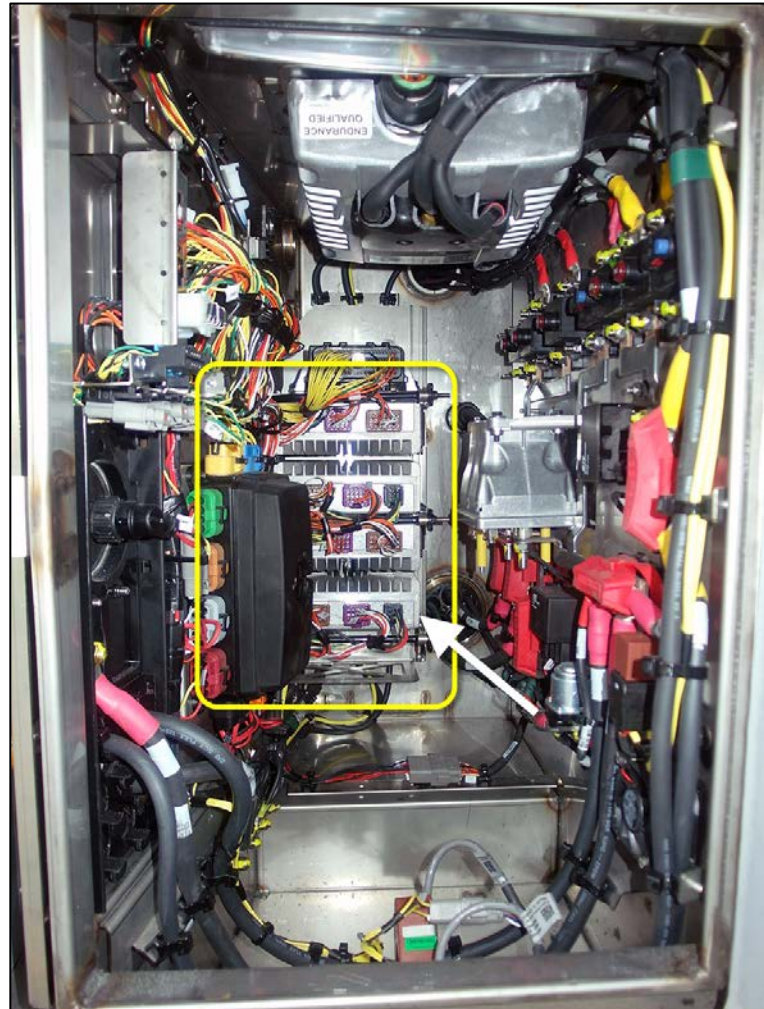
Figure 1

1. In the rear junction box, find module AE52. (Figure 1)
