PREVOST

WARRANTY BULLETIN

WB20-06

DATE :	April 2020	SECTION :	00 GENERAL
EXPIRATION:	April 2022		
SUBJECT :	TIGHTENING OF THE AIR INLET MANIFOLD PREHEATER TERMINALS

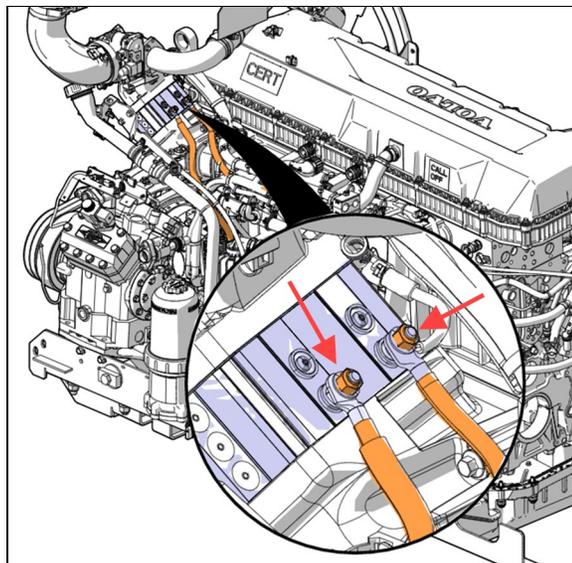
Figure 4

On the vehicles affected by this bulletin, air inlet manifold preheater electrical terminals have to be tightened and recovered with rust protector.

4. Open the engine door and locate the air inlet manifold preheater terminals.
5. If the terminals are tightened and cover with rust protector 'Color Guard' no 684013, the bulletin is complete, unless move to next step.
6. Check if the components are in good condition. If necessary, replace parts with damage.
