**SAFETY
RECALL**

SR21-308

| SUBJECT: | AMERICAN SEATING COMPANY PASSENGER SEATS INSTALLATION ISSUE. ADDITION OF A SPACER AT THE FIXED SEAT WALL BRACKET | |

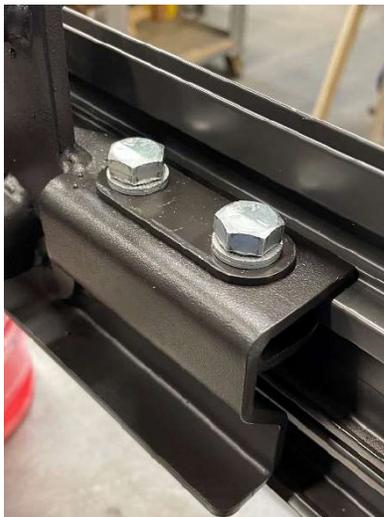
FIGURE 1: SPACER ADDED

In some instances, the two bolts used to clamp the rear wall mounting brackets on the 2096 transverse recliners to the wall track of a Prevost bus may slightly contact the seat frame bracket.

To eliminate this possibility, a spacer is being added to shorten the effective length of the bolt while still providing the 'Rule of Thumb' amount of protruding bolt past its retaining nut.

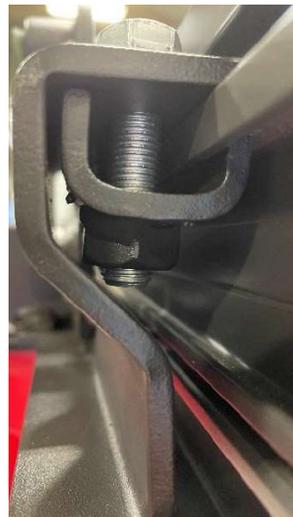
FIGURE 2: 11 GA SPACER SHOWING 3+ THREAD PROTRUSION

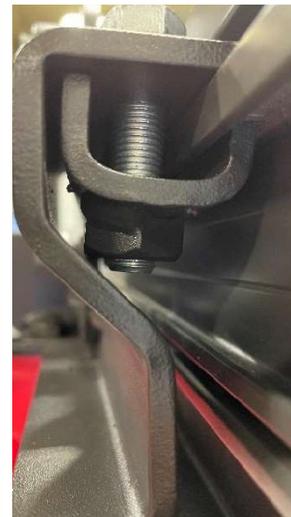
FIGURE 3: 7 GA SPACER SHOWING 2+ THREAD PROTRUSION
