# Warranty Bulletin

# WB23-84

ROOF EMERGENCY HATCHES NEEDS TO BE REPOSITIONED PROPERLY  
9700 (B13R)

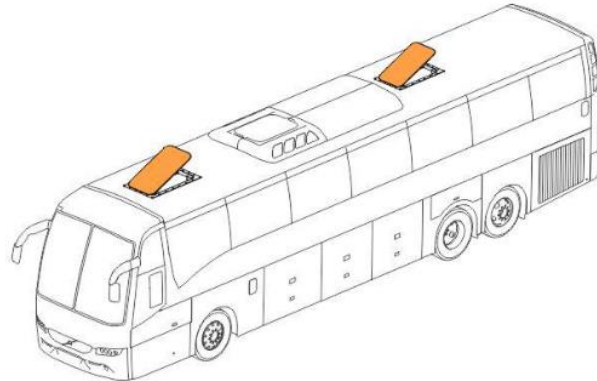
- 1) Locate the 2 roofs safety hatches inside of the buses.

Correct opening positions shown

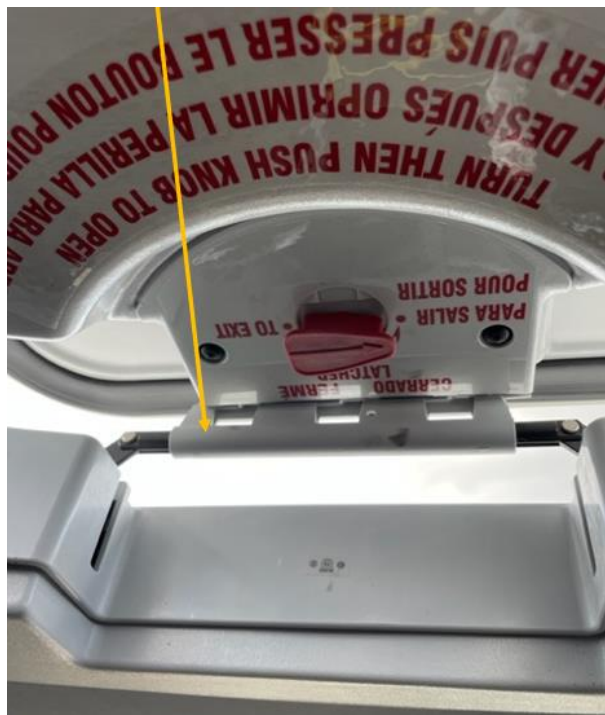
- 2) Each roof hatch needs to be located properly.

This image indicates the rear of the bus position for the hatch.

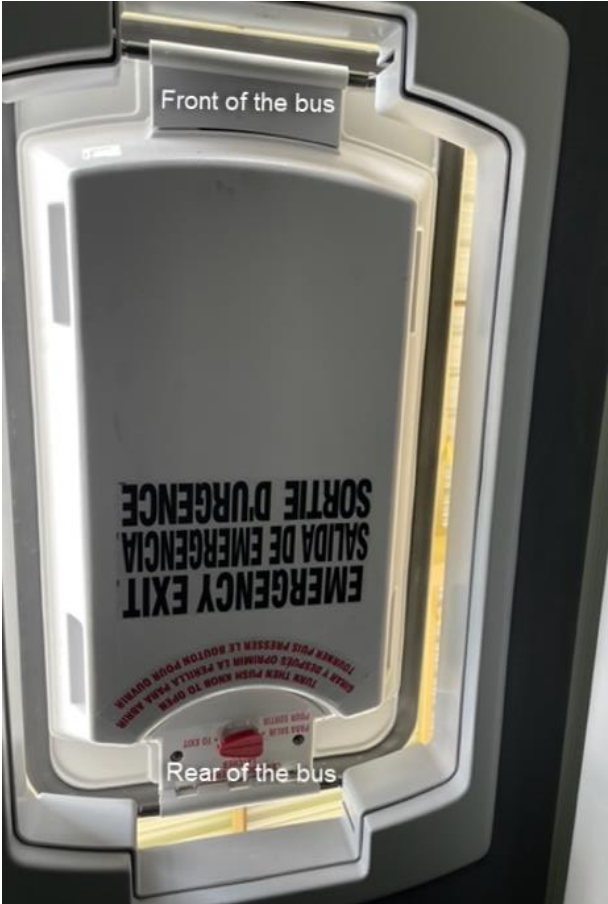
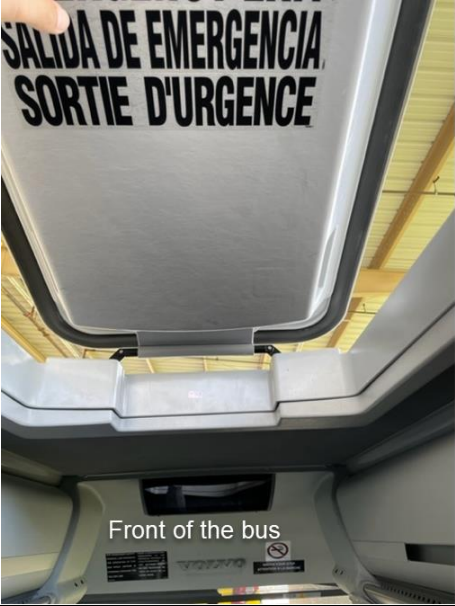
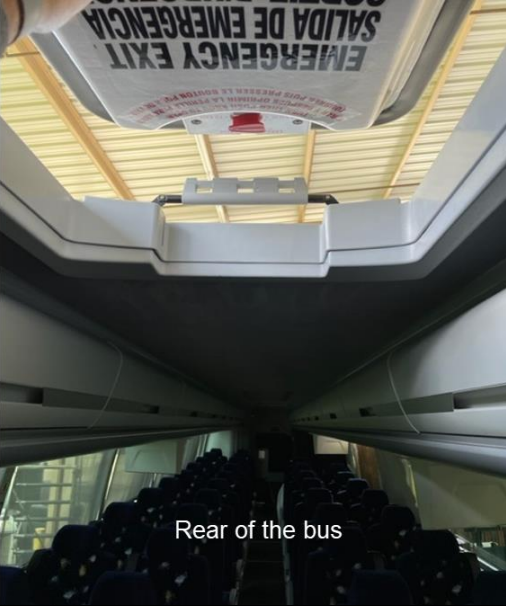
6) New position of the hatch. Opening and operating properly after the 180 degrees rotation.
