PREVOST

WARRANTY BULLETIN

WB24-41

DATE :	December 2024	SECTION :	06 ELECTRICAL
EXPIRATION:	December 2026		
SUBJECT :	CB9 WIRE CRIMP INSPECTION

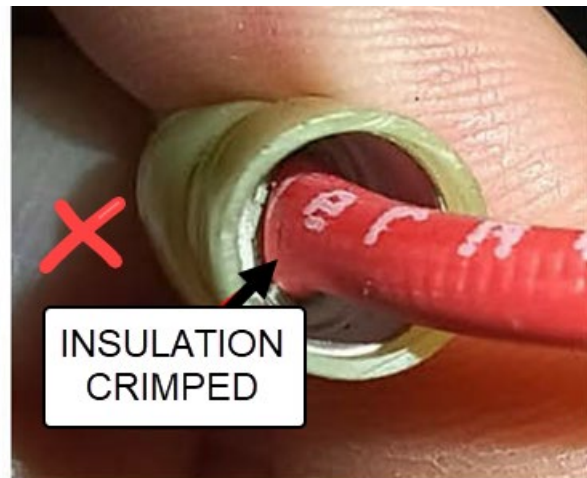
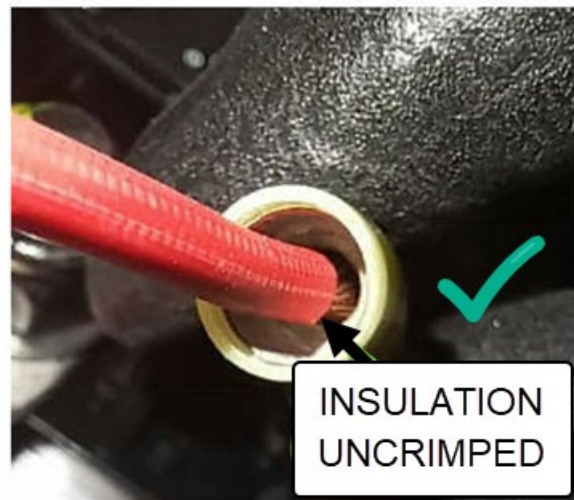
9. Inspect the wire crimp on the ring terminal:

- If the wire insulation is crimped within the terminal barrel, the crimp is non-compliant. Proceed to the **Repair section**.
- If the stripped portion of the wire is securely crimped within the terminal barrel and the insulation remains uncrimped, the crimp is compliant. Go to **Reinstallation section**.

1. Cut off the incorrectly crimped ring terminal from the wire and discard it.
2. Strip the end of the wire.

3. Insert the striped portion of the wire into the barrel of new ring terminal 561246.
4. Crimp the ring terminal. The crimp should be tight and uniform, and the insulation should not be crimped.
