DESCRIPTION

For the vehicles **on which a notification** for SP18-35 **exists**, perform the following checklist and operations. It has been determined that these vehicles had the code (DTC) P20EE activated.

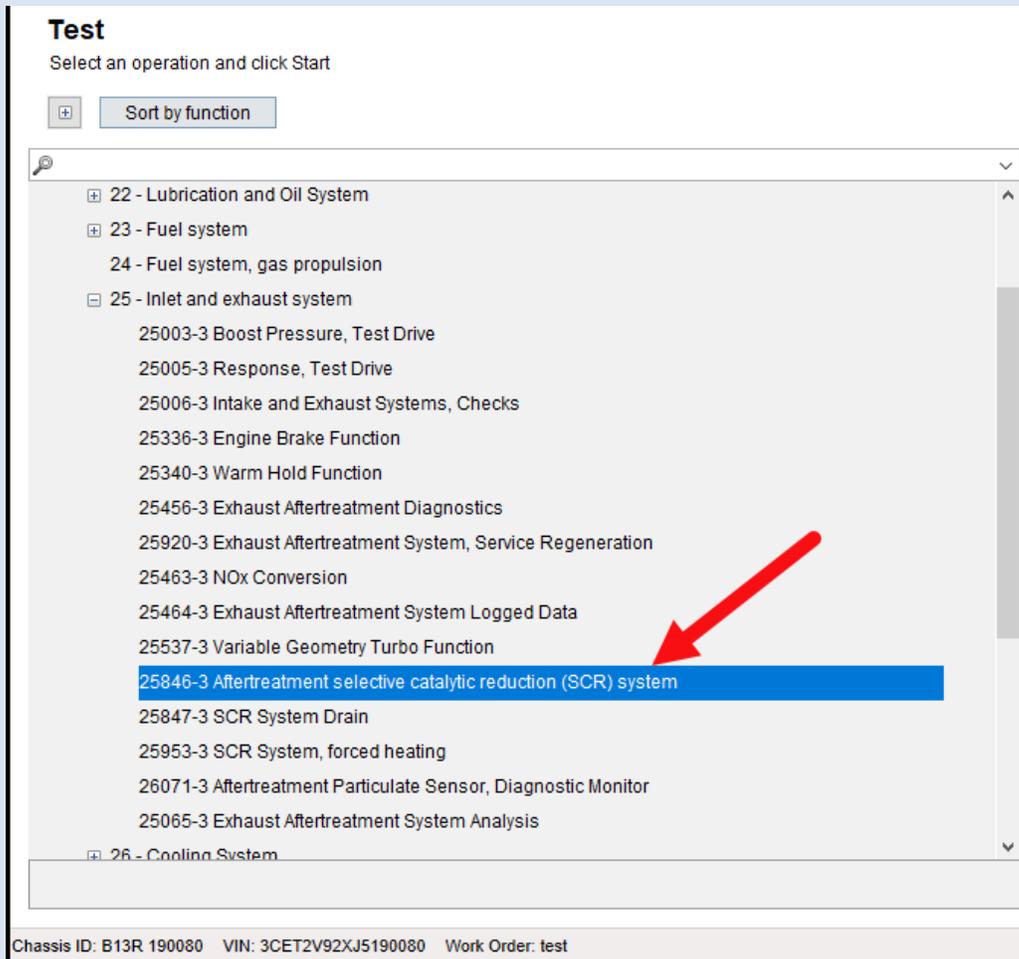
OPERATION 25846-3 OPTION D ON PTT WITH NEWEST SOFTWARE VERSION

2	<p>Before performing any engine ECM software update, take a screen capture of the five most recent SCR efficiency evaluations and save for submittal.</p> <ul style="list-style-type: none"> Test screen 2589-08-03-05 on PTT with software version prior to 2.8 Operation 25846-3 option D on PTT with newest software version (see next image) 	
---	--	--

Example of SCR efficiency evaluations

DTC P20EE	
Test Values - NOx/SCR Monitor Data	
80 %	Minimum fault limit
79 %	Evaluation (Most recent)
77 %	Evaluation 2
76 %	Evaluation 3
80 %	Evaluation 4
81 %	Evaluation (Oldest)

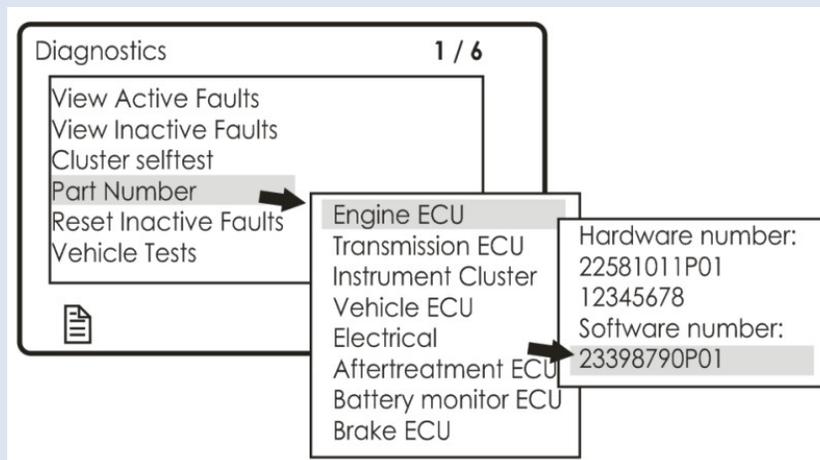
4 Check and record the engine ECU (a.k.a. Engine Control Module ECM) software number.
To do so, check in the dashboard DID. Select DIAGNOSTICS > PART NUMBER > ENGINE ECU

If the engine ECU software is not up to date, perform an update to the latest version (software version should be 23766686 or higher).

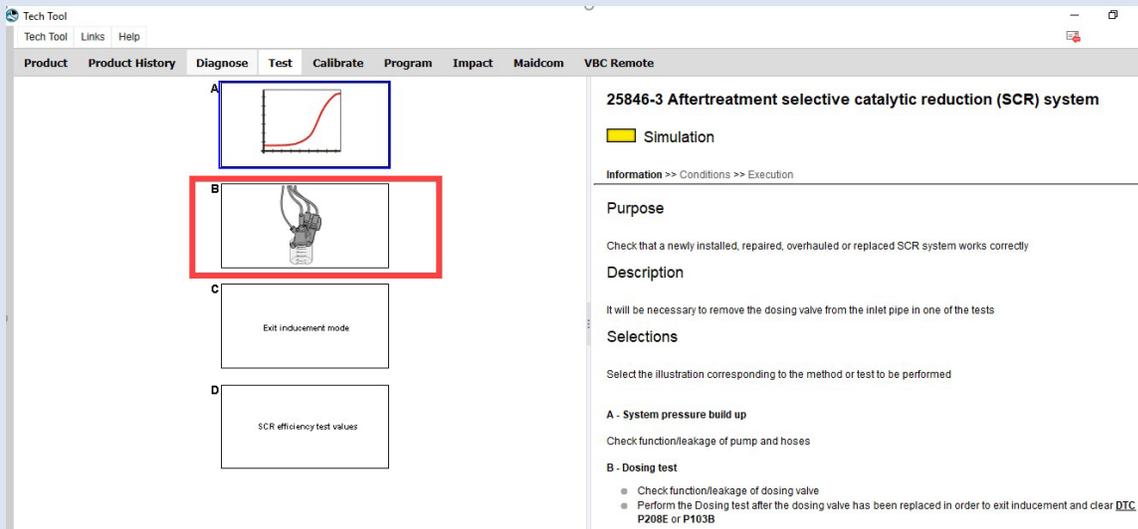
6 Remove DEF doser, perform the dosing test (operation 25846-3 option B) and record the results below.

Expected values: small dosing: 49 - 60 ml large dosing: 196 - 240 ml
Dosing amount: small _____ ml large _____ ml

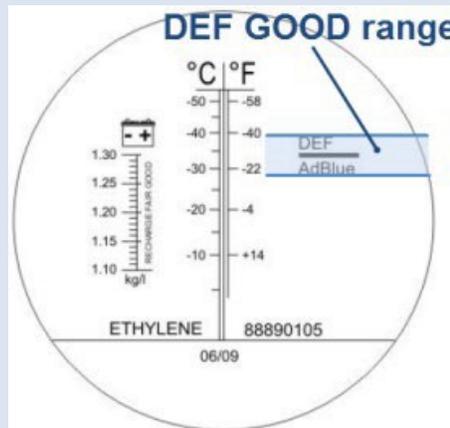
7 Test the concentration of DEF and record the result below. Tool: refractometer # 88890105.

Apply a drop of DEF on the viewer of the refractometer. If the level is above the word "DEF" or below the word "AdBlue" the DEF is contaminated. If no level is shown, it may indicate chemical residue, such as pure water or diesel fuel.

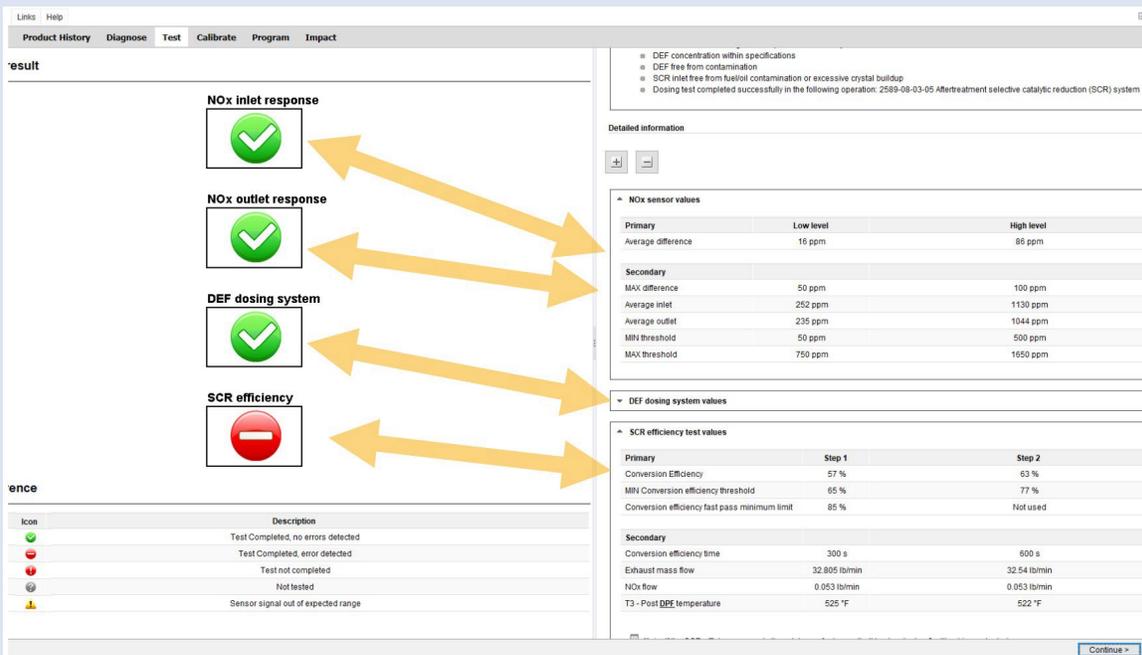
9 Perform the Exhaust aftertreatment system analysis (operation 25065-3)

Take a screen capture of the Test result (image below) and save for submittal.
