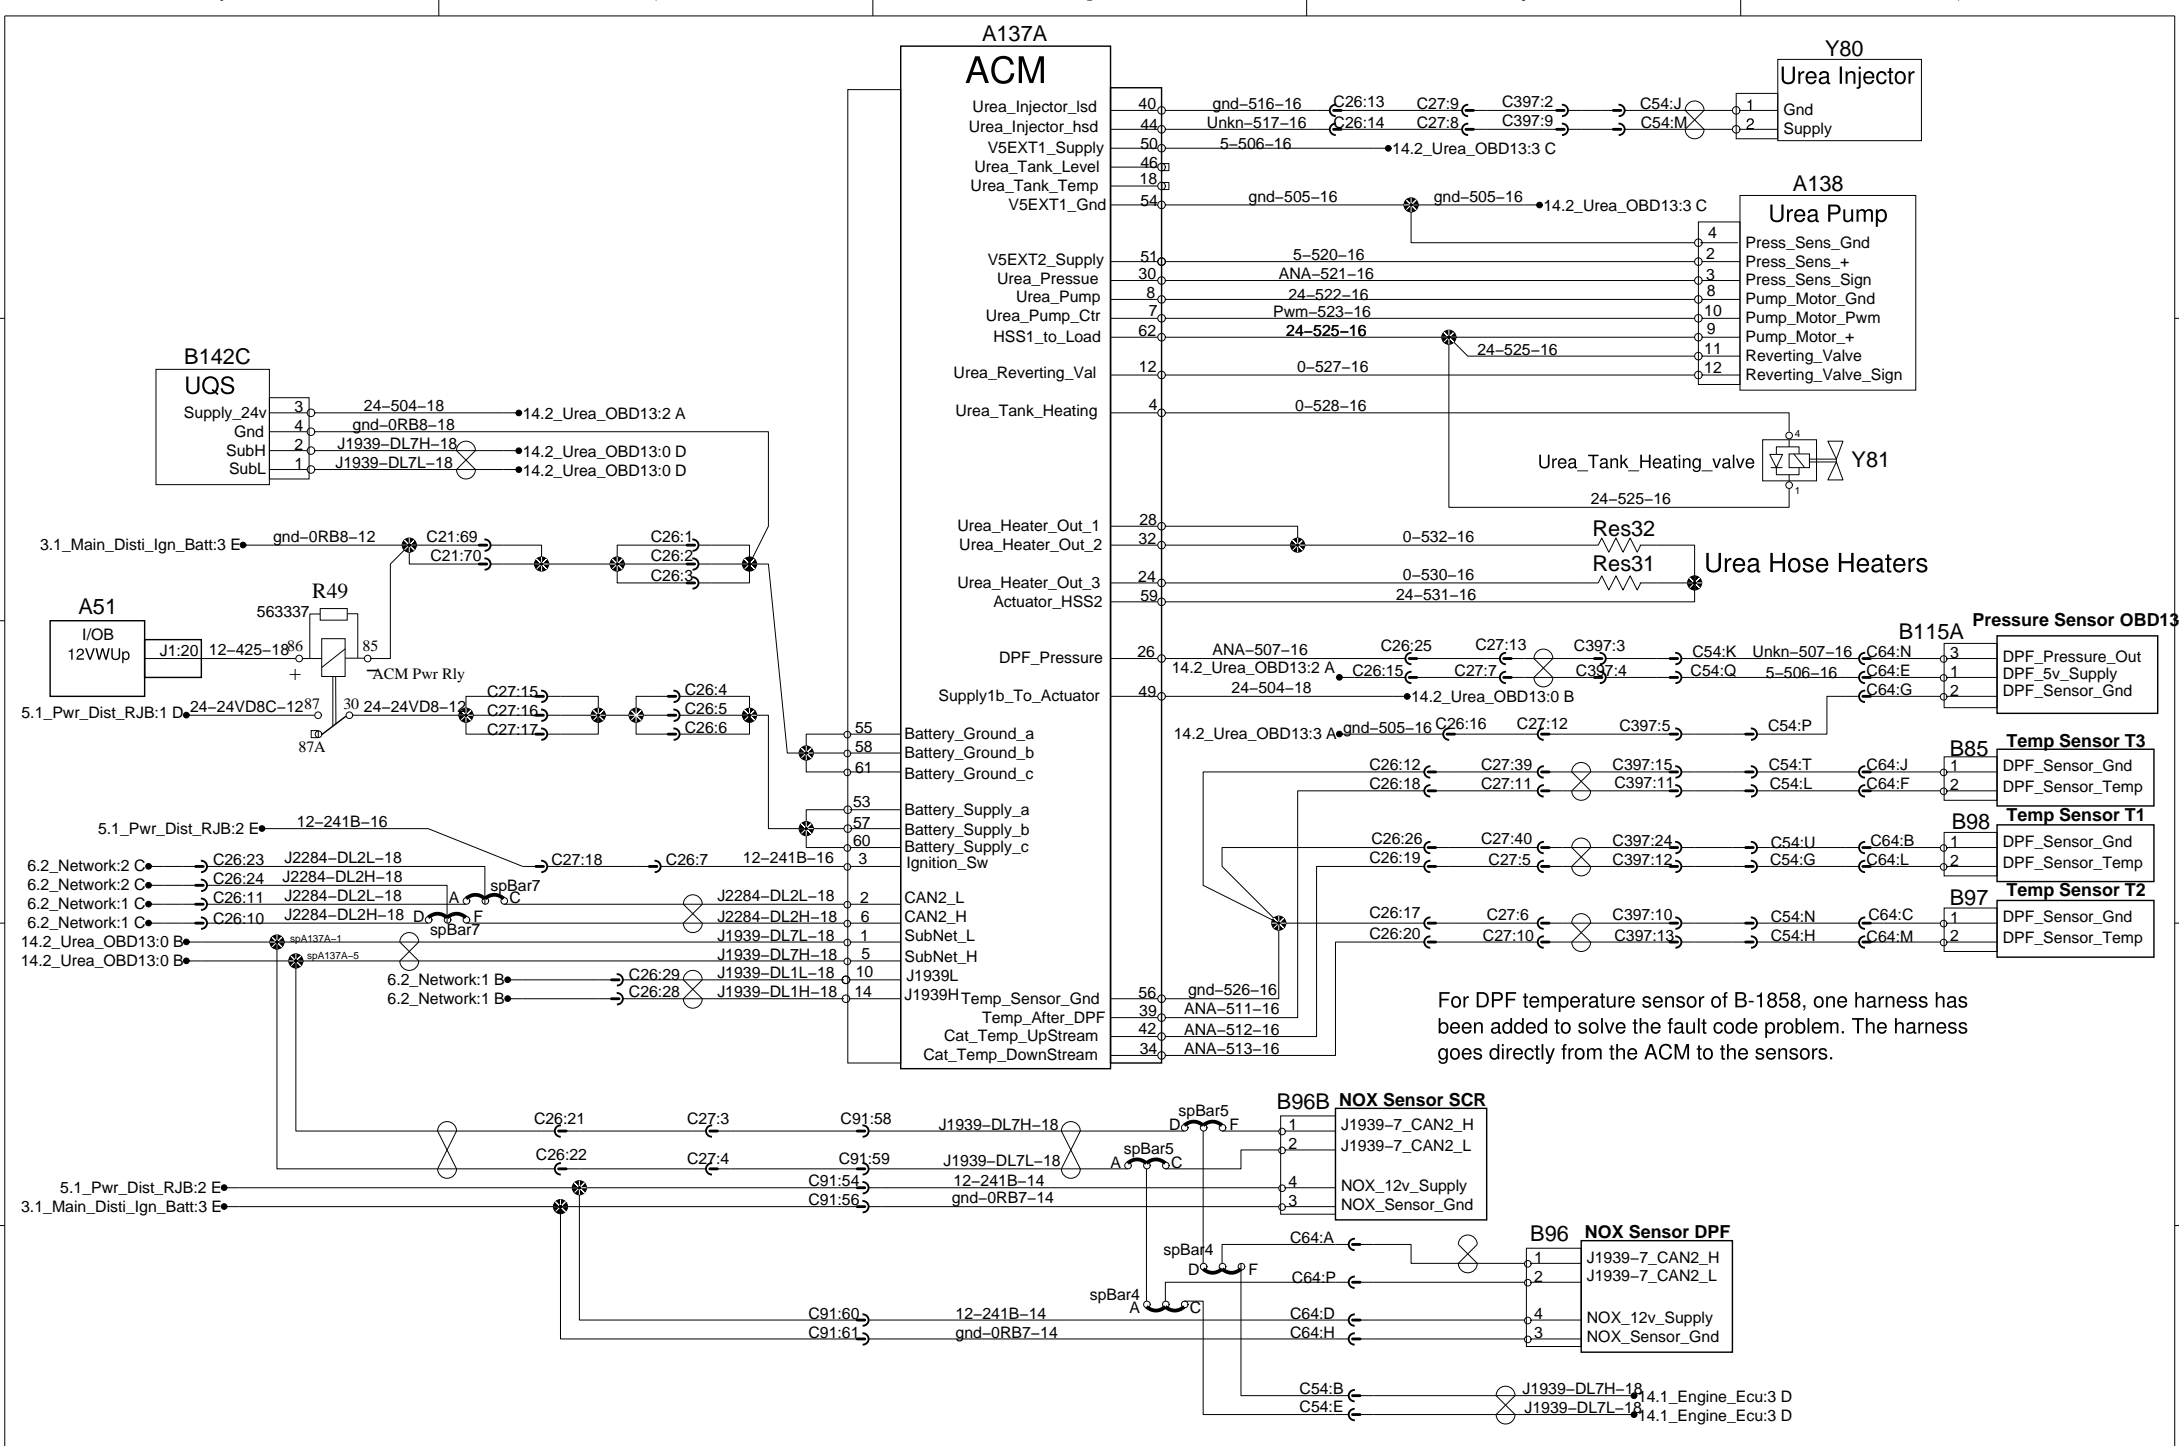
For DPF temperature sensor of B-1858, one harness has been added to solve the fault code problem. The harness goes directly from the ACM to the sensors.
