PREVOST

**WARRANTY
BULLETIN**

WB17-02A

DATE :	April 2017	SECTION :	23 ACCESSORIES
EXPIRATION:	April 2019		
SUBJECT :	ADDITION OF AN EXTENSION TO THE LINEAR THERMAL DETECTOR (LTD)

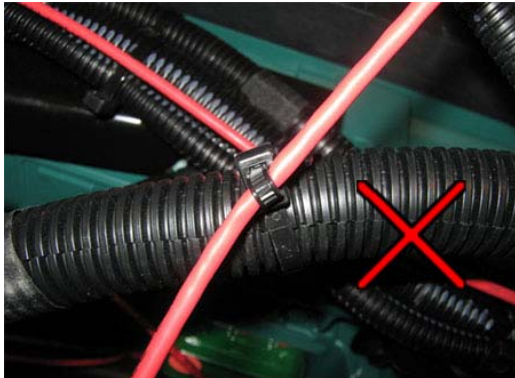
NOT ALLOWED

LTD extending slantingly from the cable tie

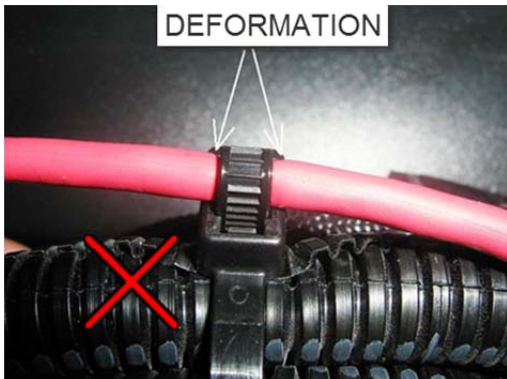
NOT ALLOWED

Cable tie tighten in excess on the LTD. Tighten cable tie on LTD by hand only. Tighten just enough to prevent LTD from slipping from one side to the other inside the cable tie loop

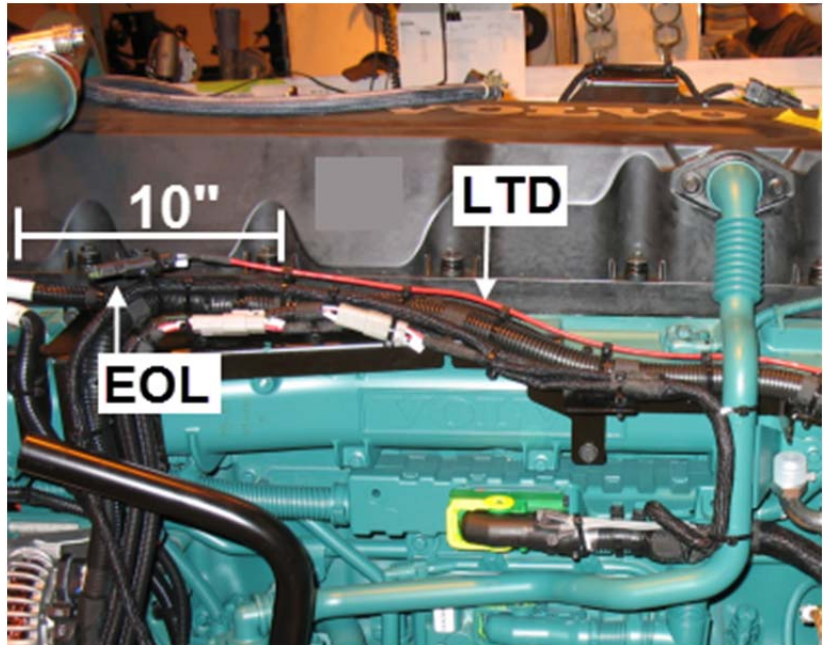
NOTE: position of the EOL resistance may vary from about 10 inches from one vehicle to another. This position will determine the final position of the EOL resistor once connected at the end of the extension.

- 1) On the cold side of the engine, remove the End of Line (EOL) resistor from the existing LTD connector. **Keep the EOL resistor for reuse.**
