PREVOST

WARRANTY BULLETIN

WB18-07B

SUBJECT:	REVERSED BUSBAR AT CIRCUIT BREAKER CB13 - VEHICLES EQUIPPED WITH A CURRENT INVERTER		
l	EXPIRATION:	March 2020		
ı	DATE:	March 2018	SECTION:	06 ELECTRICAL

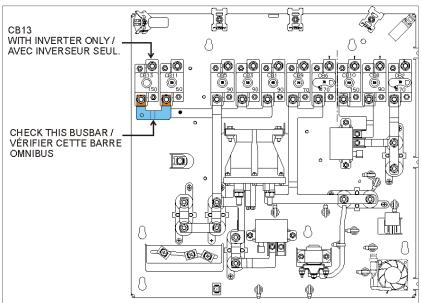
FIGURE 1 : CB13 IN THE LAVATORY, BEHIND THE MIRROR

Usually, circuit breaker CB13 is installed in the main power compartment. On some vehicles, it is installed behind the mirror in the lavatory.

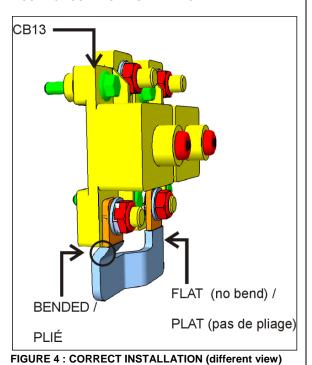
FIGURE 3: CORRECT INSTALLATION

- 2. Check if the busbar is installed correctly. The "flat" on the busbar must be placed on the circuit breaker located on the R.H. side of CB13.
- 3. If the busbar is installed properly, no further verification is necessary.

If the busbar is not installed properly, go to PART 2- CORRECTING THE INSTALLATION.
