**MAINTENANCE
INFORMATION**

MI18-28

DATE :	September 2018	SECTION : 18 BODY
SUBJECT :	Compressor Door Adjustment on X3 Vehicles

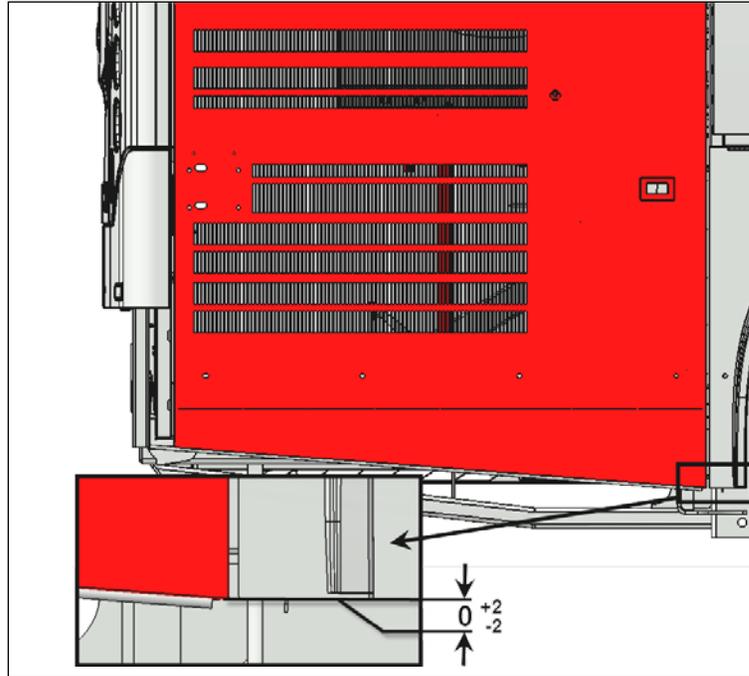
FIGURE 4

3. Compare the lower edge of the door level with the lower edge of the rear fender. The door should be flush with the fender (FIGURE 4).

Tolerance is $\pm 3/32$ " ($\pm 2mm$)

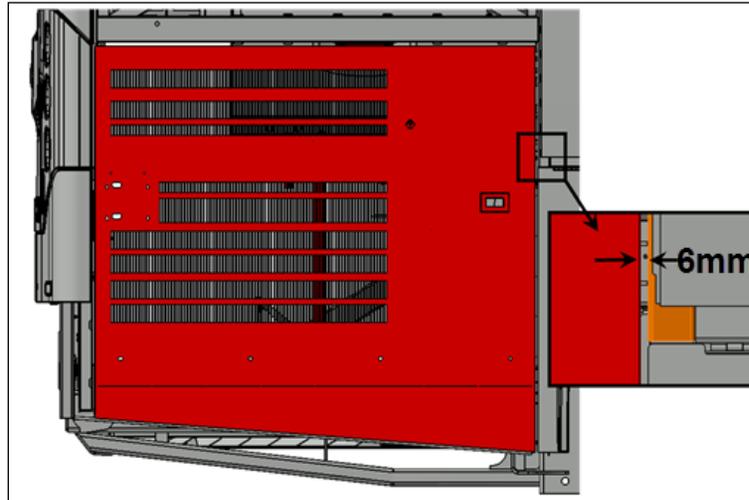
FIGURE 6

5. Check the gap between the door and the adjacent panel at the level of the upper attachment point of the arm on the door. The gap should be $\frac{1}{4}$ " (6 mm) (FIGURE 6).

Gap $\frac{1}{4}$ " (6 mm)

Tolerance is $\pm \frac{3}{64}$ " (± 1 mm)

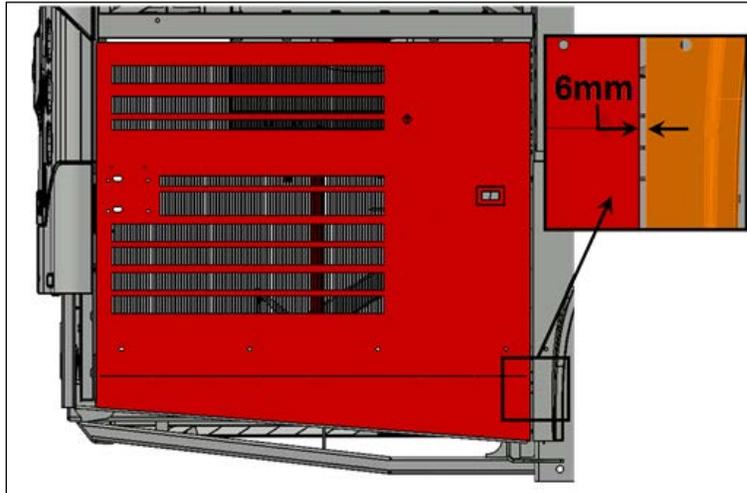
FIGURE 8

7. Check the gap between the door and the adjacent panel at the level of the lower attachment point of the arm on the door. The gap should be $\frac{1}{4}$ " (6 mm) (FIGURE 8).

Gap $\frac{1}{4}$ " (6 mm)

Tolerance is $\pm \frac{3}{64}$ " (± 1 mm)

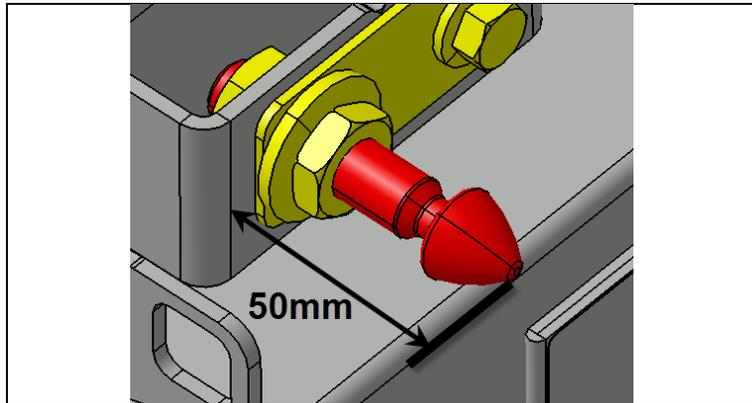
FIGURE 12

11. Before adjusting the pin, make sure that it doesn't exceed more than 2" (50mm) at the first closing of the door (FIGURE 12). Damage to the door can result if this condition is not respected.

Not more than 2" (50mm)

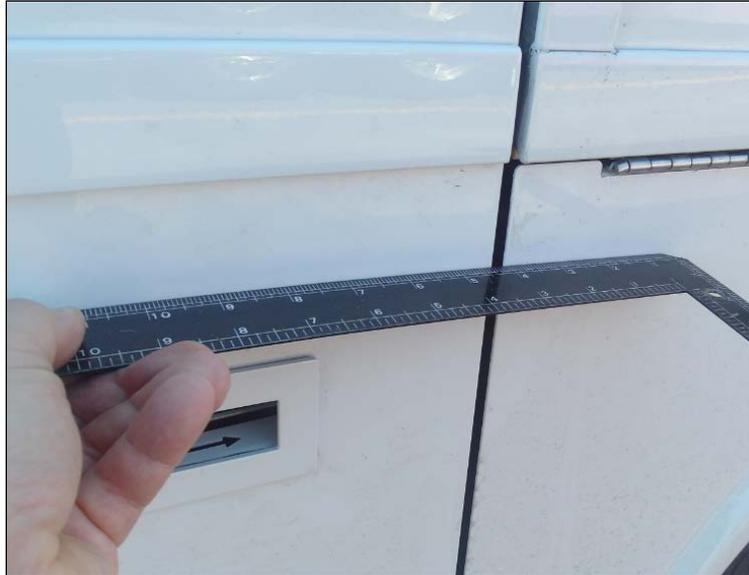
14. Once closed, the door surface must be even with the adjacent steel panel.

Tolerance is 3/64" (1mm)

FIGURE 15: USE A RULER (SHOWN IN BLACK) TO CHECK THAT SURFACES ARE EVEN

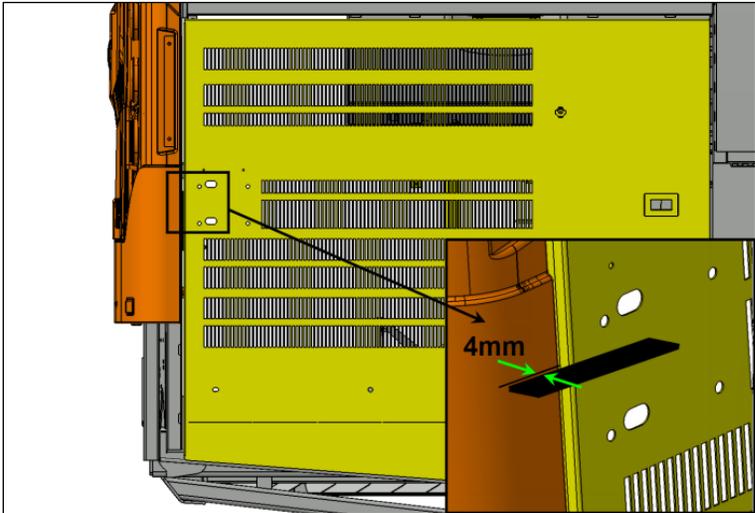
FIGURE 17

16. The R.H. side engine access door must exceed the engine compartment by 5/32" (4mm).

Tolerance is $\pm 3/64$ " (± 1 mm)

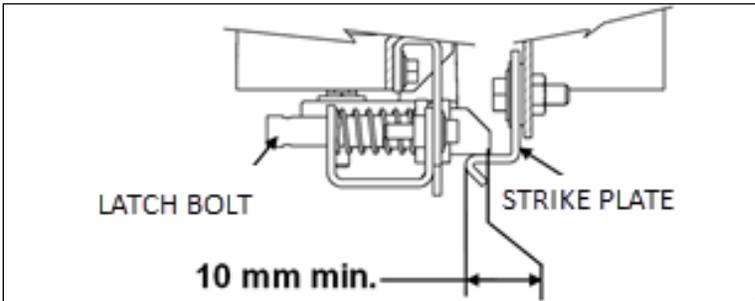
FIGURE 19

18. The latch bolt must engage not less than 13/32" (10mm) behind the strike plate.

13/32" (10mm) min
