# PREVOST

## WARRANTY BULLETIN

**WB19-07**

DATE : May 2019	SECTION : 12 BRAKE & PNEUMATIC
EXPIRATION: May 2021	
SUBJECT : BRAKE HOSE CLEARANCE INSPECTION – VEHICLES WITH INDEPENDENT FRONT SUSPENSION

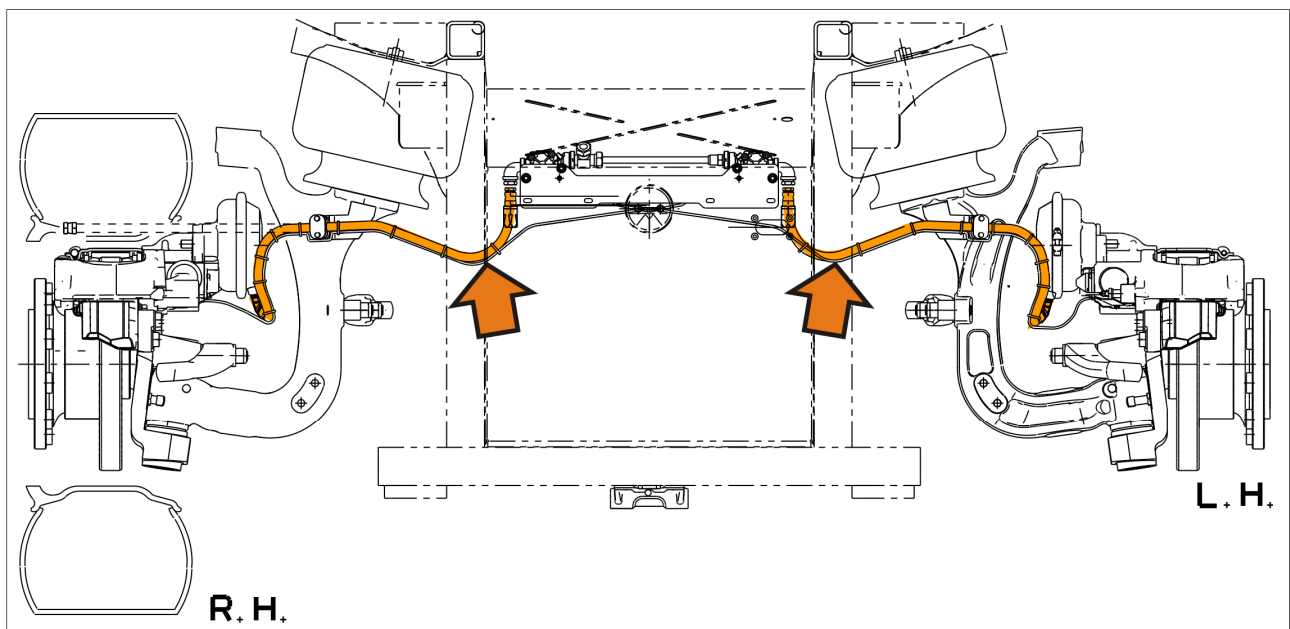
On the **independent front suspension** (IFS) of the vehicles affected by this bulletin, check and make sure that there is enough clearance between the brake hoses identified in the procedure and their respective support bracket.

There are two hoses to inspect, one on each side of the vehicle.

FIGURE 1 : INSPECT THE TWO (2) HOSES IDENTIFIED ON THE IMAGE

In some cases, it might be necessary to change the position of the hose in order to obtain the necessary minimum clearance. If signs of rubbing and wear are present, replacement of the damaged hose will be necessary.

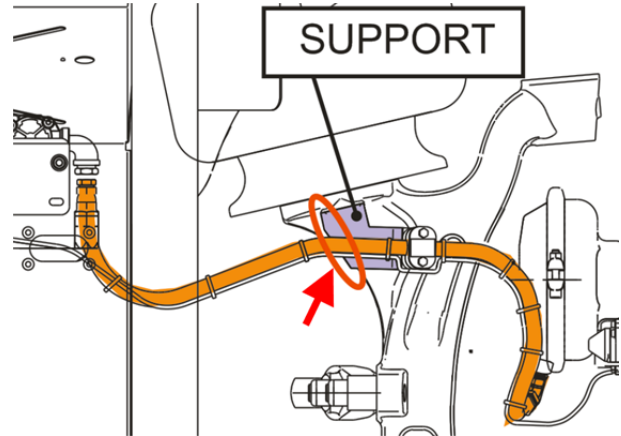
1. Check the clearance between the brake hose and the edge of the support as shown on the image.

The **MINIMUM** clearance is 1/2 inch (12 mm)

FIGURE 2 : DRIVER SIDE (L.H.)

2. If the clearance is 1/2 inch (12 mm) or **greater, no adjustment** is necessary.

3. If the clearance is **less than 1/2 inch (12 mm)**, it is necessary to **increase the clearance** as explained in Part 2 to avoid rubbing of the hose.
  - a) If the hose shows signs of rubbing or wear, change the hose. If the inspection shows that there is rubbing of the black and greasy Tectyl coating only, then the hose does not require replacement.

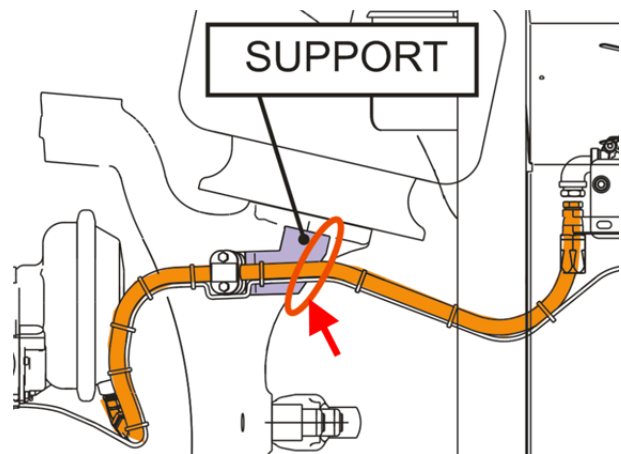
FIGURE 4 : CURB SIDE (R.H)
