PREVOST

**SAFETY
RECALL**

SR19-43

DATE :	December 2019	SECTION :	09 PROPELLER SHAFT
SUBJECT:	DRIVE SHAFT BOLTS TIGHTENING

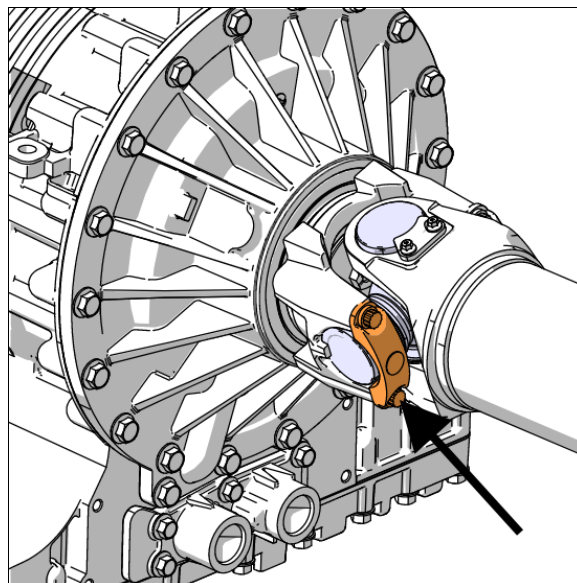
Figure 3

Inspect visually all bolts. Threads should not be damaged or should not have presence of metal fillings.

In case of important thread damages or metal fillings, it might be necessary to replace the transmission coupling. If necessary, replacement of the coupling is considered as a different operation.

5. Dismount both screws of only one strap on the transmission coupling and remove the strap.
