>	WARR BULL		RE Wb98-33	ENREGISTRÉ-REGISTERED ISO 9001 & ISO 14001
	DATE :	October 1998	SE	CTION : 22, HVAC
-1	EXPIRATION :		October 199	9

A/C SYSTEM MODIFICATIONS

PART A: INSTALLATION OF LIQUID SOLENOID VALVE

PART B: VALVE PLATE AND VALVE CHANGEOUT

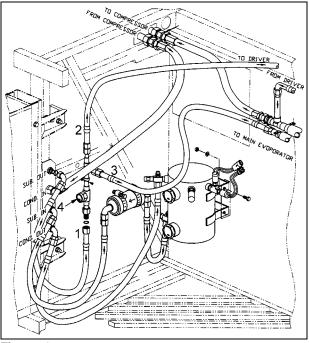
Figure 2: Shadowed parts: existing filter dryer and hoses to be removed and discarded. Items 1 to 3 : hoses to be fixed on the new filter dryer assembly; Item 4: moisture indicator assembly to discard

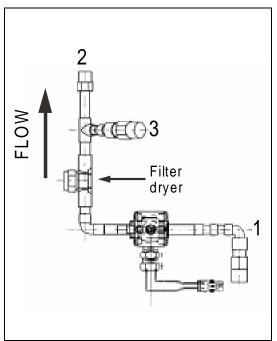
Figure 3: Front view of the liquid solenoid valve new assembly.

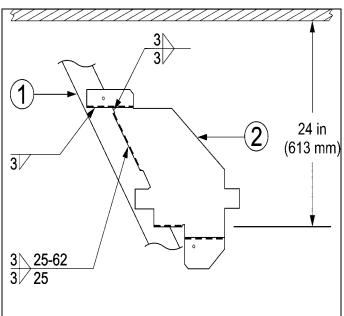
Figure 4: (1) Condenser compartment's metallic structure; **(2)** New bracket fixed at 24 in (613 mm) below compartment's veneer top.

- 4. Remove existing filter dryer support;
- 5. Install bracket #213752 on the left-hand side of the compartment. As shown on figure 4, the bracket should be welded on the metallic structure at 24 inches (613 mm) below the veneer top of the compartment. It is recommended to use a semi-automatic electric arc welding in accordance with the following specifications:

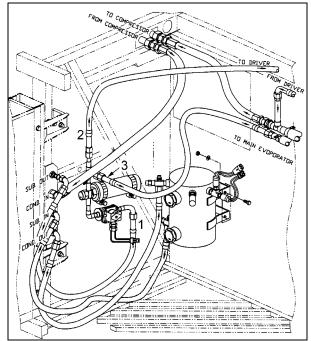
Figure 5: Final aspect of the assembly. New hose #452383 (in gray).

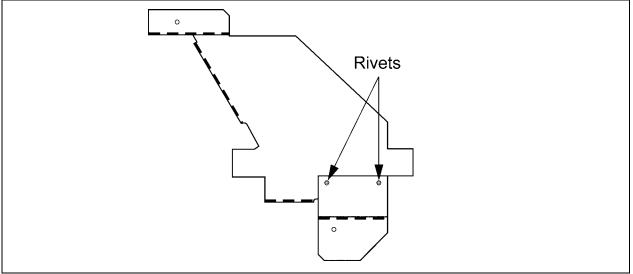
Figure 9: Shadowed portion to be riveted on the existing bracket.

METHOD 2: Using a bandsaw, cut the new bracket on figure 7 dotted lines. Keep the portion shown on figure 8. Rivet this bracket portion on the existing bracket, as presented on figure 9.

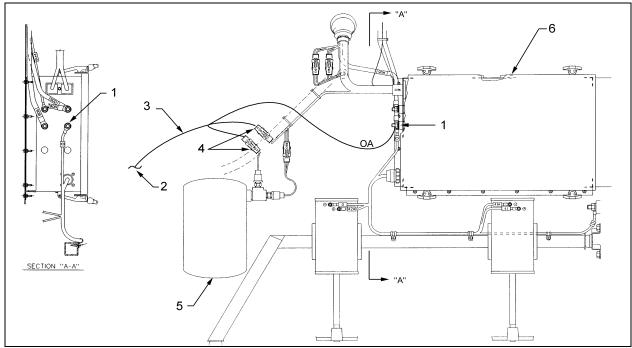
Figure 11: Condenser compartment: (1) Ground; (2) Wire going to solenoid valve; (3) #064934 Cable; (4) C158 Connectors; (5) Receiver Tank; (6) A/C Junction Box.

- 1. Open the condenser compartment (see figure 1);
- 2. Locate C158 connectors and the receiver tank (items 4 and 5 on figure 11);
- 3. Unplug C158 connectors and plug on each of them the connectors pertaining to #064934 cable (item 3 on figure 11);
- 4. Connect OA terminal to the ground located above two circuit breakers, on the left side of the A/C junction box (see sectional view A-A on figure 11);
- 5. Connect terminal #2 of figure 11 to the liquid solenoid valve connector;

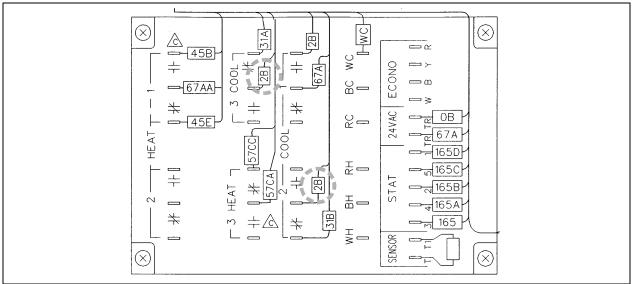
Figure 12: Location of the two wire 2B on Cool 2 and Cool 3 commons on the A/C control panel.

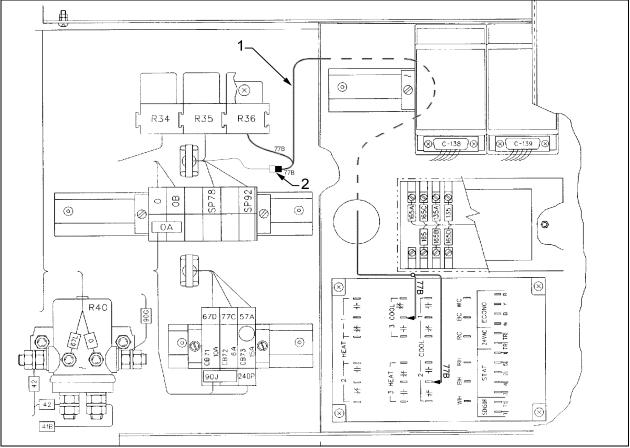
Figure 13: Wiring connection final aspect in the A/C junction box. (1) 064933 Cable; (2) Heat shrinking tube.

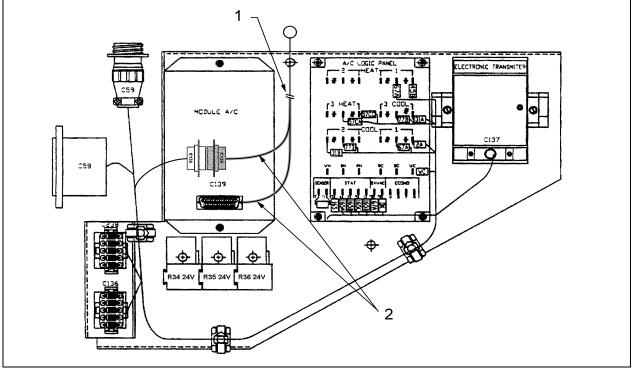
Figure 15: Rear electrical compartment. (1) Cable to cut coming from thermostat; (2) Two C139 connectors to unplug and discard.

2. Cut 67A and 67M wires coming from thermostat, as shown on figure 15, item 1. Unplug and discard the two C139 connectors located on the A/C module and on the vehicle's wiring (item 2, figure 15);

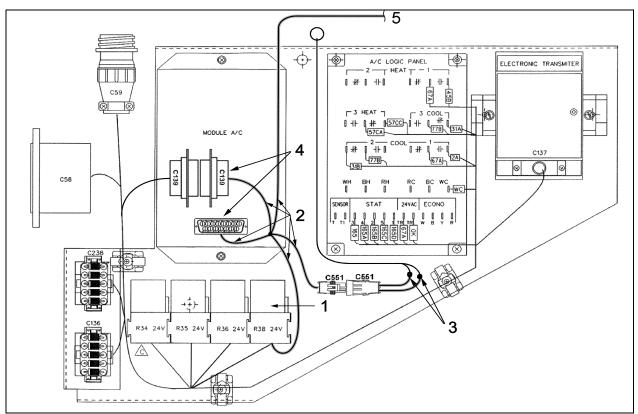
Figure 16: Rear electrical compartment. (1) R38 Relay; (2) 064931 Cable; (3) Welding; (4) C139 Connectors; (5) 2B wire.

- 3. Fix new R38 relay base on the A/C junction panel, next to R36 relay. This base belongs to 064931 cable (item 2, figure 16);
- 4. Fix R38 relay on its base (item 1, figure 16);
- 5. Replace the connectors removed on step 2 with 064931 cable's proper connectors (item 4, figure 16). Use cable ties to secure the connection and avoid any vibration effect;
- 6. Locate C551 connector of 064931 cable. Cut this connector's jumper and weld each wire coming from the thermostat (67A and 67M) to both jumper wires (item 3, figure 16);
- 7. Identify spare wire SP92 located near C52 connector in the rear electrical compartment. Crimp and heat 2B wire (item 5, figure 16) with SP92 wire;

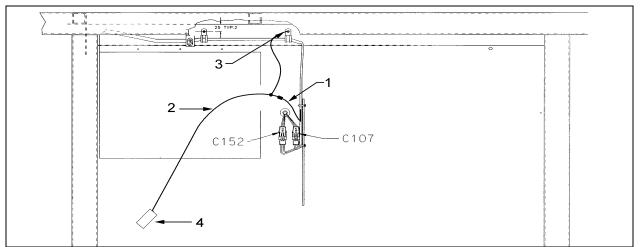
Figure 17: Condenser compartment final aspect: (1) SP92 wire; (2) 064932 cable; (3) Ground OA; (4) C95 Connector.

- 8. Open the condenser compartment (figure 1);
- 9. Plug 2B wire of 064932 cable on SP92 (item 1, figure 17) then crimp and heat;
- 10. Connect 0A terminal of 064932 cable on a stud as shown on figure 17, item 3;

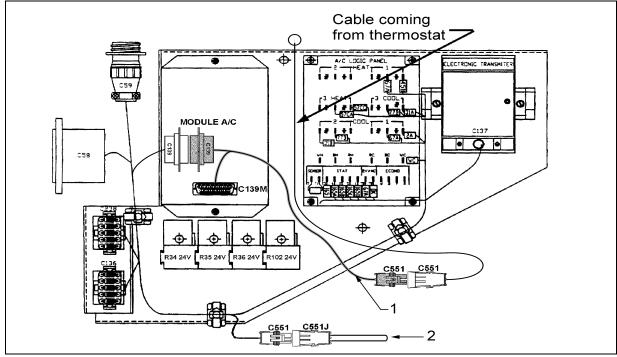
Figure 18 : Rear electrical compartment. **(1)** Cable to remove linking C551, C139 and C139M connectors ; **(2)** C551J connector to leave in place.

- 1. Open the rear electrical compartment (figure 14) and locate the A/C junction panel on the front wall of the compartment;
- 2. Remove and discard existing cable including C151, C139 and C139M connectors, as shown on figure 18, item 1. Leave C551J connector in place (item 2, figure 18) by cutting the cable tie;

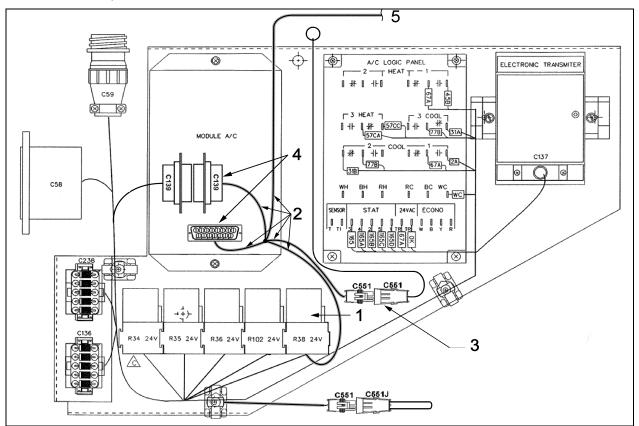
Figure 19: Rear electrical compartment. (1) R38 relay; (2) 064931 cable; (3) C551 connector; (4) C139 connectors; (5) 2B cable.

- 3. Fix new R38 relay base on the A/C junction panel, next to R102 relay for instance. This base belongs to cable 064931 (item 2, figure 19);
- 4. Fix R38 relay on its base (item 1, figure 19);
- 5. Remove and discard C551 jumper of 062931 cable. Plug C551 connector belonging to 064931 cable on the C551 connector coming from the thermostat (77A and 77HA wires are coming from thermostat), as shown on figure 19, item 3 ;
- 6. Plug both C139 connectors pertaining to 064931 cable on the A/C module and on the vehicle's wiring (item 4, figure 19). Use cable ties to secure the connections;
- 7. Plug 2B cable (item 5, figure 19) on SP92 spare wire. SP92 is located near C52 connector in the rear electrical compartment;

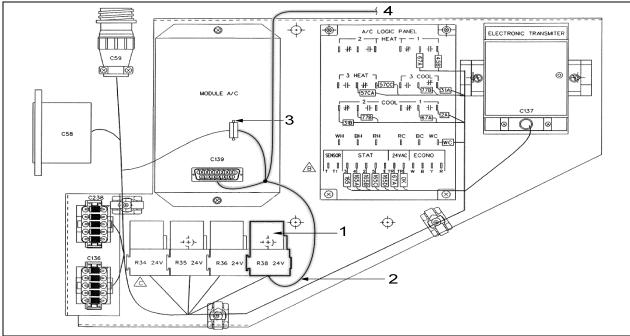
Figure 20: Rear electrical compartment: (1) New R38 relay; (2) 064931 cable; (3) Tie wrap; (4) 2B wire.

- 1. Open the rear electrical compartment (figure 14) and locate R36 relay on the front wall of the compartment;
- 2. Fix new R38 relay base next to R36 relay. This base belongs to cable 064931 (item 2, figure 20);
- 3. Unplug C139 connector and connect it to 064931 cable's connector. Use 2 cable ties to secure the connection (item 3, figure 20);
- 4. Plug 069431 cable's proper terminal to the C139 connector located on the A/C module;
- 5. Identify spare wire SP92 located near C52 connector in the rear electrical compartment. Crimp and heat 2B wire (item 4, figure 20) with SP92 wire;
- 6. Open the condenser compartment (figure 1);
- 7. Plug 2B wire (item 1, figure 17) of 064932 cable on SP92 wire then crimp and heat;
- 8. Connect 0A terminal of 064932 cable on a stud as shown on figure 17, item 3;

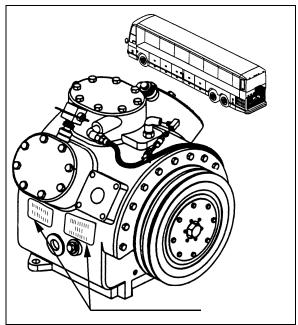
Figure 21: Rear engine compartment. Compressor's serial number location.

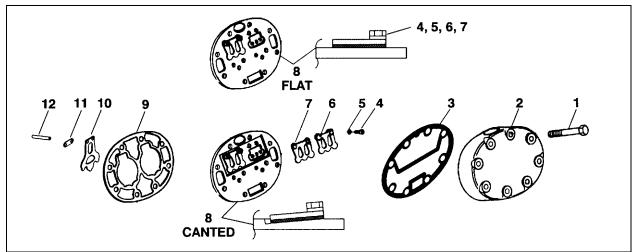
Figure 23: (1) Capscrew; (2) Cylinder head; (3) Cylinder Head Gasket; (4) Capscrew; (5) Lockwasher; (6) Discharge Valve Stop; (7) Discharge Valve; (8) Valve Plate; (9) Valve Plate Gasket; (10) Suction Valve; (11) Position Spring; (12) Dowel Pin.

3. Using a 9/16 wrench or socket, loosen the head capscrews (4) a few turns, using a criss-cross pattern. If the head (2) is stuck, tap it lightly with a wooden or lead mallet to free it. Do not remove screws until the head has been unseated from the cylinder deck of compressor, and any pressure that may be contained inside the head has been relieved.

• Free the valve plates (8) from the cylinder deck by using the discharge valve capscrews, without washers, as jackscrews through the outermost tapped holes in the valve plate after the valve stops (6) and valves (7) have been removed. Remove the valve plate gasket (9).

5. Install the new suction valves (10) and valve plates (8). The side heads should have 4 dowel pins for positioning of the suction valves. Place the new suction valve springs on dowel pins and springs, with the springs bowing upward (see figure 24). Place a new gasket (9) and valve plate (8) onto the cylinder deck over the suction valves (10) and aligned with dowels pins (12).

6. Once the valve plates (8) are in place, position the new head gaskets (3) and heads (2) onto valve plates (8) and install the capscrews (1). Using a criss-cross pattern, tighten the head bolts from the center to outside of each head. The final torque value for bolts is 40 to 50 ft-lb. This torque should be obtained by stepping up the value in two separate sequences. (Example: 25 ft-lb the first sequence, then 40-50 ft-lb on the second sequence).

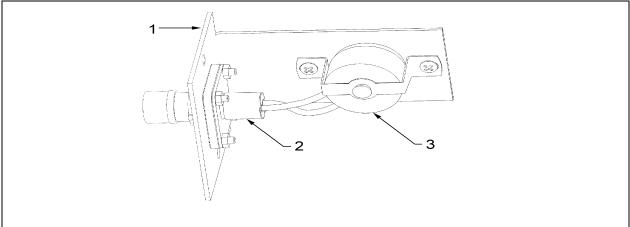
Figure 26: (1) Thermostat support; (2) Connector to remove; (3) Thermostat to remove.

- 3. Unplug C550 connector;
- 4. Unscrew the thermostat support (item 1, figure 26) and remove the connector (item 2, figure 26) and the thermostat (item 3, figure 26) ;
- 5. Install new thermostat assembly (figure 27);
- 6. Fix the thermostat support on the air intake duct;
- 7. Plug C550 connector.

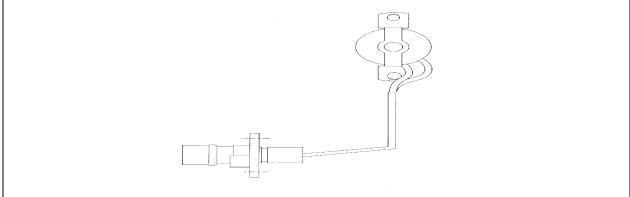
Figure 27: New thermostat assembly.
