PREVOST

WARRANTY BULLETIN

WB24-30

SUBJECT: REORGANIZING CONDENSER FAN POWER

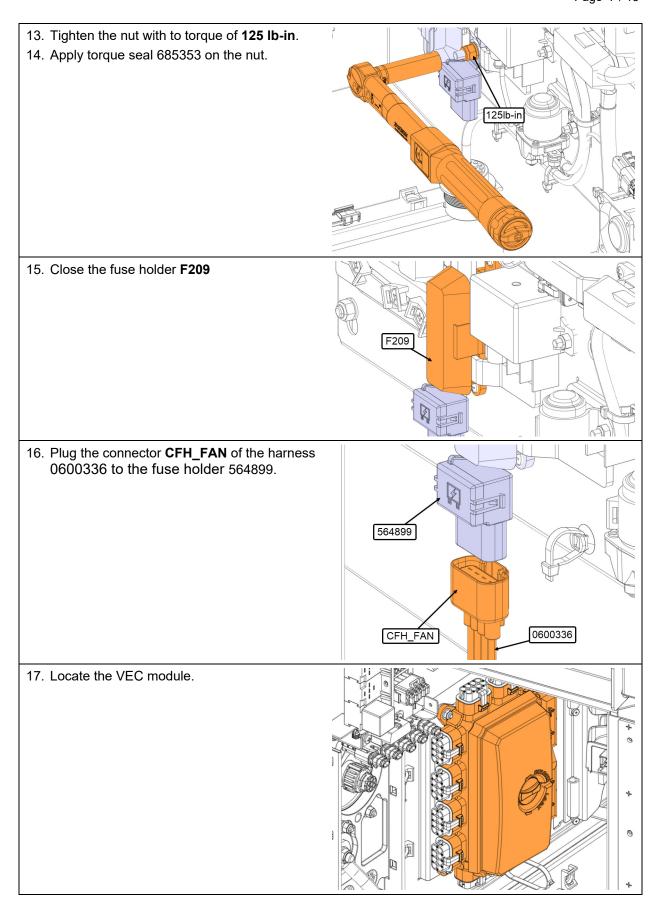
Locate the connectors VECR1 (gray),
VECR2 (red), VECR3 (black) and VECR4 (orange).
