WARRANTY BULLETIN

WB24-31

SUBJECT: ENTRANCE DOOR LOCK - JAMMING ISSUE SOLUTION

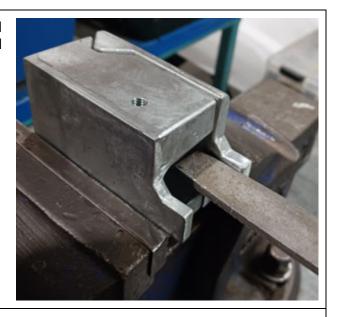
10. Remove the guiding block from the door lock mechanism and locate the injection point which causes the lock to jam.

11. Place the guiding block in a vise and ground all around the injection point until the surfaces become smooth.
