**MAINTENANCE
INFORMATION**

Mi03-14A

DATE : September	SECTION : 23 - Accessories
SUBJECT : HOW TO REPLACE THE POLLAK OR DIXSON INSTRUMENT CLUSTER BACKLIGHTING BULBS

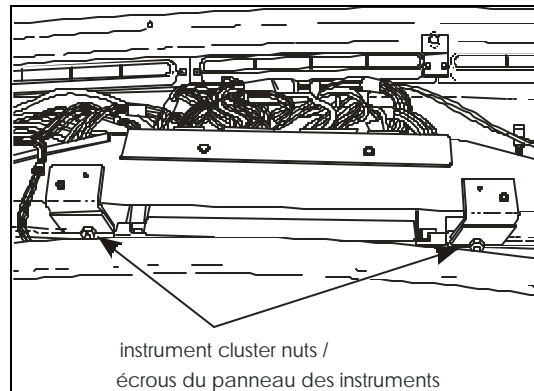
FIGURE 1

1. Remove the air from the air tank by applying the brakes repeatedly.
2. Remove the dashboard cover.
3. Disconnect the instrument cluster cabling.
4. Disconnect the 3 air hoses.
5. Remove the nuts fixing the instrument cluster to the dashboard housing (figure 1).
6. Remove the instrument cluster.

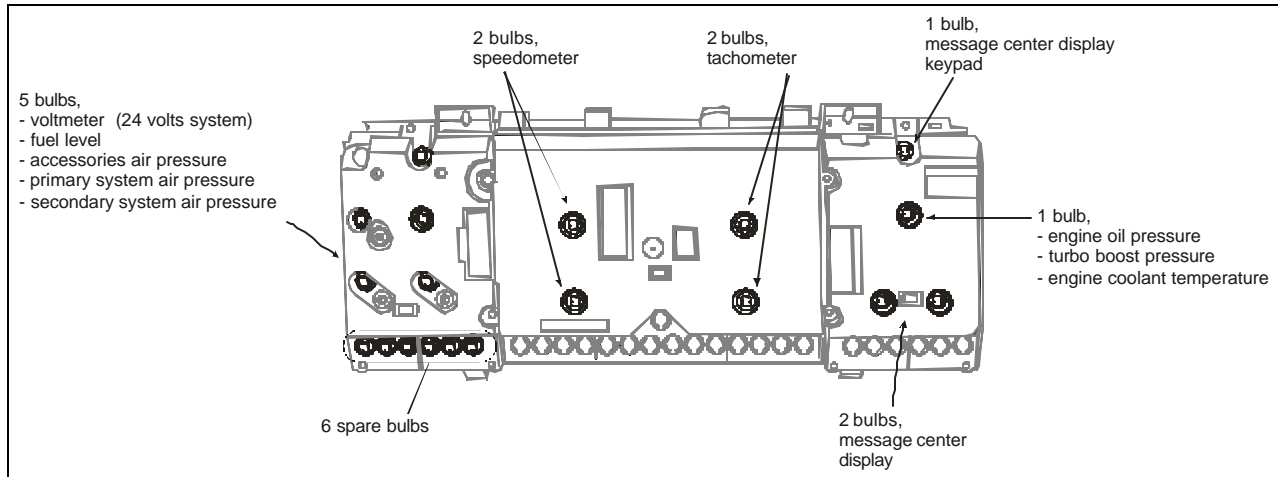
FIGURE 2: REAR VIEW OF THE POLLAK INSTRUMENT CLUSTER (DIXSON CLUSTER IS SLIGHTLY DIFFERENT)

SYMPTOM	ACTION (Pollak cluster)
RPM gauge appears darker than usual	Replace both bulbs located behind RPM gauge
Speedometer gauge appears darker than usual	Replace both bulbs located behind speedometer gauge
Message center display appears darker than usual	Replace both bulbs located behind message center display
Turbo pressure, oil pressure and engine coolant temperature gauges appear darker than usual	Replace the bulb behind these 3 gauges
Voltmeter, fuel level or pressure gauges appear darker than usual	Replace the 5 bulbs behind these gauges

Note: Having only one defective backlighting bulb is barely noticeable in normal operation except for the turbo pressure, oil pressure and engine coolant temperature gauges which are backlit by only one bulb. All other gauges are backlit by more than one bulb.

7. Insert removal tool onto the defective bulb.
8. Rotate ¼ turn and pull assembly out of the socket.
9. Insert the new bulb assembly into the removal tool.
10. Insert the assembly into the cluster socket and rotate ¼ turn.

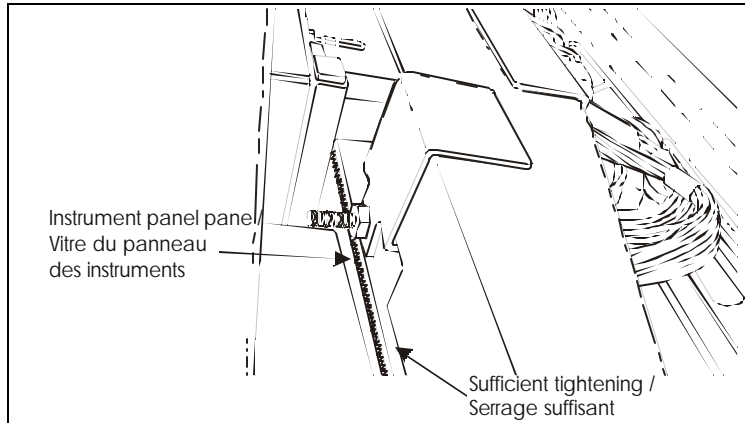
FIGURE 3

Note : The instrument panel supports may be lowered from 1mm to 2mm maximum if, after tightening, the pane does not clear the housing (figure 3).

12. Bring back the top of the instrument cluster, insert the screws and tighten the nuts until the instrument cluster rests against the housing (figure 3).
13. Reconnect the 3 air hoses.
14. Reconnect the instrument cluster cabling.
15. Reinstall the dashboard cover.
