PREVOST

MAINTENANCE INFORMATION

Mi98-38

DATE : September 1998	SECTION : 13
SUBJECT : Brake Air Chamber Cap Removal

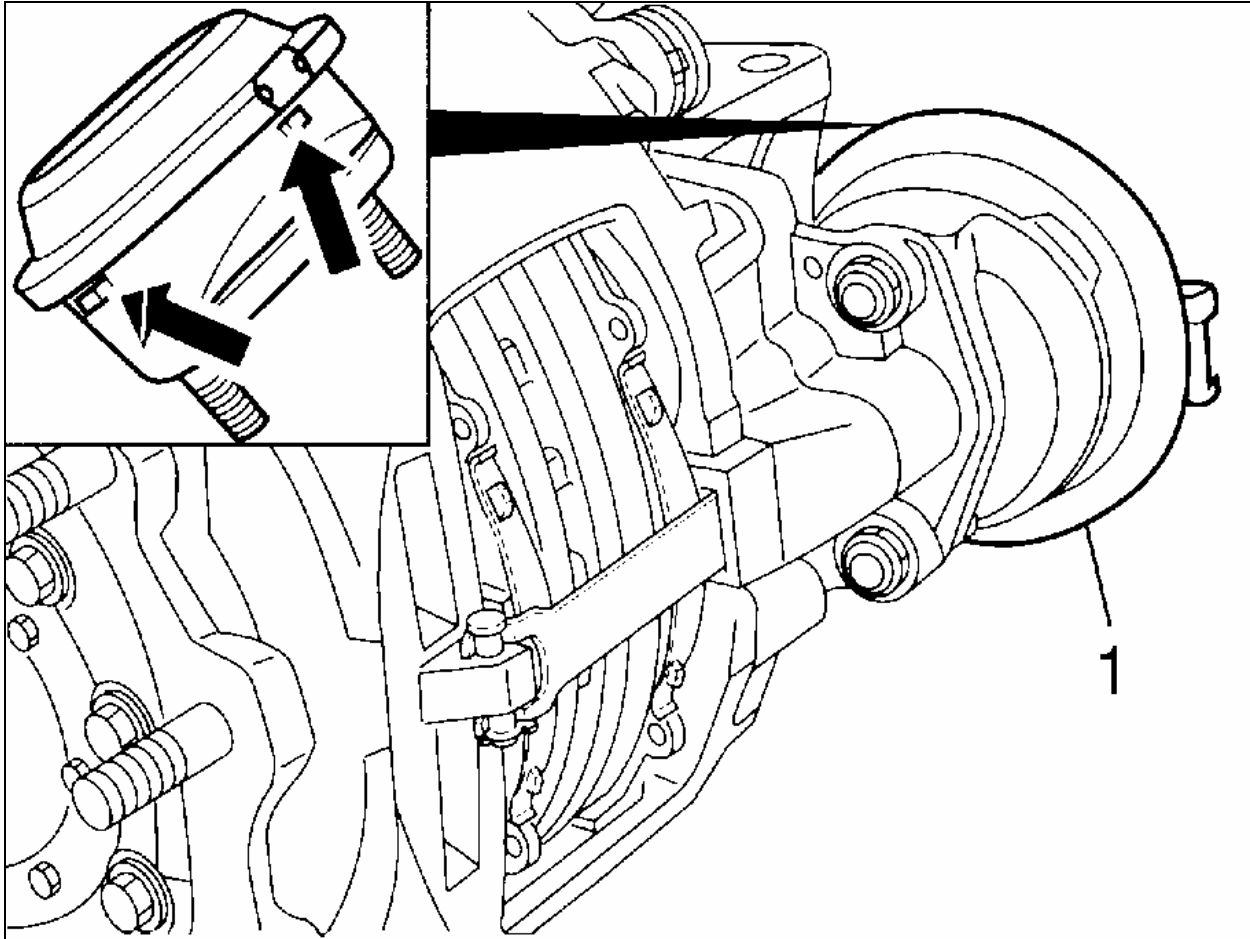
On the drive axle air brake chamber, a rubber cap needs to be removed in order to ensure the secondary chamber drainage.

Figure 1: Location of rubber caps on brake air chambers.

1. Lift vehicle using proper jacking points (refer to your vehicle's Maintenance Manual for further details);
2. Locate each drive axle brake air chamber (see figure 1);

3. With a screwdriver, remove the lowest rubber cap located on the air brake chamber (see enlarged portion in figure 1). Proceed on both sides of the vehicle, but only on the drive axle;
4. Lower the vehicle.
