**SAFETY
RECALL**

Sr00-17

DATE : August 2000	SECTION : 23 - Accessories
SUBJECT : UPPER A-ARM BALL JOINT INSPECTION ON INDEPENDENT FRONT SUSPENSION

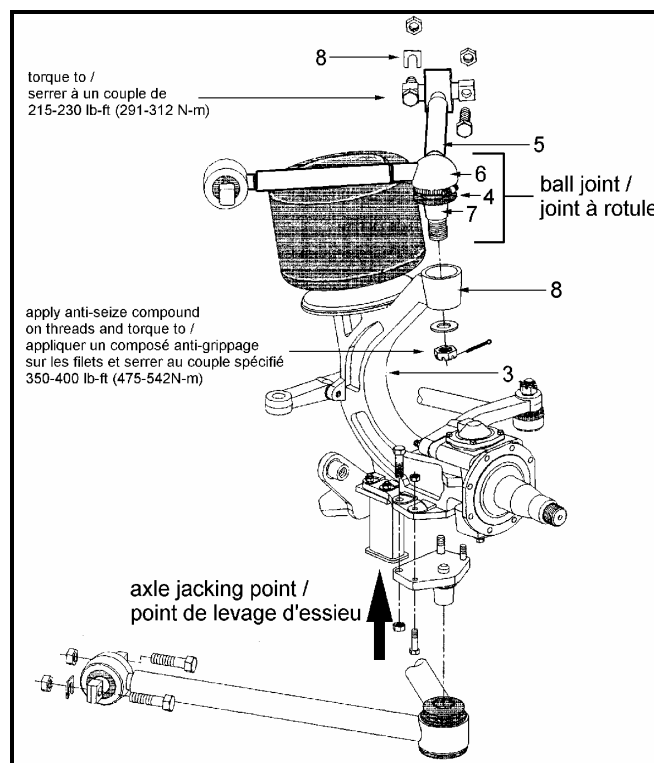
FIGURE 5 : INDEPENDENT FRONT SUSPENSION DETAIL

On the above mentioned vehicles, it is necessary to inspect the ball joint on the upper A-Arm. During normal use, on the high mileage vehicles (over 300 000 miles), it is possible that the ball joint sealing boot be perforated and grease leaks may occur. A joint with a perforated boot will have its life reduced and must be replaced. **You must make an appointment with the nearest Prevost service center in order to have your vehicle inspected.**

6. Check the boot • (figure 5) for perforations or grease leaks.
 - I. If sealing is perforated but there are no traces of grease contamination or rust, replace sealing boot only (Partie B).

- II. If sealing boot is perforated, there are traces of grease contamination or rust and the socket ● (figure 5) is not in good condition (see next step), the upper A-arm ● has to be replaced (Part C).

7. Locate the ball joint (figure 5).
8. Using a pry bar underneath the A-arm, apply an upward force as to separate the ball from the socket.
9. If there is a play between the ball and the socket, the upper A-arm ● has to be replaced (Part C). Take note that a play of $1/32$ to $1/16$ is normal and acceptable. If the play is normal and the sealing boot is in perfect condition, no replacement or repair is needed. See added supplement at the end of this bulletin.

6. Remove the cotter pin and partially unscrew the ball element retaining nut (figure 5). With the use of a hydraulic jack or a puller, extract the ball element from the conical sleeve • (figure 5). To facilitate extraction, change the position of the A-arm by changing the height of the vehicle.

7. Remove hose clip and clamping ring fixing the boot then take off sealing boot.
8. Fill sealing boot with 20 grams of Molykote Longterm 2/78 grease. Make sure that sealing boot is properly seated in the socket retaining groove and then fit hose clip and clamping ring.

9. Insert the ball element in the conical sleeve.
10. Apply anti-seize compound on threads and torque to 350-400 lb•ft (475-542 N•m). Insert the cotter pin.
