PREVOST

SAFETY RECALL

Sr03-06

SUBJECT: INSPECTION OF STEERING COLUMN

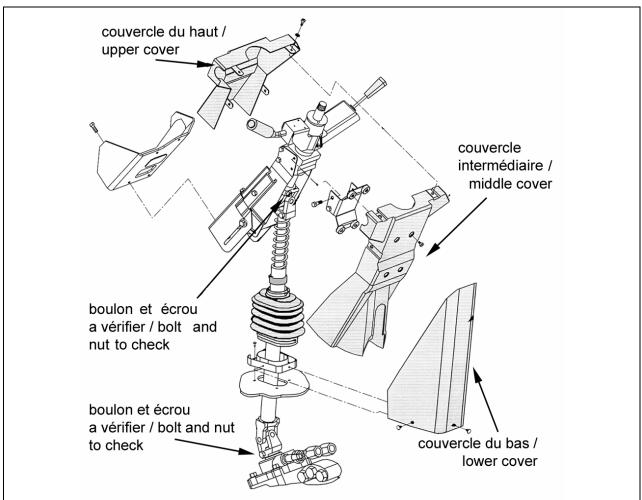
FIGURE 1: STEERING COLUMN

Some of the above mentioned vehicles may have had their steering column universal joint yokes secured with replacement fasteners that do not meet the manufacturer specifications. A groove in the steering gearbox input shaft prevents the yoke from disengaging even if the fasteners torque is insufficient. If replacement fasteners torque not proper, this protection is not provided and the yoke could separate from the gearbox input shaft when a steering column adjustment is done, resulting in a lost of control.

- 1. Locate the lower universal joint (figure 1) and check if the bolt and nut are up to the manufacturer's specifications. To do so, use a standard SAE 11/16 socket or a 17mm metric socket. If the dimensions of the nut and the bolt head fit with the socket, i.e. they could be tighten with the socket, they meet the manufacturer's specifications and they do not need to be changed. If they are too small and do not fit with the socket, they have to be changed according to part B of this recall.

- 2. From the driver's compartment area, remove the three plastic fasteners on steering column cover (figure 1). Remove the lower cover. Unscrew the four retaining screws on steering column middle cover. Unscrew the four retaining screws fixing steering column upper cover to middle cover. Remove the steering column middle and upper covers. Position the steering wheel in order to gain access to the joint. Check if the upper joint fasteners are up to the manufacturer's specifications as described in step 1.

- 1. Remove the nut and bolt that need to be replaced. Do not dismount the joint yoke from the shaft.
- 2. Put the proper nut and bolt in place and tighten to a torque of 43 lbf-ft (60 N·m).
- Reinstall the steering column covers.
