PREVOST

SAFETY RECALL

Sr09-10

DATE : JUNE 2009	SECTION : 14-STEERING
SUBJECT : INSPECTION AND REPLACEMENT OF DRAG LINK SPHERICAL PLAIN BEARING ROD END

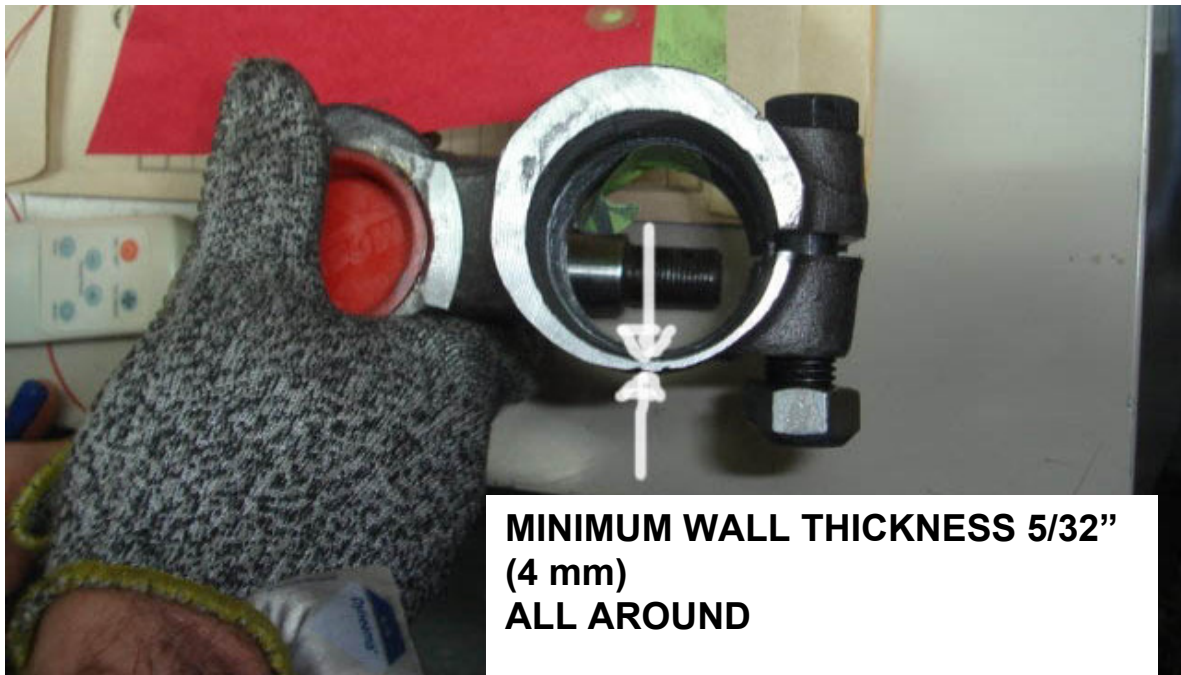
FIGURE 2

On items affected by this recall, material that may not meet Dana requirements for installation on the steering linkage of I-beam axle equipped vehicles have been purchased by you via Prevost Parts. Drag link end opening being off-centered, this can reduce the wall thickness below tolerances.

Inspect inventory parts ideally using a vernier caliper or an outside caliper and steel ruler (Refer to figure 2).

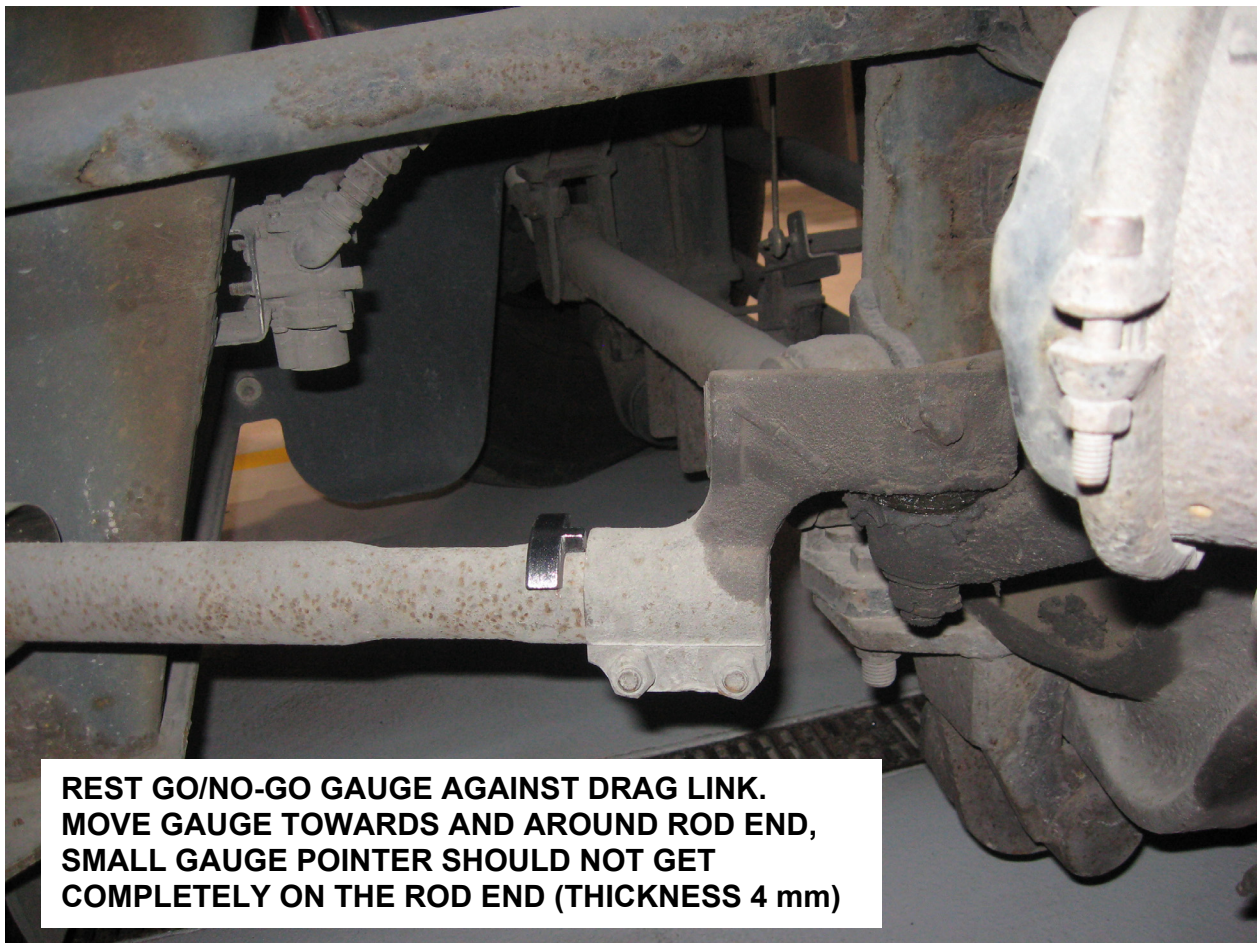
FIGURE 3

1. Raise vehicle in order to inspect already installed parts.
2. Clean drag link surface near the rod end and also spherical plain bearing rod end to ensure proper measurements (Refer to figure 3)
3. Use supplied go/no-go gauge (169159) to check wall thickness of the drag link spherical plain bearing rod end located near front L.H. side wheel without having to remove drag link. **Minimum wall thickness is 4 mm (0.158 inch or 5/32")**. While resting go/no-go gauge against drag link, if you can get the gauge completely on the rod end up to 10 mm (3/8") from the rod end extremity, rod end must be replaced (Refer to figures 3, 4 and 5).

NOTE
<i>Control thin sections of rod end.</i>

4. If measurement is outside tolerances, part 610991 must be replaced.
