**PREVOST**

## SAFETY RECALL

Sr12-29

<b>DATE :</b> SEPTEMBER 2012	<b>SECTION :</b> 23-ACCESSORIES
<b>SUBJECT :</b> AUTOMATIC FIRE DETECTION AND SUPPRESSION SYSTEM (AFSS) – PROTECTION OF LINEAR THERMAL DETECTOR (LTD)

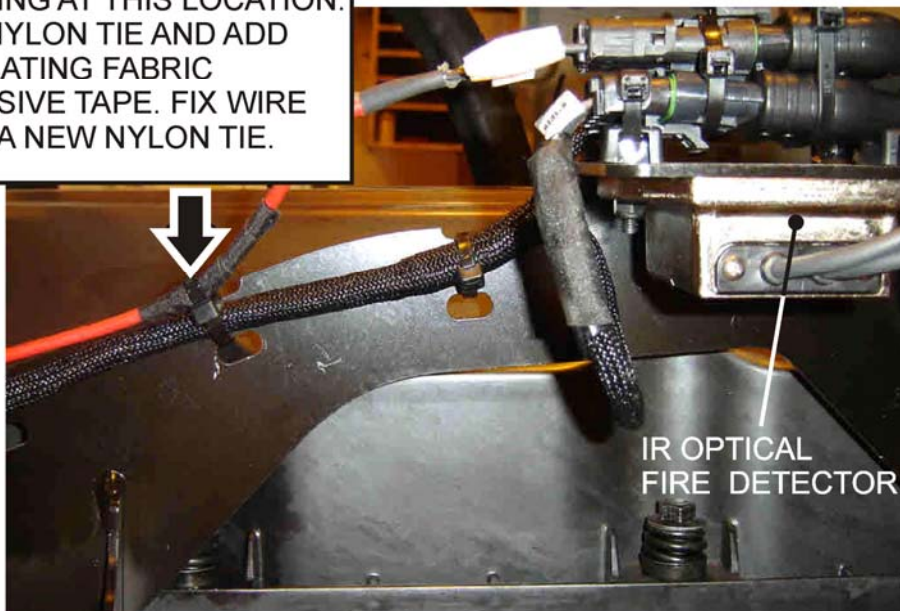
At only one location, the protective insulating fabric tape might be too short or improperly placed on the LTD (red cable) to prevent rubbing against the nylon tie.

PROTECT LINEAR THERMAL DETECTOR SHEATH FROM RUBBING AT THIS LOCATION. CUT NYLON TIE AND ADD INSULATING FABRIC ADHESIVE TAPE. FIX WIRE WITH A NEW NYLON TIE.

2. Cut and remove the existing nylon tie. Add enough fabric tape to protect LTD (red cable) from rubbing against the nylon tie. Fix LTD cable at the same location using included nylon tie.

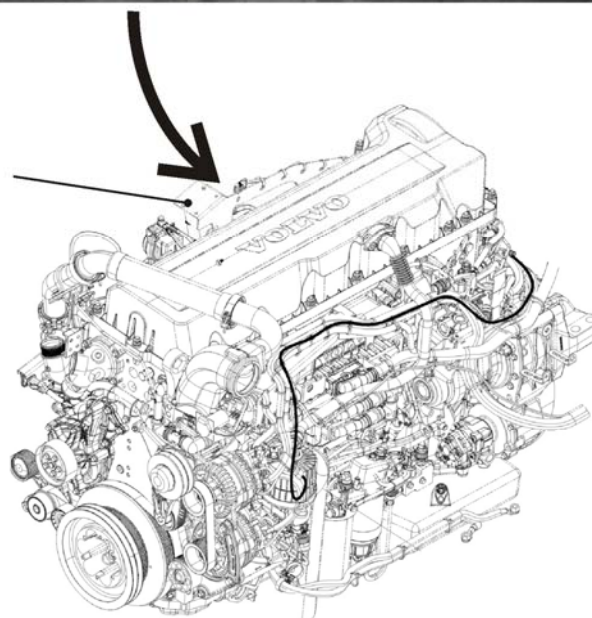
IR OPTICAL  
FIRE DETECTOR  
LOCATION

1. There is only one location where the protective fabric tape might be too short or improperly located. Check the engine turbocompressor side near the optical infrared (IR) fire detector (see image above).
