Safety Recall

SR12-61A

PASSENGER SEAT TRACK INSPECTION AND REPAIR.

9700 (B13R)

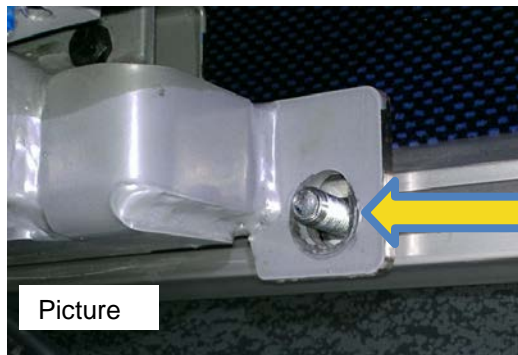
Picture

When the first nut is removed (picture 1), you will notice that the holes on the mounting brackets are slotted and they are generally NOT resting all the way down, but the seat has a tendency to “drop” on that side when the last nut is removed. **DO NOT look through the holes on the brackets for inspection.**

1. Take all mounting nuts off the wall mounts.

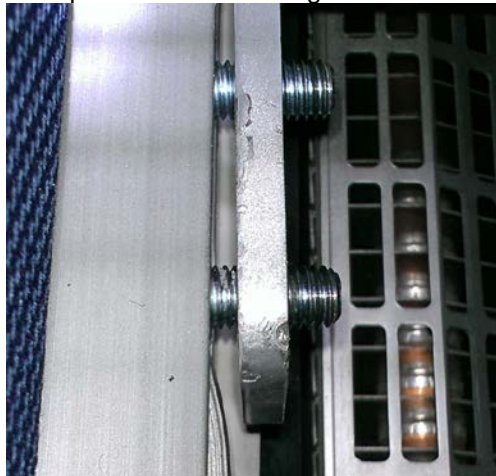
Picture 3

A “good” track (as shown on picture 3 below) will look perfectly flat around the bolt. If there is any deformation of the track surface around the bolt, which would be a sign of over-torquing, as the track has begun to “pull through” the mounting bracket.

This type of damage can generally NOT be noticed through the mounting holes, this is why it's important to inspect the track looking at it from the top (as shown on picture 3)

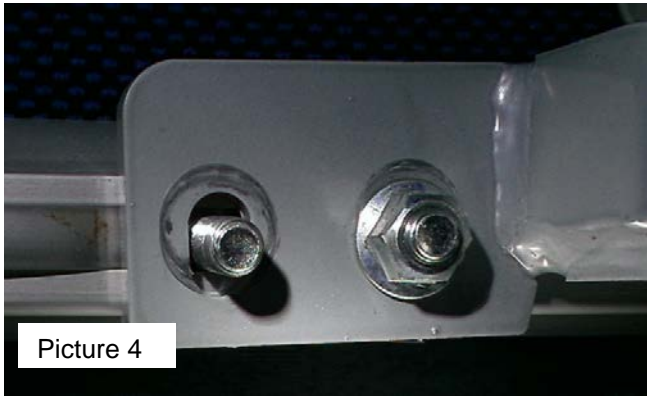
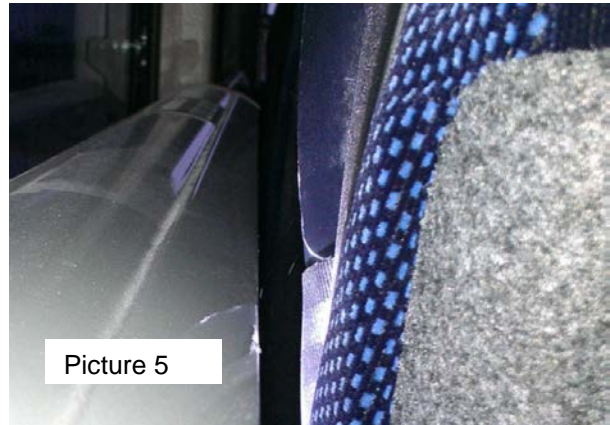
NOTE: you must inspect all seats on the side being worked on BEFORE re-assembling hardware, because if there's any damage found, you will be taking all that hardware back off to perform the necessary repair.

3. Once all the seat mounts have been inspected and no damage found, be sure to push each seat up on that side as it's being tightened. Verify torque to **23 lbf-ft**.

If the seat is too low on the wall side, it will pitch the backrest to where it might interfere with the emergency exit window. Once mounting is complete *always verify that the window can be opened freely*, without the bar touching the seat. This is extremely important
