PREVOST

**SAFETY
RECALL**

SR13-03E

DATE : MARCH 2013	SECTION : 23-ACCESSORIES
SUBJECT : AUTOMATIC FIRE DETECTION AND SUPPRESSION SYSTEM – LINEAR THERMAL DETECTOR REPLACEMENT

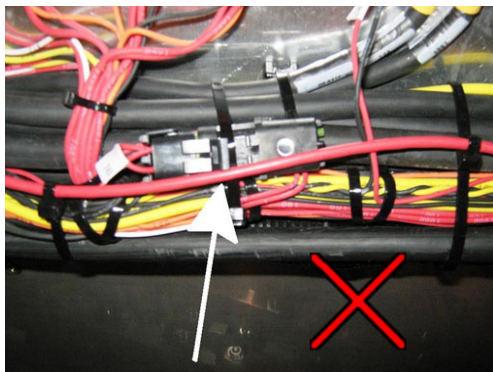
NOT ALLOWED

Possible contact or rubbing against screws, edges, etc.

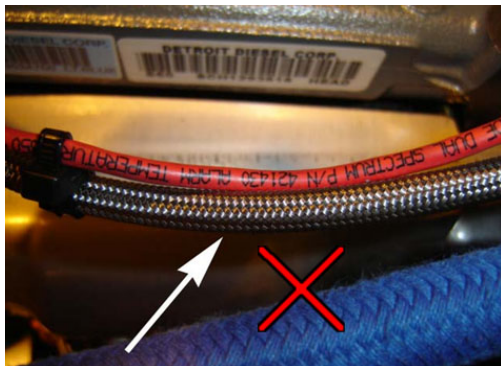
NOT ALLOWED

Rubbing or possible rubbing against abrasive surfaces

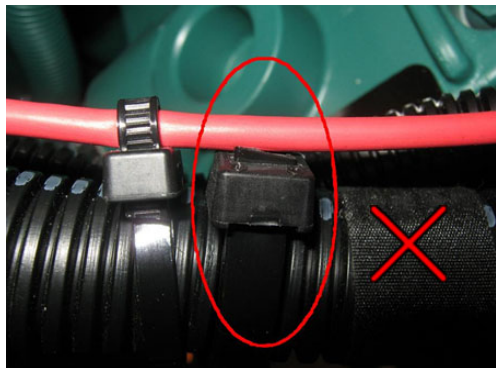
NOT ALLOWED

LTD touching cut cable tie

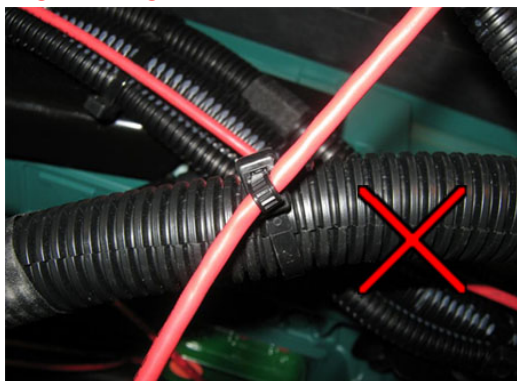
NOT ALLOWED

LTD extending slantingly from the cable tie

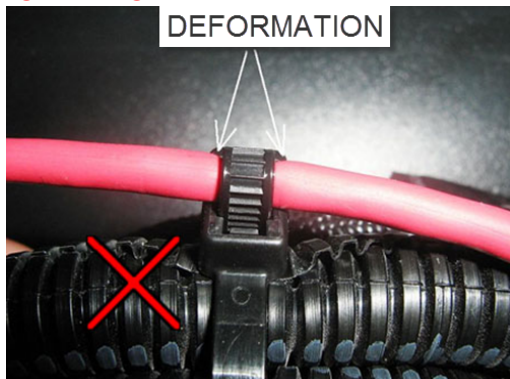
NOT ALLOWED

Cable tie tighten in excess on the LTD. Tighten cable tie on LTD by hand only. Tighten just enough to prevent LTD from slipping from once side to the other inside the cable tie loop

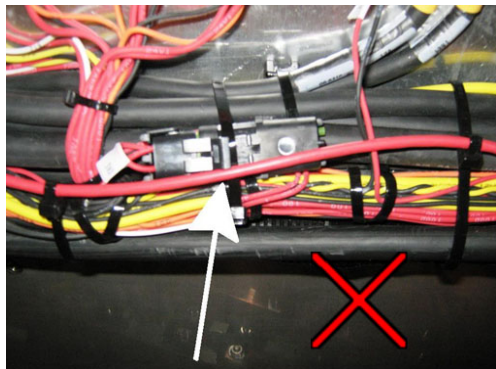
NOT ALLOWED

Possible contact or rubbing against screws, edges, etc.

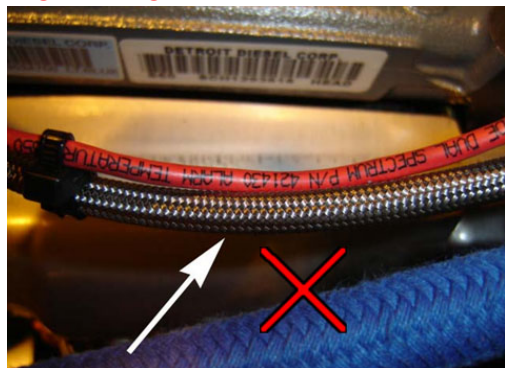
NOT ALLOWED

Rubbing or possible rubbing against abrasive surfaces

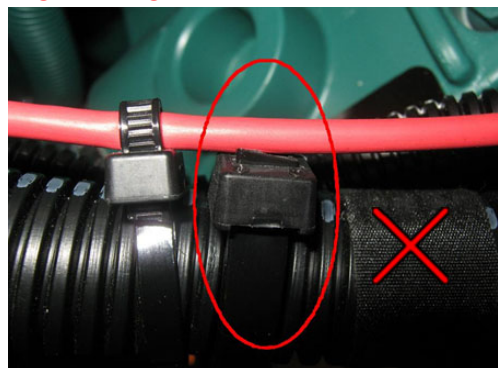
NOT ALLOWED

LTD touching cut cable tie

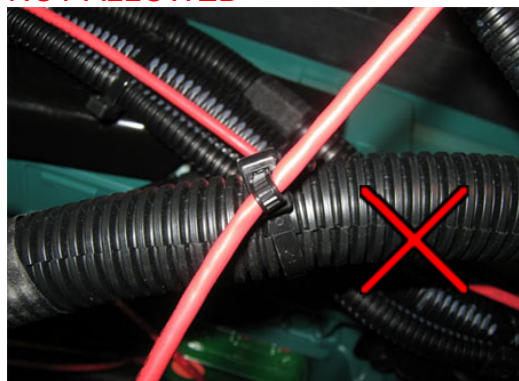
NOT ALLOWED

LTD extending slantingly from the cable tie

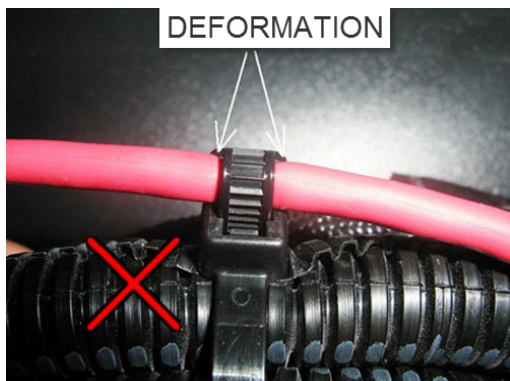
NOT ALLOWED

Cable tie tighten in excess on the LTD.
Tighten cable tie on LTD by hand only.
Tighten just enough to prevent LTD from slipping from once side to the other inside the cable tie loop
