**SAFETY  
RECALL**

**SR14-26A**

DATE :	JUNE 2014	SECTION :	18 - Body
SUBJECT:	SEAT BELT INSPECTION AND REPLACEMENT: AMAYA FLIP-UP SEAT

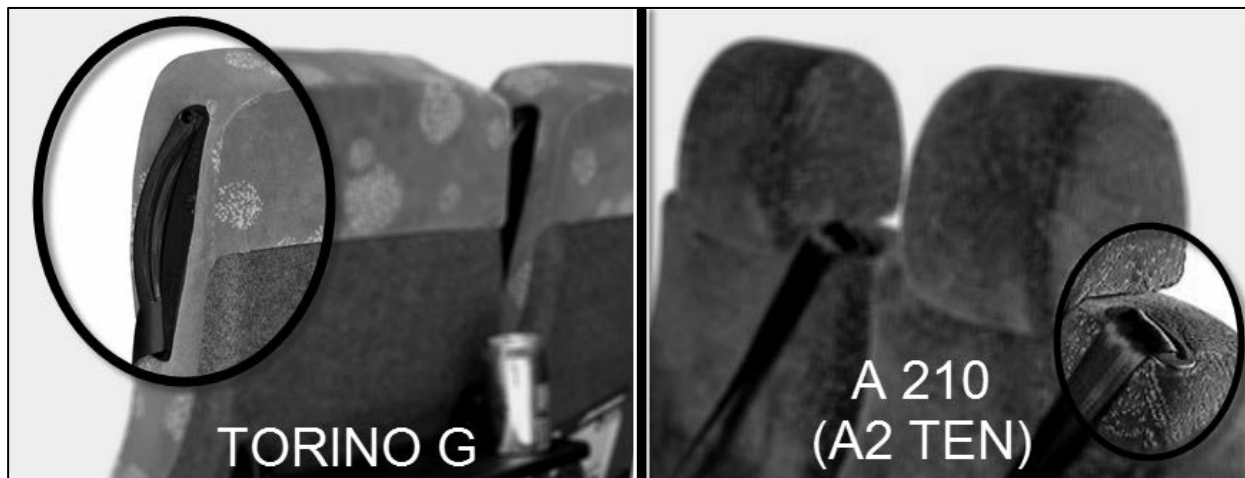
Figure 1: Seat differentiation

On the vehicles equipped with a wheel chair lift and AMAYA TORINO G or A210 (A2 TEN) flip-up seats (fig 1), the seat cushion frame when raised and lowered may rub against the seat belt anchor point on wall side. This presents a risk that the seat belt may be damaged over time and may fail if a crash occurs. If the seat belt fails during a crash, the occupant may be injured.

Depending on seat model (Fig 1), order one of the following kits for each belt to replace:

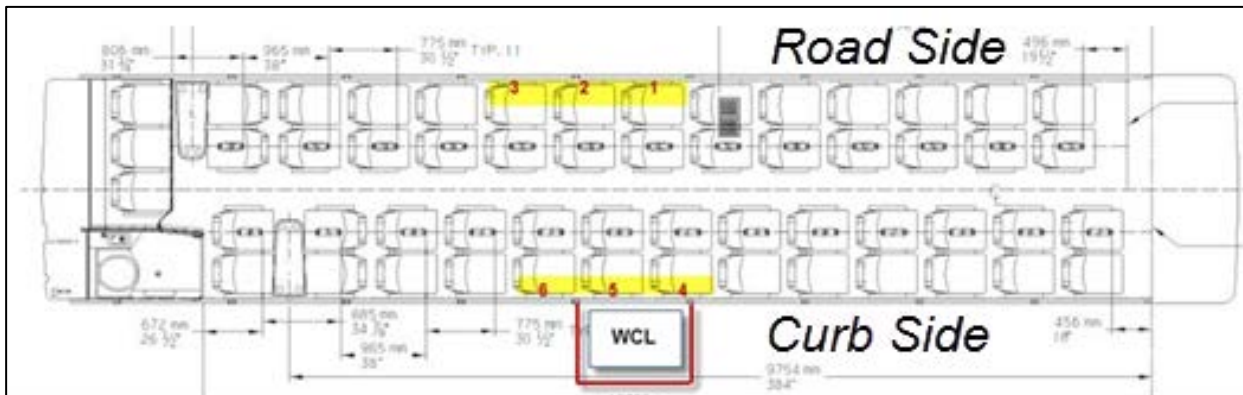
Figure 2

The outboard (wall side) seat belt anchor of all flip-up seats must be inspected for damage. (fig 2 & 3).

**Note:** the damage to the belt can sometimes be hard to see. Use a flash light, if necessary and expose the underside of the belt that is located in and around the anchor loop.

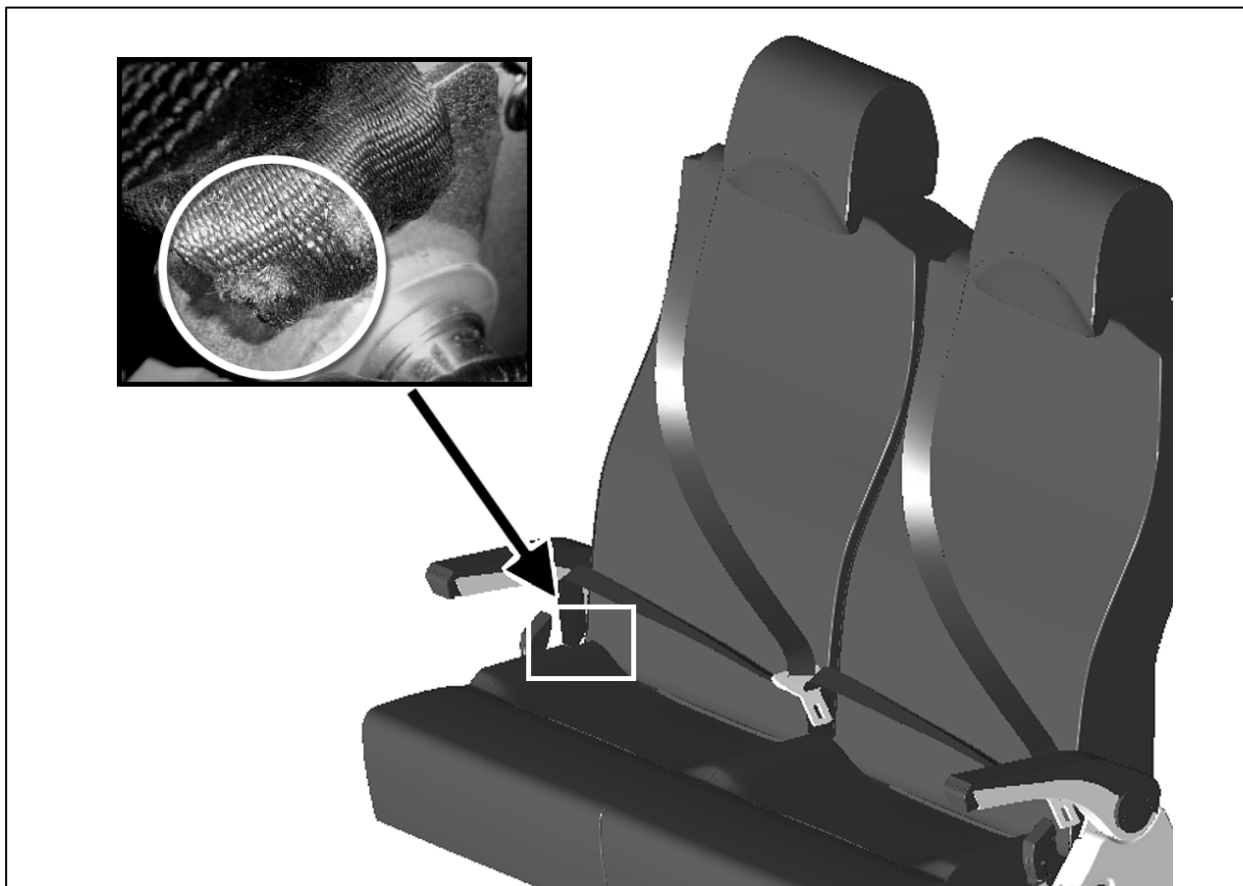
Figure 3: Typical belt damage (Curb side seat)

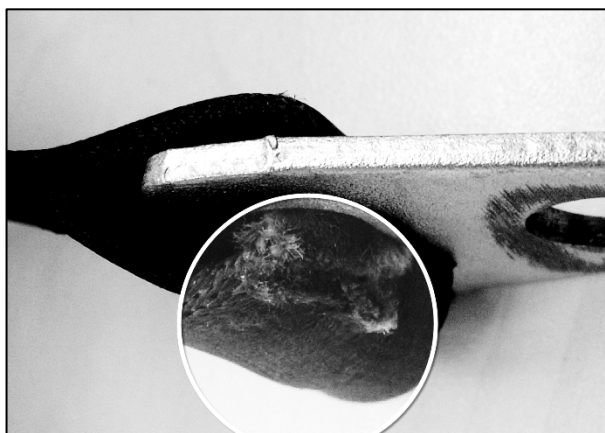
If it is damaged (Fig 5), replace with a new belt.

Figure 5: Typical Damaged belt

For Torino G models, order kit SR14-26-1.

For A210 models, order kit SR14-26-2.

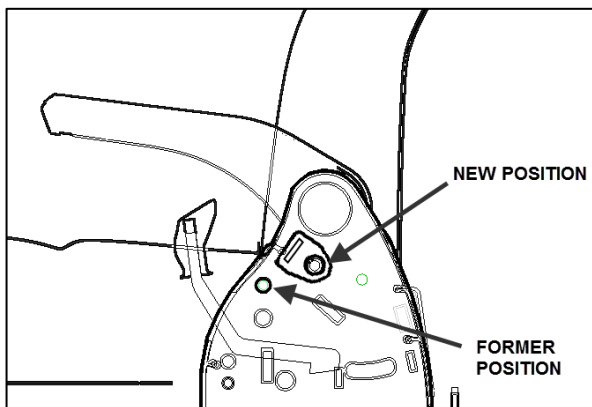
Figure 10: New position of belt anchor.

7. Re-install belt anchor in new location as shown, away from pivot. (Fig 10 & 11)

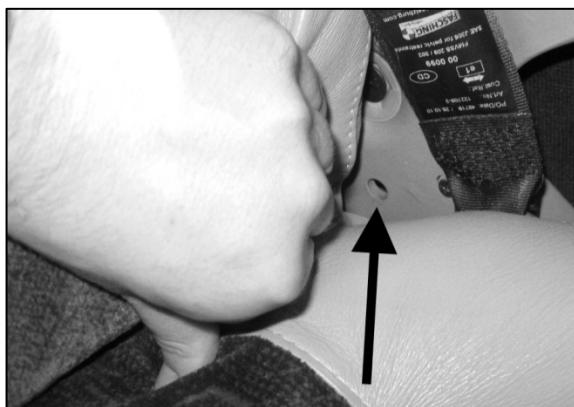
Figure 11: New position

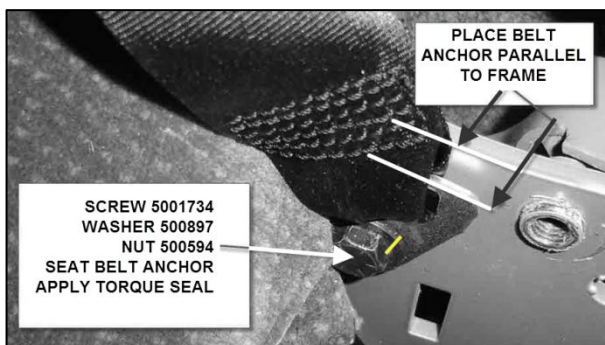
Figure 12: New hardware and torque seal

8. Belt anchor plate should be installed parallel to seat frame.

Install with:  
5001734 Screw  
500897 Washer  
500594 Nut

**Tighten to:35 lbf-ft**

Apply torque seal mark to confirm belt relocation. (Fig 12)
