Warranty Bulletin

95-08

Date: **April 1995**
 Section: **06**
 Subject: **Evaporator Motor Supply Cable**
 Application:

Model	VIN
Le Mirage "XL" Coach	2P9L3340XM1001883 up to 2P9L33409R1001994 inclusively

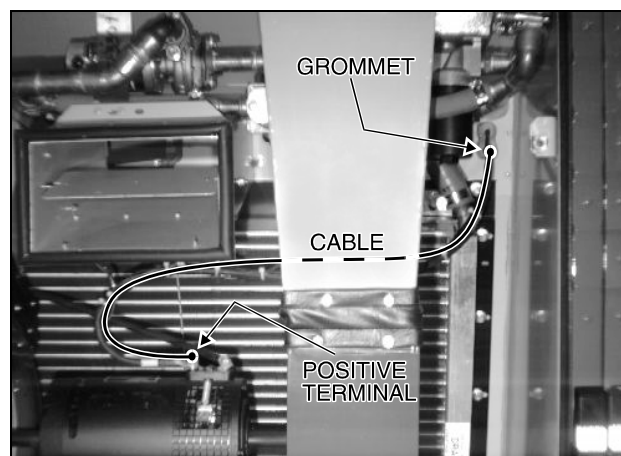
FIGURE 1

On the above-mentioned vehicles, the routing of the evaporator motor cable is inadequate, and could short-circuit, eventually causing a fire. We ask you to replace the supply cable according to the following procedure.

1. Inside evaporator compartment (on L.H. side of vehicle), locate evaporator motor (Fig. 1). Disconnect cable from positive terminal (L.H. side) from evaporator motor. Cut cable ties and undo retaining clips on cable route. Scrape off caulking around the grommet.
