**WARRANTY
BULLETIN**

Wb04-05C

DATE : MARCH 2006	SECTION : 05 - Cooling
EXPIRATION: MARCH 2008	
SUBJECT : REPLACEMENT OF THE BELT TENSIONER BELLOWS ATTACHMENT BRACKETS

REVISION : C

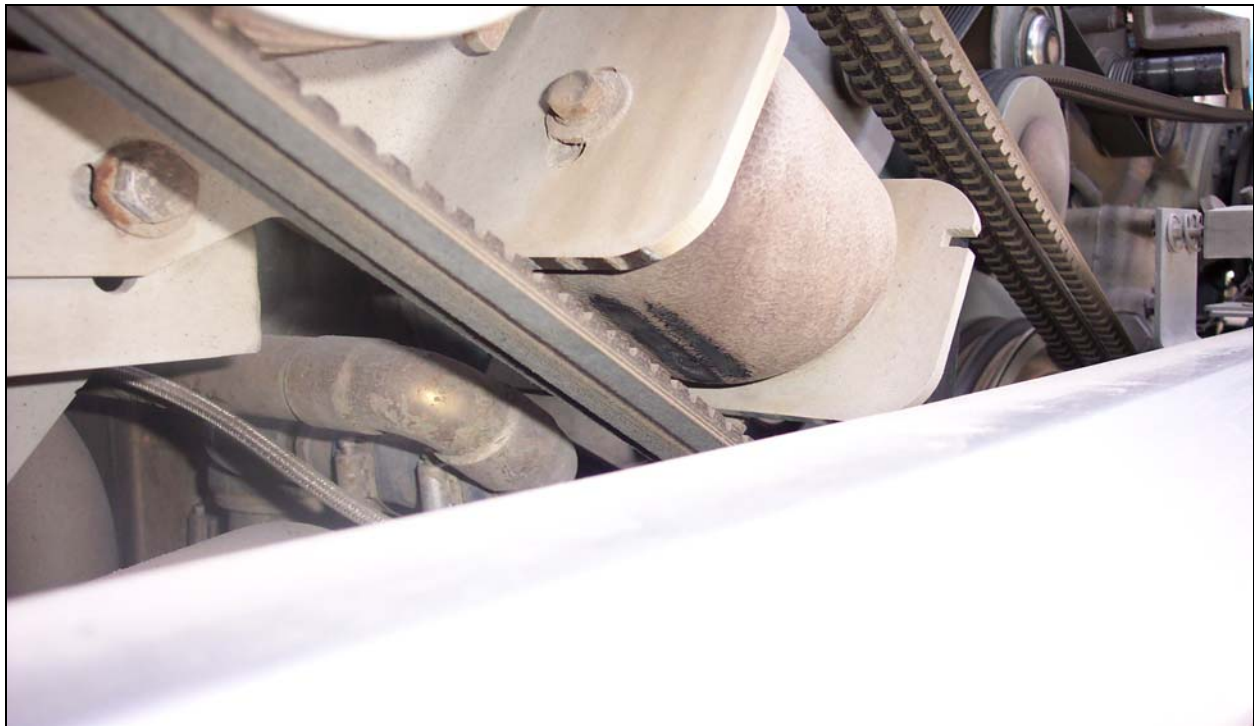
FIGURE 3

1. Inside the engine compartment, release pressure from the air bellows by turning the belt tensioning pressure control valve handle to OFF (figure 1 & 2).
2. Disconnect the air lines and fittings from the bellows (figure 5 & 6).
3. Dismount the attachment brackets and bellows.
4. Check if the air bellows and belts were damaged as shown in figure 3, replace as needed.
