**PREVOST**

**WARRANTY  
BULLETIN**

Wb04-07

<b>DATE : SEPTEMBER 2004    SECTION : 07 - Transmission</b>
<b>EXPIRATION: SEPTEMBER 2006</b>
<b>SUBJECT : INSPECTION OF CLUTCH ACTUATOR AIR LINE ON ZF-ASTRONIC TRANSMISSION</b>

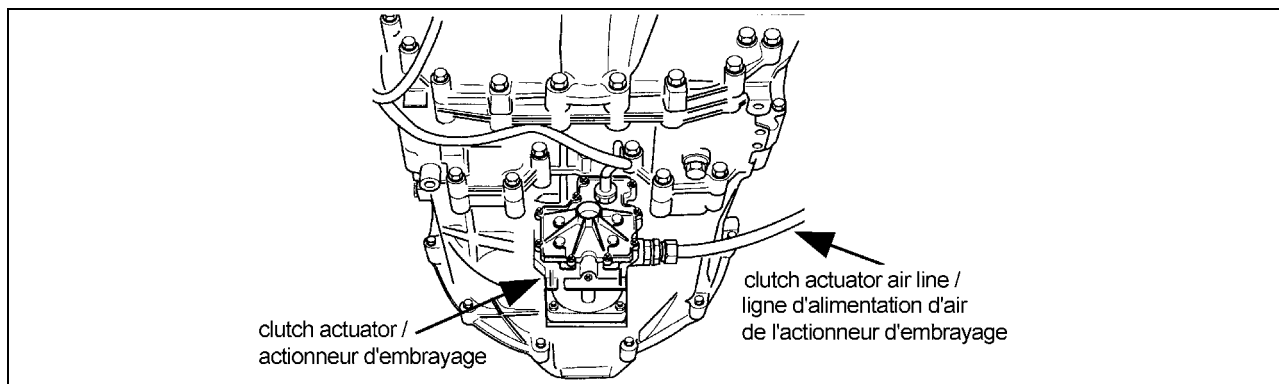
Figure 1: LOCATING THE CLUTCH ACTUATOR AND AIR LINE

1. Under the transmission, locate the clutch actuator and the air line (Figure 1).
2. Inspect the clutch actuator air line up to the air tank (Figure 2) especially where the air line passes through the transmission protective panel. There is a risk of rubbing between the air line and the passing hole. Check for cuts, rub or abrasion marks on the nylon tubing.

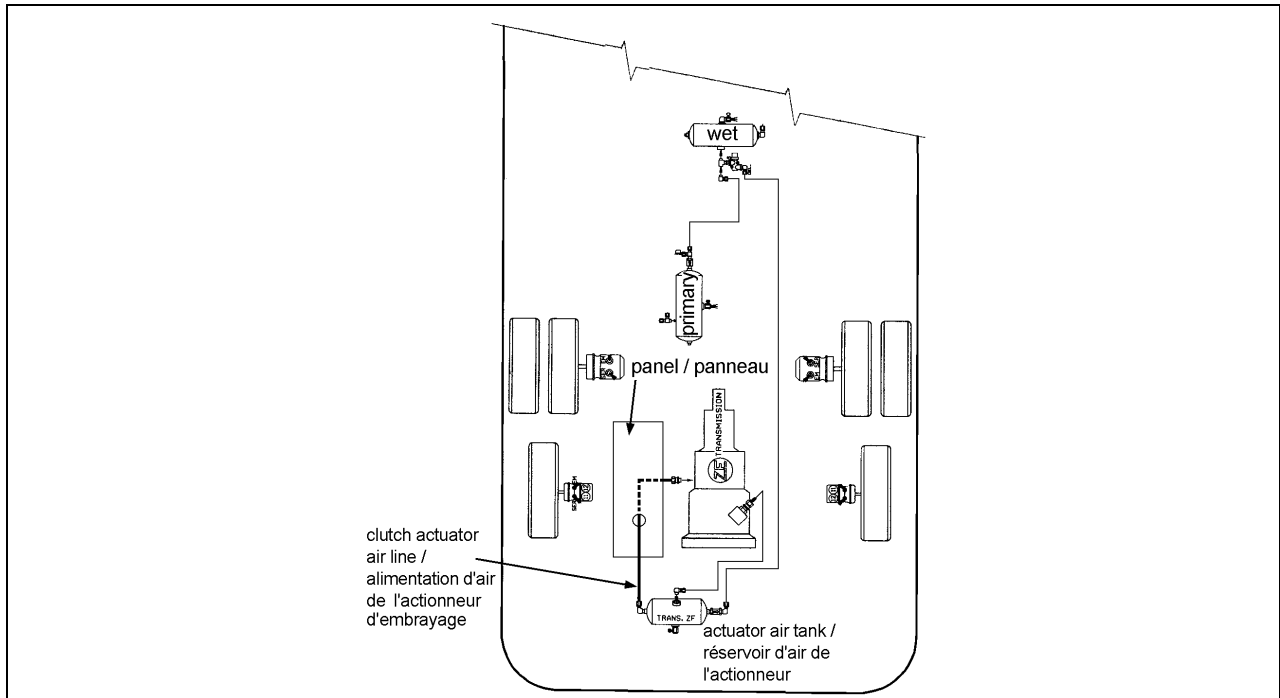
Figure 2

On the vehicles equipped with ZF-Astronic transmission, it is necessary to inspect the clutch actuator air line. There is a risk of rubbing between the air line and the transmission protective panel which may cause rapid wearing of the nylon tubing. Corrective measures must be performed to prevent this problem.

1. If there is evidence of rubbing between the nylon tubing and the transmission protective panel, enlarge the passing hole and properly secure the air line to prevent from moving and rubbing.

*Before tackling step 2, purge the clutch actuator air tank (Figure 2).*

2. If necessary, remove the damaged section of nylon tubing and join the air line using one **5/8" OD union fitting (Prevost #501901)**. If a longer section of damaged tubing is removed, replace with **5/8" OD Parker Parflex black tubing** and use two **5/8" OD union fittings (Prevost #501901)**. If the entire air line is replaced, use the forementioned nylon tubing type.
3. Assure that the tank air cock is closed. Start the vehicle and wait long enough for the tank to be refilled with air.
