WARRANTY BULLETIN

Wb06-08

DATE: OCTOBER 2006	SECTION :	06 - Electrical		
EXPIRATION: OCTOBER 2	2008			
SUBJECT : REPLACING 24-VOLT RELAYS IN THE REAR JUNCTION BOX

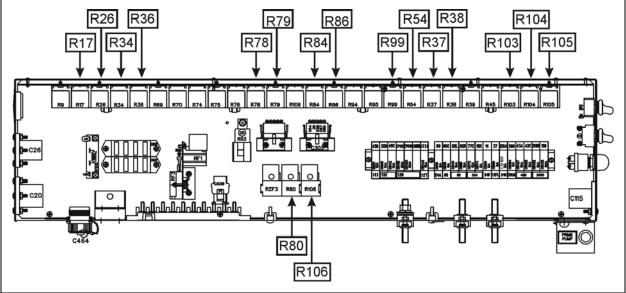
FIGURE 1 : REAR JUNCTION BOX ON COACHES

In specific applications, the 24-volt relays P/N 563332 need to be replaced by improved 24-volt relays that are more appropriate for their duty, in order to prevent any risk of failure. For this reason, it is recommended to replace all 24-volt relays P/N 563332 which function implies extended coil activation.

- 1. Inside engine compartment, open the rear junction box access panel.
- 2. On coaches, replace the relays identified on figure 1. On Entertainer's, replace the relays identified on figure 2.

If the relays are kept, it is very important not to use them as replacement parts for the following relays: R17, R26, R34, R36, R37, R38, R54, R78, R79, R80, R84, R86, R99, R103, R104, R105, R106.
