**WARRANTY
BULLETIN**

Wb09-13A

DATE : MARCH 2010	SECTION : 05 - Cooling
EXPIRATION: MARCH 2012	
SUBJECT : INSPECTING THE RADIATOR FAN DRIVE MECHANISM SUPPORT ON A DETROIT DIESEL ENGINE

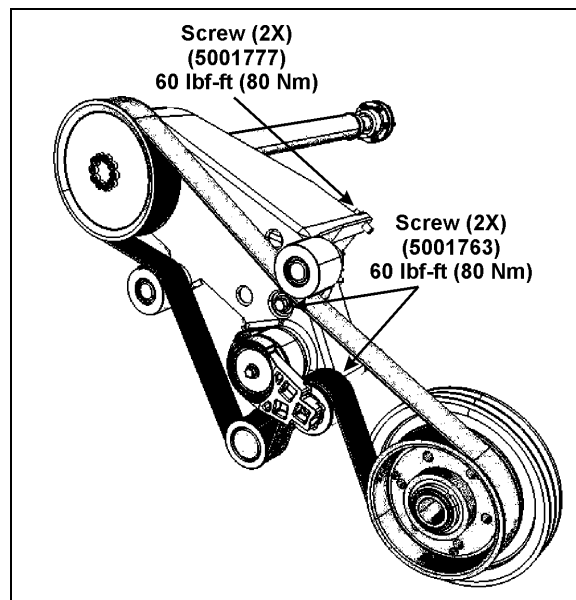
FIGURE 1: SUPPORT # 550919

On the vehicles affected by this bulletin and equipped with a Detroit Diesel engine, it is **absolutely necessary** to check the radiator fan drive mechanism support. There is a possibility that the cap screws were not tightened to the proper torque and for that reason may result in cracks in the drive mechanism support. The vibrations generated may require replacing the drive mechanism support.

Check especially belt tensioner area and cap screws clamping area.

1. After inspecting the radiator fan drive support, for purpose of reference, mark cap screw heads and support.
2. Torque radiator fan drive mechanism support short cap screws to 60 Lb-ft (80 Nm) (Refer to figures 1 and 2).
3. If the two cap screw heads do not move, the verification is complete; there is nothing to replace.
4. If the two cap screw heads move but less than $\frac{1}{4}$ turn (90° angle), replace the two short cap screws with new ones (5001777).

5. First pre-torque cap screw heads to 25 Lb-Ft (34 Nm).
