AFTERTREATMENT HYDROCARBON INJECTOR (AHI) FUEL LINE FITTINGS -  
 PROPER TIGHTENING VERIFICATION  
 9700 (B13R)

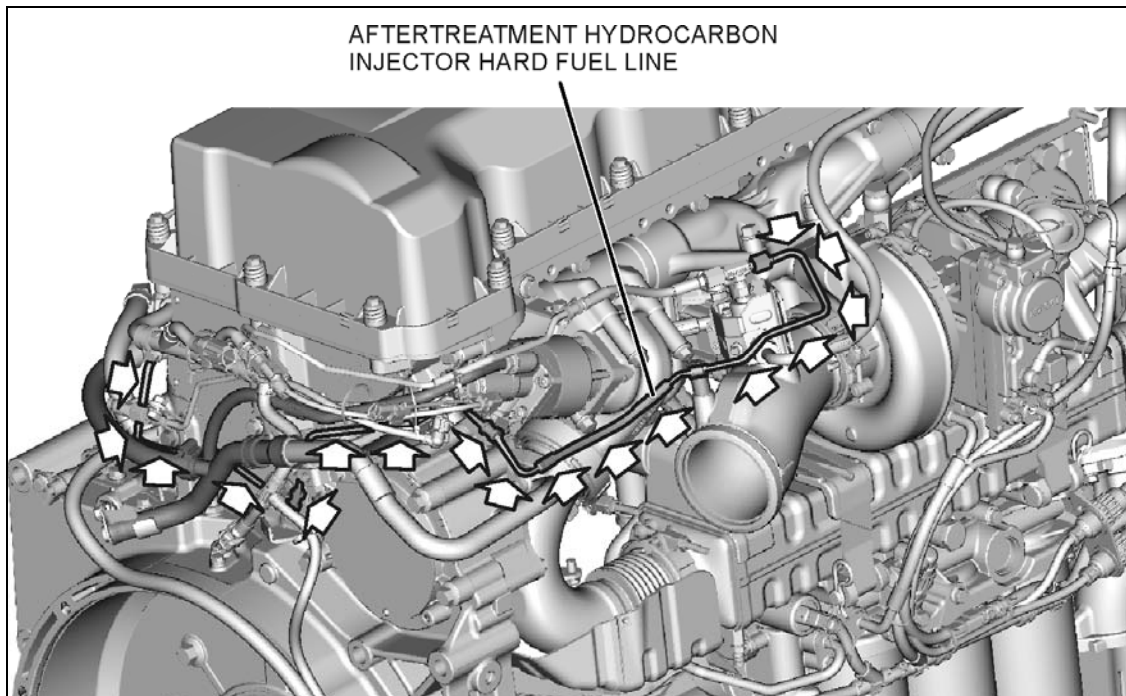
FIGURE 1

- 1) Open the engine compartment door and the engine access hatch found at the rear of the passenger's area.
- 2) Locate the aftertreatment hydrocarbon injector hard fuel line on the engine (see figure 1).

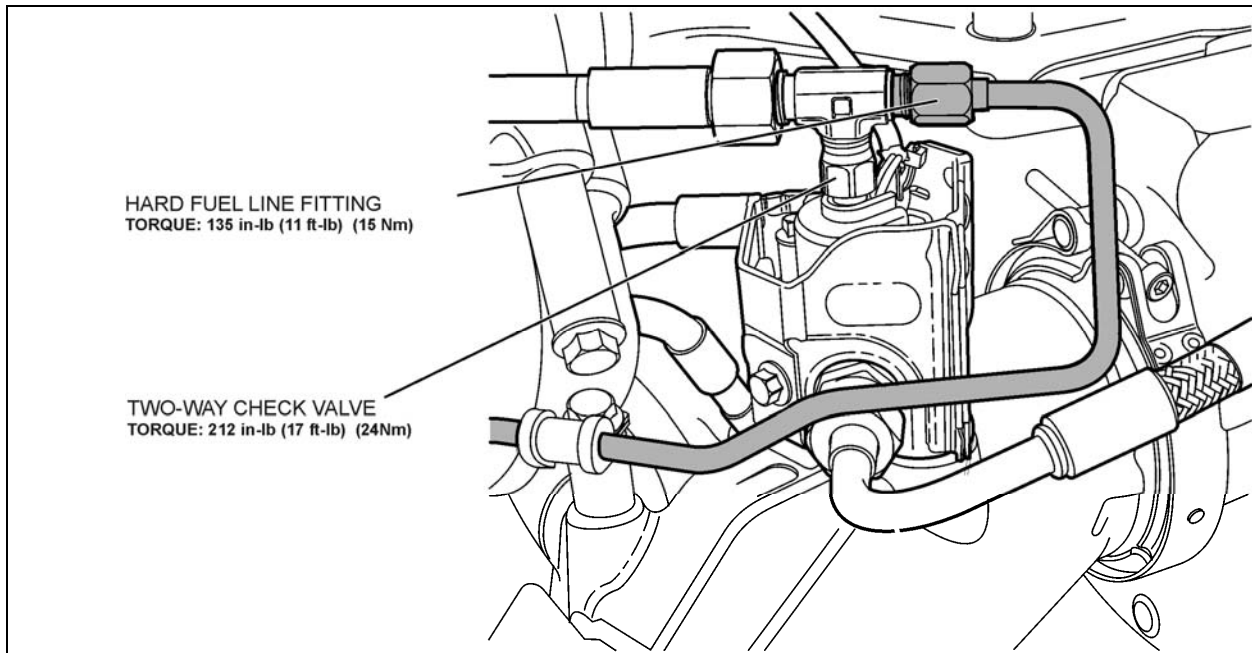
FIGURE 2

On the vehicles affected by this bulletin, it is necessary to check that the aftertreatment hydrocarbon injector hard fuel line fittings are properly tighten. Loose fittings can leak.

- 3) Check that the hard fuel line fitting connected to the two-way check valve is properly tighten (see figure 2). If necessary, tighten fitting to prevent fuel leaks (torque: 135 lb-in, 15 Nm). When tightening the fuel line fitting, secure the two-way check valve with a wrench, do not allow tightening force to be transmitted to the check valve nipple. Damage to nipple can result.
- 4) While securing the two-way check valve with a wrench, tighten the check valve swivel nut if loose (torque: 212 lb-in, 24 Nm).
