WB11-54

AIR SPRING MEMBER REPLACEMENT 9700 (B13R)

MODEL YEAR(S) AND VEHICLE SERIAL NUMBERS (VIN) INVOLVED

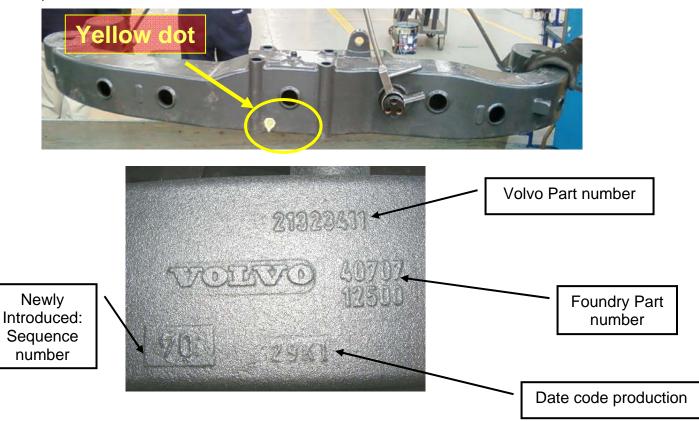
On the vehicles affected by this bulletin, the left-hand and right-hand side air spring members are not compliant and have to be replaced as soon as possible and before the expiration of this bulletin. The new members can be recognised by the yellow dot they have and/or a sequence number of the casting, see pictures below.
