**PREVOST**

**WARRANTY  
BULLETIN**

WB12-18

DATE : AUGUST 2012	SECTION : 23 - Accessories
EXPIRATION: AUGUST 2014	
SUBJECT : AFSS HARNESS MODIFICATION IN FRONT SERVICE COMPARTMENT

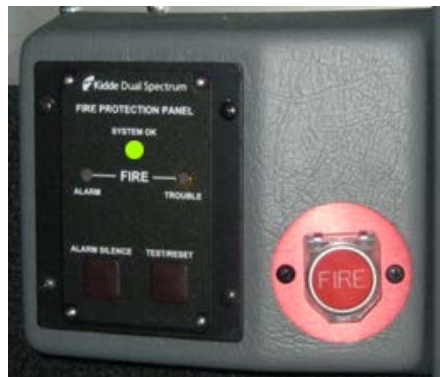
Make sure the green « SYSTEM OK » LED is illuminated on the AFSS control panel.

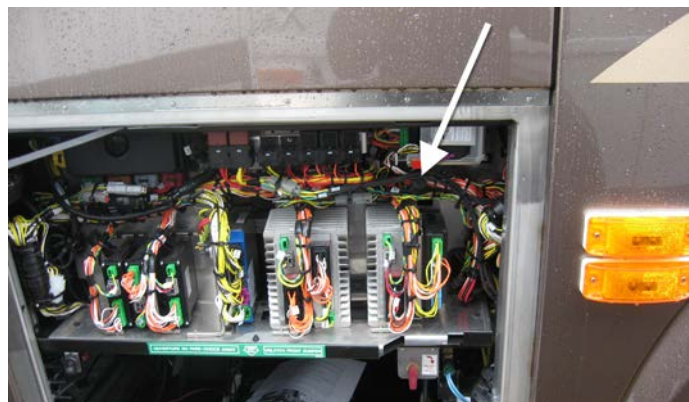
Locate fuse F45 in the front service compartment.

Following the harness path from fuse F45 towards the front of the vehicle, locate the harness identification tab.

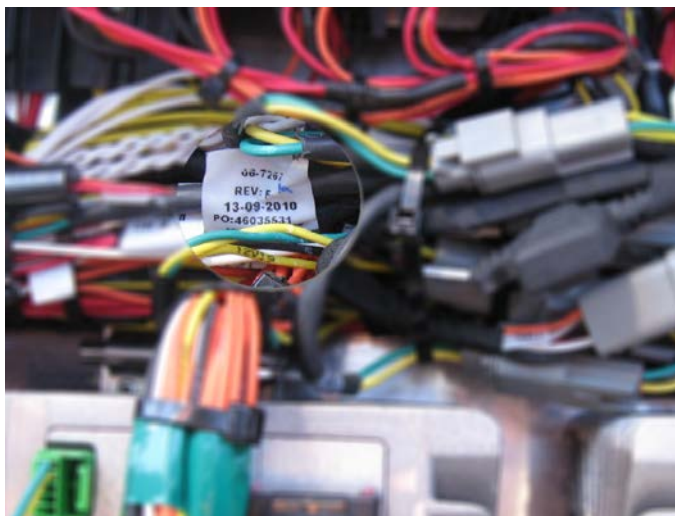
This bulletin applies only to:

*Harness 067267 RevG*

or

*Harness 068270 RevC*

Any other version of the harness is not submitted to this modification.
